SUBJECT: Rancher died when he was crushed beneath an overturned tractor

SUMMARY

A 59-year old rancher died on August 10, 2001 from injuries received when he was crushed beneath the overturned tractor that he was operating. OKFACE investigators concluded that to prevent similar occurrences, employers should:

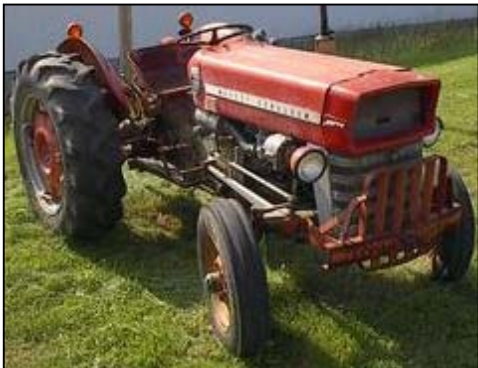
At the time of the incident, the victim was operating a tractor equipped with a brush hog. The tractor, which was manufactured no later than 1975, was generally in good operating condition at the time of the incident but was not equipped with a rollover protective structure or a seat belt. OKFACE investigators did not identify any objective evidence that the farm operation had a formal safety program.

Figure 1. Tractor similar to the one used by the rancher

The temperature at the time of the incident was approximately 98°F, and there had been no measurable precipitation for at least 10 days. The decedent was using a tractor (similar to the one shown in Figure 1) equipped with a brush hog to mow a hayfield located along a creek approximately three to four miles from his home. He was last seen at approximately 3:30 p.m. when he drove the tractor from his home to the hayfield.

Discussion: Although the tractor was otherwise reportedly in good condition, OKFACE investigators determined that the tractor was not equipped with a rollover protective structure (ROPS) or seatbelt. The tractor was not originally equipped and delivered from the manufacturer with a ROPS or seatbelt; however, a retrofit has been available for several years. The installation of such equipment, as required by Occupational Safety and Health Administrative regulations for equipment used by employees, may have prevented the fatal injuries sustained by the operator when the tractor overturned on top of him.

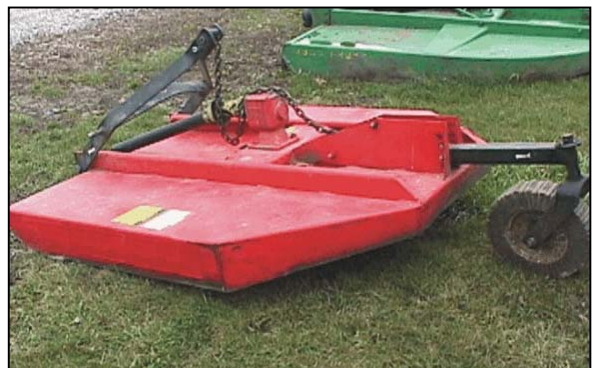
Figure 2. Brush hog
