# City Maintenance Worker Dies After Being Pinned In Street Sweeper

MN FACE Investigation 02MN034

Date: February 26, 2003

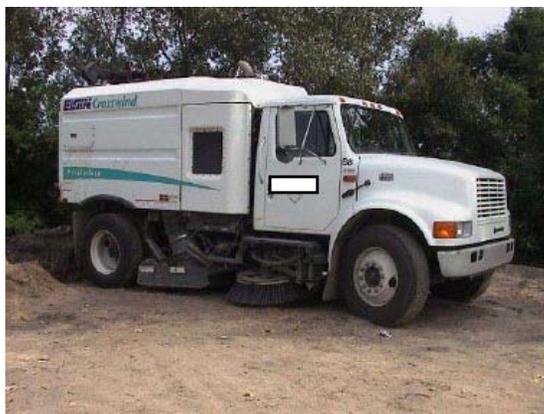
The sweeper that the victim was operating was purchased new by the city in 2000. The sweeper was an Elgin Series J Crosswind Sweeper (Figure 1). The crosswind design uses a device called an impeller to move air through the sweeper in a continuous loop. The air is blown down a pressure hose on the left side of the unit, through a pressure slot and into the sweeper's pickup head. This creates turbulence as the air flows across the pickup head and lifts debris from the street. Air and debris are pulled from the right side/end of the pickup head through a large suction hose. The air and debris then

Figure 1. Elgin Series J Crosswind Sweeper at the incident site.

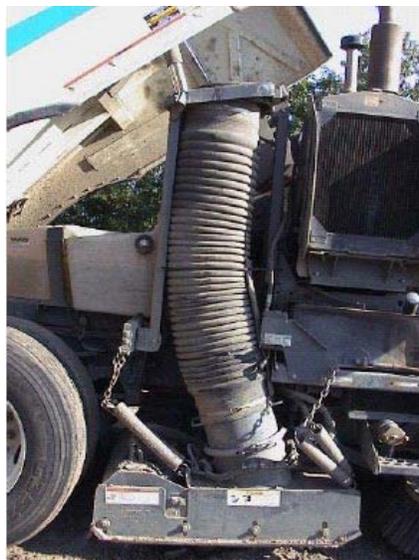
The sweeper's pickup head is 90 inches long, extends across the width of the sweeper and is located in front of the unit's rear wheels. A twelve inch diameter flexible suction hose connects one end of the pickup head to the sweeper's collection hopper. The suction hose is about 5 feet long and extends vertically from the end of the pickup head in front of the right rear wheels to a round opening in the bottom of the hopper (Figure 2). When the hopper is in the lowered position, the hopper contacts the discharge end of the suction hose and forms a seal for the transfer of debris from the pickup head to the collection hopper. When the hopper is raised to empty the sweeper, the seal between the discharge end of the suction hose and the hopper is broken as the hopper is raised.

Figure 2. 12" diameter suction hose with hopper raised to dump debris.

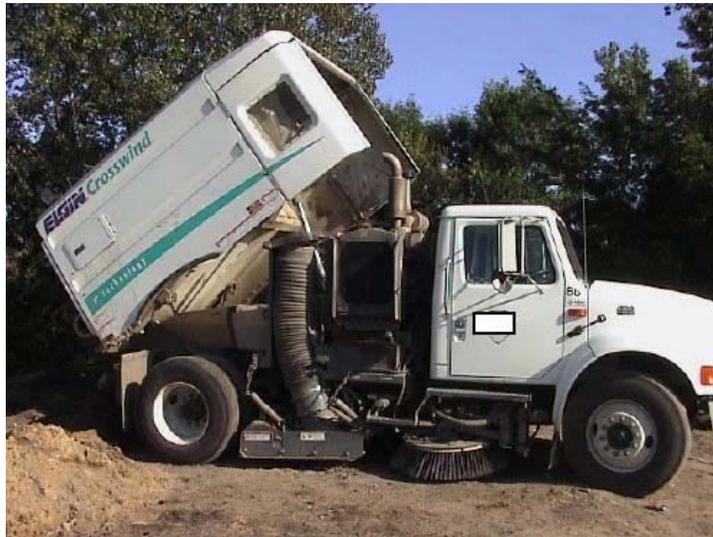
When the hopper is raised to its maximum height, there is a space or opening between the right side of the sweeper hopper and the top of the suction hose (Figures 4a and 4b). This space/opening is approximately 14-16 inches wide and provides enough room for an operator to climb up and look into the large suction hose.

Figure 4a. Sweeper with hopper raised showing space between side of hopper and top of suction hose.

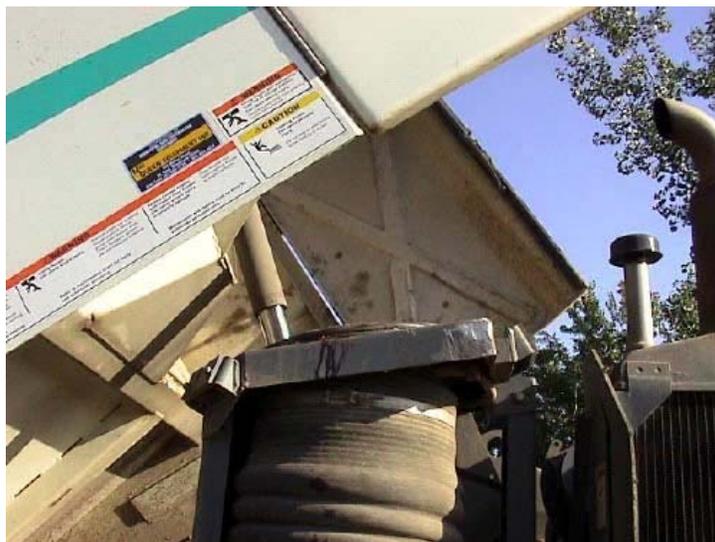
After dumping the debris from the hopper, the victim apparently used a 1 inch diameter by 12 inch long steel bar to dislodge stuck items from the vertical suction hose. This was routinely accomplished by tapping the suction hose with the steel bar. The bar, which workers had put in the cab of the sweeper was found on the ground near the sweeper's right rear wheels. Apparently, after tapping on the hose, the victim climbed up to look down into the suction hose to ensure that it was clear of debris. While looking into the suction hose, the victim may have placed his right foot on the safety plate located directly above the two hopper control levers. While in this position, his foot apparently slipped and struck the lever that controlled the raising and lowering of the hopper. When the lever was inadvertently pushed down, the hopper began to lower. Because of the small distance between the victim and the bottom of the hopper, he became pinned between the top of the suction hose and the side of the hopper.

Figure 4b. Close up of space between side of hopper and top of suction hose.

Discussion: The hopper controls of the street sweeper were located immediately adjacent to the suction hose and covered by a steel plate intended to protect the controls against inadvertent activation. The cover was marked with a “no step” warning placard. Although not intended as an access step, the location of the cover was such that it afforded ready access to the top of the suction hose if used as a step. Locating the controls away from the suction hose, further forward and near the truck cab, for example could decrease the potential for workers to use the protective cover as a step. Additionally, the steel plate could be extended to more effectively cover the controls and a separate step could be located to provide access to the suction hose.
