INCIDENT HIGHLIGHTS

REPORT#: 2020-01 **REPORT DATE:** April 28, 2022

Logging processor lost traction and rolled down hillside fatally injuring operator - Idaho

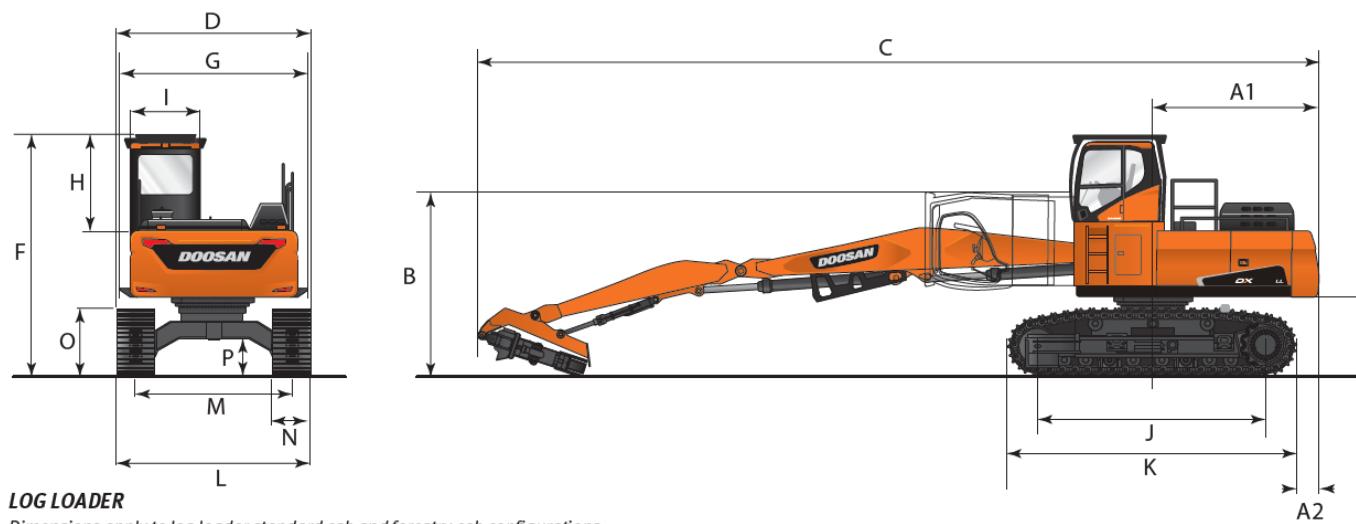
Diagram 1. Doosan DX300LL. Source: [Doosan log loaders brochure](#)

Equipment on the jobsite included a LS-98 Link-Belt yarder and a D6C CAT dozer as a tie back for the link belt, a 240LX Link-Belt shovel loader, a [Doosan/Daewoo 225LL](#) shovel loader, and a 2013 [Doosan/Daewoo DX300LL](#) log loader with a 2013 [HTH623C](#) Waratah dangle head processor [[Diagram 1](#)]. The decedent was operating the DX300LL processor at the time of the incident. The Doosan/Daewoo DX300LL logging processor was equipped with a fixed riser, which raised the operator cab an additional 4 feet. The processor was also equipped with a forestry cab with side entry and falling object guard (FOG) which is intended to provide protection for the operator from falling objects. The equipment measured 11'10"(L) wide and 16'6"(K) long, with track grouser (track cleats which provide ice traction) heights from $\frac{1}{2}$ " to 2" tall, 5" between each grouser, and a circular track clean out. Forestry equipment with 360-degree rotation is required to have falling object protection structures (FOPS). The equipment had a FOG and a forestry cab and was not equipped with a falling object protection structures (FOPS), roll over protection structure (ROPS) or tip over protection structure (TOPS) based on the [Doosan log loaders brochure](#) on page 21. The Doosan was outfitted with a 2013 Waratah Processor [HTH623C](#) Harvester Head (CTM10021) which weighed approximately 6,700 pounds [[Photo 1](#)]. The processor head has a stationary heel wrap or thumb to help position the logs. Employer fabricated ice bits were installed for winter equipment operation to increase traction on ice covered surfaces. There were 2 ice bits on each pad and approximately 50 pads per track placed

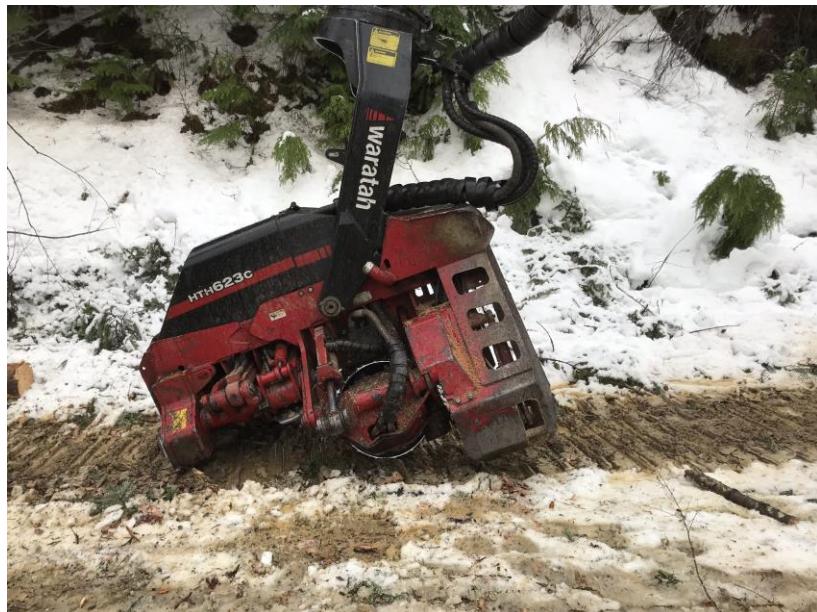
Photo 1. Waratah Processor head HTH623C, NIOSH Photo

in a diagonal pattern (inside, middle, outside). The ice bits were made from $\frac{1}{2}$ " thick stock approximately $1\frac{1}{2}$ " tall installed on the track/grouser. The ice bits are typically installed on the equipment around November 1st and are removed in the spring. Ice bits are installed by the welder, in a parallel orientation, step pattern on the tracks creating a diagonal pattern across the track.

Discussion: Manufacturers of forestry equipment should design forestry attachment stowing or sway control features for dangle head processors to increase equipment stability. As equipment travels on forest roads, attachments can swing and change the center of gravity for equipment with knuckle attachments like the dangle head processor attachment involved in this incident. As forestry equipment is transported from one location to another, either on transport equipment or by its own propulsion, the equipment should not create a hazard to any employee. Forestry equipment is sometimes equipped with a loading heel that can be used to stabilize attachments. Manufacturers should integrate operator control features that allow equipment attachments to be stabilized through sway controls or stowing. Employers and operators should review the operator's manual for guidance on safe positioning of booms while traveling or consult with the equipment manufacturer if sufficient guidance is not provided.

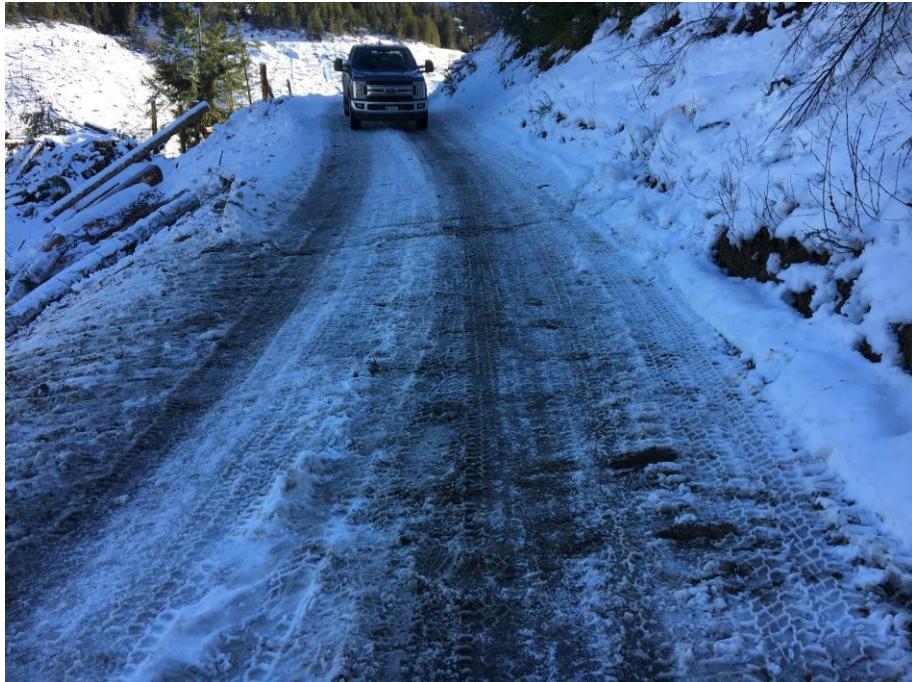
Photo 2. Road draw and grouse groves, *photo courtesy of USDOL*

The location of the incident was on a large tract of privately owned and managed timberland approximately 10 miles out on a logging road from the entrance to the property [[Diagram 2](#)]. At the time of incident, there were six employees onsite at a cable logging operation: a yarder operator, processor operator, two log loader operators, and two choker/ setters. The subcontracting owner was not onsite. The crew had been onsite since early December and much of the timber had been cleared. Throughout the job, the crew had safety concerns about the construction and maintenance of the road. The landowner was responsible for building and maintaining the road. The road was a single lane with base made of stone and sand. There were wide spots in the road throughout the jobsite to allow equipment and vehicles to pass each other on the one lane logging road system. The road was approximately 13 feet in width at the incident location [[Photo 2](#)]. The road grade varied but was approximately 4 percent with an approximate 9 percent outward slope at the site of the incident as measured with an inclinometer [[Photo 3](#)]. The surrounding hillside terrain had an approximate 20 percent slope [[Photo 4](#)]. At the time of the incident, the logging road was covered with 2 inches of ice and lined with snow on both sides.

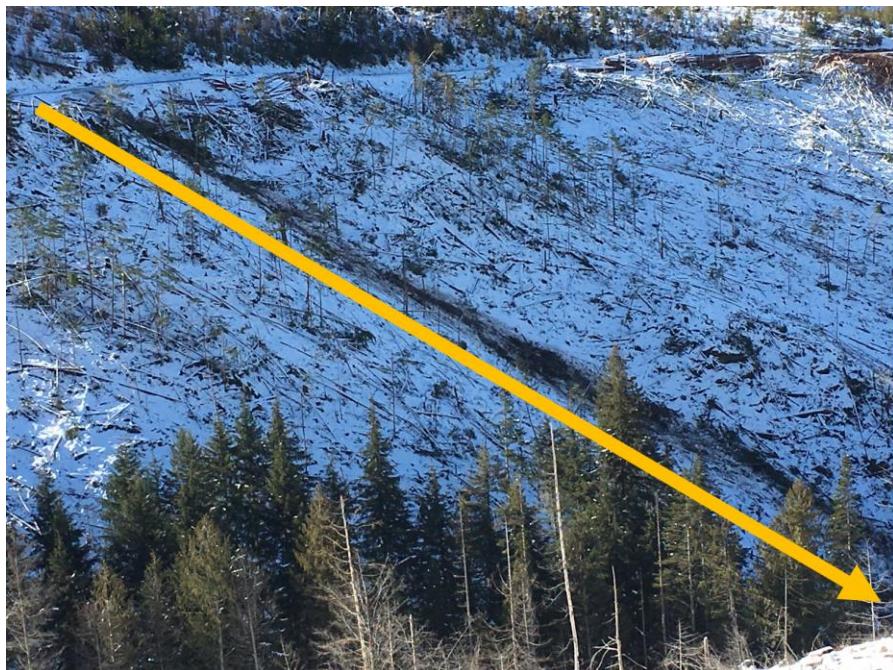
Photo 4. Clear-cut hillside showing dirt pathway from rolling equipment, *photo courtesy of USDOL*

At approximately 1 pm, the processor operator was traveling along the narrow outsloped spur road toward the main logging road where the equipment was to be loaded on a lowboy and transported to a new timber harvesting location. As the processor operator traversed the road, the equipment boom was up, and the 6,000-pound dangle processor head would swing and rock freely as the equipment traveled the road over rocks and around corners. The equipment slipped

laterally on the ice covered outsloped road and temporarily stopped on logs that had been decked. The processor operator swung the boom to the right and placed the processor head down on the road attempting to stabilize the equipment, placing the equipment counterweight slightly over the hillside. The yarder operator saw the equipment slipping down the slope, and he yelled over the radio, "Get the boom down and get out of there!" While the processor operator was attempting to exit the cab, the equipment rolled down the hillside, shearing the operator cab off the equipment, and fatally crushing the processor operator before coming to a rest in the creek near the road below [[Photo 5](#)]. The yarder operator called emergency response over the emergency radio and the employer from a previously established cell phone reception location. Emergency response arrived by land and declared the processor operator deceased at the time of their arrival.

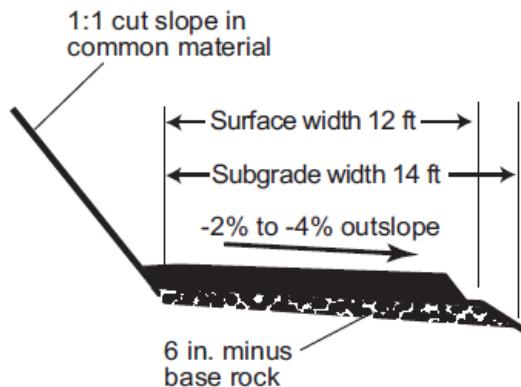
Diagram 3. Outsloped forest road, Source: [Kramer 2001, Oregon State University](#)

Outsloped roads are used by private landowners because they provide adequate drainage and are less expensive to construct and maintain [[Kramer 2001](#)]. Outsloped road surfaces typically have no more than 6 percent road grade and a negative 2 percent to negative 4 percent outslope to provide adequate drainage [[BC 2002](#); [Bowers 2012](#); [Kramer 2001](#); [US Forest Service n.d.](#); [Wiest 1998](#)]. The combination of grade and outward sloping of the road surface can cause a compounding effect on stability and lateral sliding of machinery [[Kramer 2001](#)]. Outsloped roads should not be used when adjacent terrain grades are 20 percent or more, road grade is more than 3 percent, on high traffic roads, and where safety concerns exist, such as winter travel during ice or snow conditions, in order to keep logging equipment and logging trucks on the road surface during logging operations [[BC 2002](#); [Kramer 2001](#); [Washington State 2013](#); [Wiest 1998](#)]. If road surface slopes exceed 20 percent, specialized equipment should be used and additional safety measures should be implemented [[WSDLI 2017a](#)]. The location of the incident was a large logging tract on privately managed land. The road was a single lane logging spur road with a base made of stone and sand with adjacent terrain grades of more than 20 percent. During this incident, the logging road was covered with 2 inches of ice and lined with snow on both sides. The road at the site of the incident width was 16 feet wide, the grade was 4 percent, and the outslope was approximately negative 9 percent compounding the slope effect on the road.

Recommendation #1: Road designers should limit outsloping on forest roads with potential winter travel.

Discussion: Land owners have a responsibility to ensure forest roads are built safely [[WSDLI 2017a](#)]. Landowners should hire qualified, trained, and licensed professionals to design forest roads and ensure these road designers limit outsloping on forest roads with the potential for winter travel. Forest roads used for logging operations typically have a 12 ft to 16 ft surface width and grades vary between 0 percent and 10 percent [[Diagram 3](#)]. Spur roads are secondary side roads and tend to be challenging to navigate as the change in grades affect the center of gravity of the equipment. Newer spur roads tend to have less compaction because they are built with a track hoe instead of a dozer. Forest roads may deteriorate due to factors including the logging activities and weather. Logging activity may deteriorate the outside edge of the road due to factors including the skidding of logs/tree lengths, processing of trees into log lengths, and the loading of logging trucks. Inside draws or corners are challenging to navigate for large equipment due to the combination of angles, narrowness, and out-slopes for drainage and turns which affect the track pressure and overall center of gravity of the equipment.

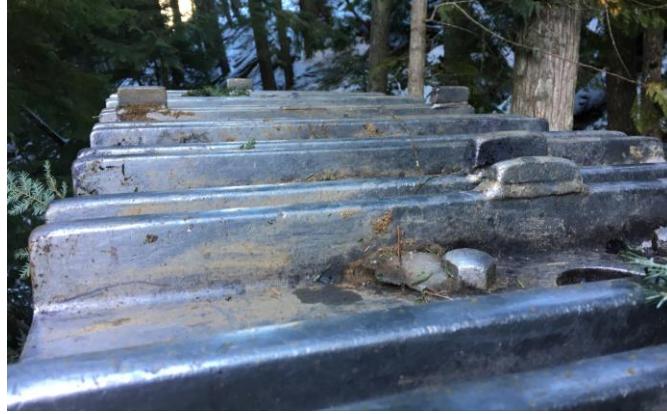
Photo 6. Ice bit and grouser heights, spacing, and orientation, *photo courtesy of USDOL*

conditions. In this incident, the non-commercial ice bits were fabricated short pieces 1 ½" tall, with a grouser bar (typically 2"– 6" long) welded on top of the existing grouser in a parallel orientation to the track grouser [Photo 6]. Commercial ice bits should be installed according to manufacturer's instructions and removed at the end of the winter season.

Recommendation #8: Manufacturers should provide engineer designed ice bits for forestry equipment operating during winter snow and ice conditions to reduce lateral slipping.

Discussion: Although it was not considered a contributing factor for this incident, manufacturers should provide engineer designed ice bits for forestry equipment operating during snow and ice conditions to reduce slipping. Logging employers typically install employer fabricated ice bits to improve forestry equipment safety. Ice bits increase stability, traction, and grip by puncturing the ice and penetrating the snow to prevent lateral sliding of the equipment tracks in icy and snowy road conditions throughout the winter months. Employers can purchase and install commercially available ice bits in preparation for winter weather [[Dura tuff 2020](#); [Montana track claw 2020](#); [Woodbridge equipment 2020](#)]. Engineer designed ice bits are currently unavailable for purchase. Manufacturers should work with standards organizations and engineers to develop industry standards, design elements and evaluation criteria for ice bits to be installed on forestry equipment operating on the ice and snow. Evaluations should include stability, traction, and grip in all directions of potential equipment movement, structural integrity, and equipment performance of the ice bits during winter operating
