FACE

Fatality Assessment and Control Evaluation Program

FACE Report Number 2010-01

## ***Solid Waste Compost Facility Worker Dies, Body Is Recovered In Digester Tube – Tennessee***

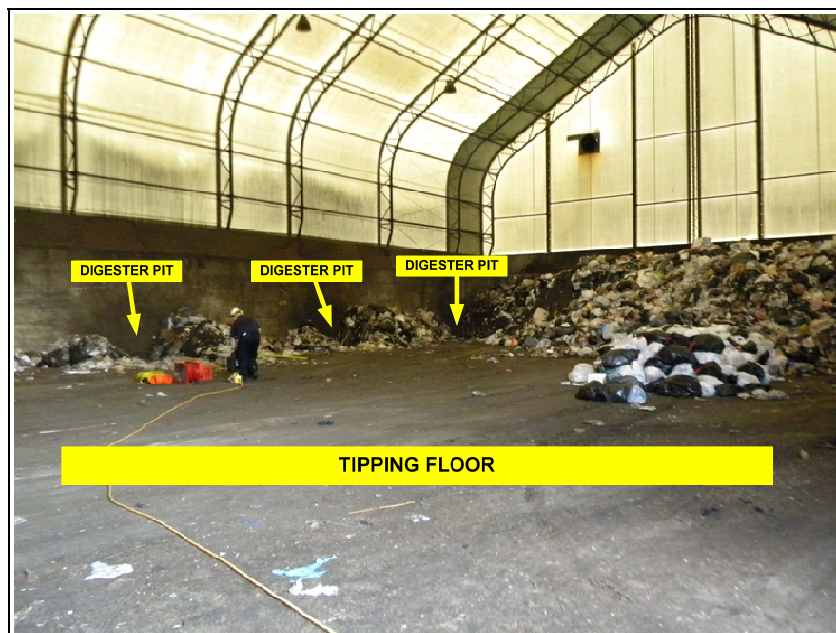
**Photo 1. Photo of the tipping floor where the incident occurred showing the location of the separated materials and the pits where the waste is ram-fed into the digester tubes.**  
(Photo courtesy of local Police Department)

The solid waste facility consists of approximately 200 acres and four waste processing buildings. The fatality occurred in the building where the tipping floor was located. The structure has a poured concrete floor and measures approximately 80 feet x 120 feet (Photo 1). There are five digester pits located along one wall that feed waste into five digester tubes. The pits are approximately six feet square and about five and one half feet deep. Each digester tube can hold 75 tons of composting waste. The tubes are 14 feet in diameter, 180 feet long, and are made of ¾-inch steel. The tipping floor building is equipped with large bay doors and fans to provide ventilation. The temperature inside the building at the time of the incident is unknown.

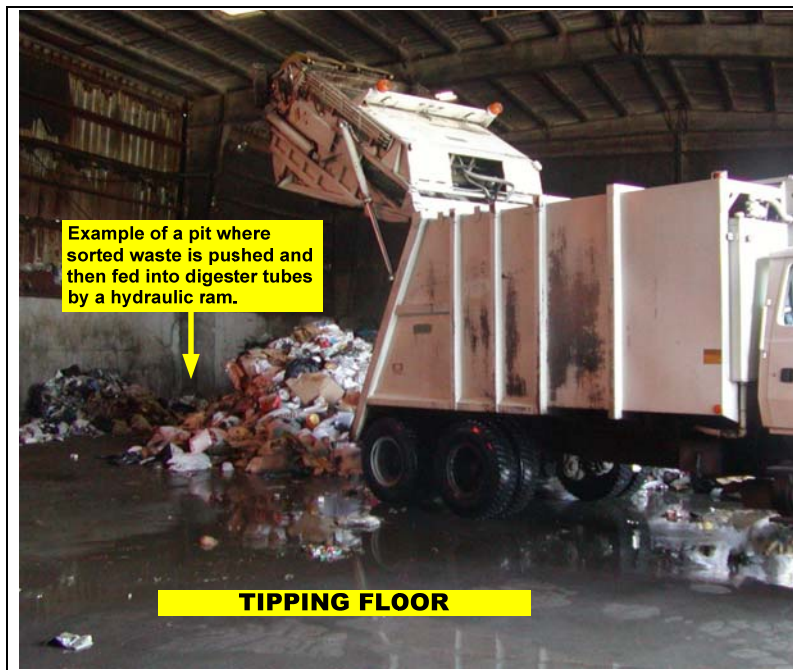
**Photo 2.** Photo of a truck dumping a load of solid waste onto a tipping floor.  
*(Photo courtesy of county information on solid waste facility)*

The composting process begins when municipal waste haulers deliver commercial and residential solid waste to the facility. Drivers stop at a weigh station near the entrance to the facility to check in, and then proceed to the tipping floor to dump their load of waste (Photo 2). The picker (victim) then sorts through the waste to remove large items and non-compostable materials that are then taken to an appropriate solid waste landfill. After the non-compostable items are removed, the remaining waste is pushed by a front-end loader (Photo 3) into one of the digester pits (Photo 4).

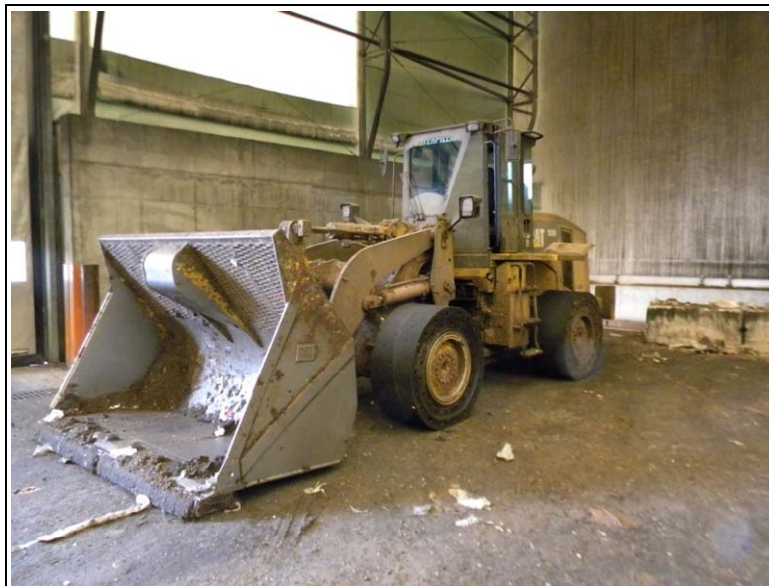
**Photo 3.** Photo of the front-end loader that was used to push the compostable material into the digester pits.  
*(Photo courtesy of local Police Department)*

At the time of the incident the standard operating procedure was for the picker to hand signal to the front-end loader operator when he was done sorting materials and the waste was ready to be pushed into the pit. Radios were not used due to the relatively small size of the tipping floor and the perceived ease of maintaining visual contact. After motioning to the loader-operator, the picker would then move from the area and the front-end loader would push the waste into the pit.

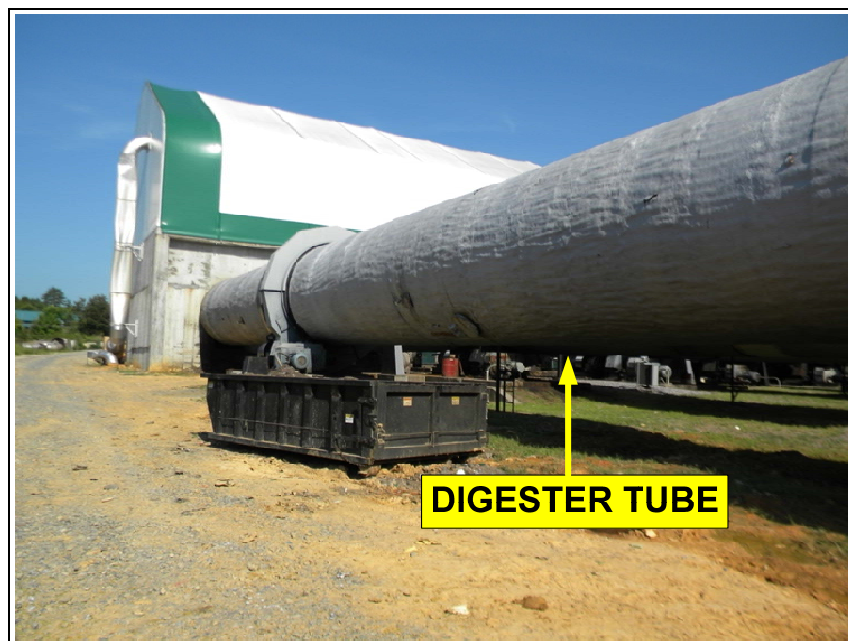
**Photo 5. Photo of the digester tube extending from the tipping floor to the discharge area.**  
*(Photo courtesy of local Police Department)*

The hydraulic ram in the pit would continuously cycle until all material had cleared the pit and was pushed into the digester tube (Photo 5). The biodegradable material (e.g. paper, food waste and bio-solids) in the waste would break down over a three-day period at a temperature of approximately 120°- 140°F. After this three-day period, the remaining digester material was discharged onto a conveyor belt and sent to a screening process (Diagram). Screened materials were moved by a front-end loader to an aeration floor where the material was periodically turned and dried while continuing the composting process for an additional four weeks.
