FACE Report Number 2009-01

Hispanic Worker Dies After Fall From Step Ladder While Cleaning Windows—North Carolina

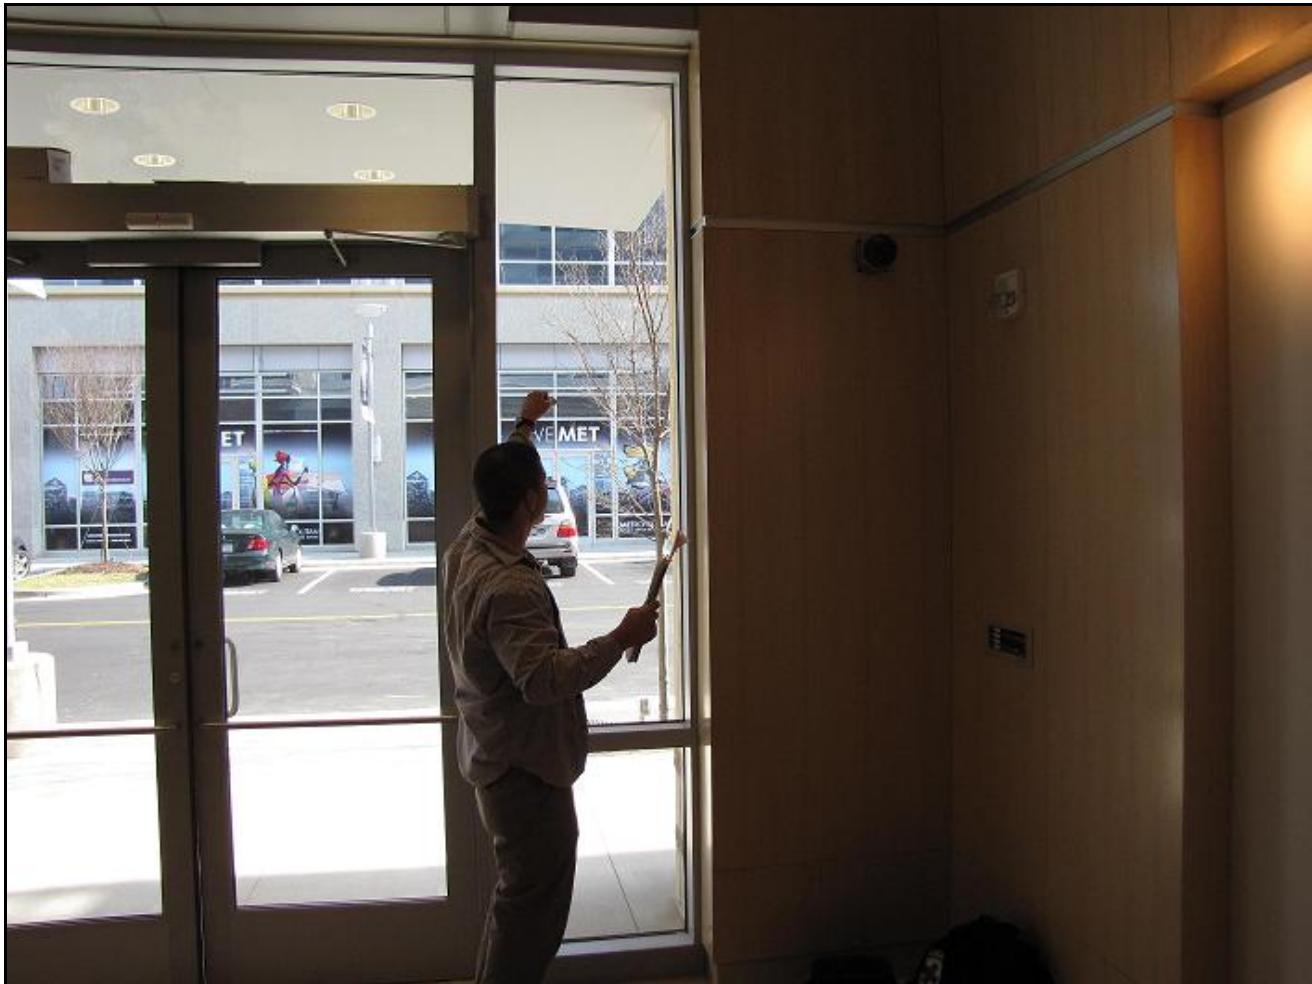
Photo 1. Double Door Glass Entranceway and the Windows the Victim was Cleaning at the Time of the Incident.
(Photo courtesy of NCOSHA)

At the time of the incident, the victim was working in a recently finished elevator lobby in a new 10-story luxury condominium complex. The size of the lobby was approximately 12 feet by 14 feet. The floors were covered in a porous porcelain tile with a non-glossy finish. The double door entranceway wall was glass with an anti-glare coating on the outside. The top window height measured 9 feet above the floor (Photo 1). An active elevator was directly across from the entry doors. The ceiling in the lobby was more than 15 feet in height. Security cameras had been installed, but were not in operation the day of the incident. The construction project was approximately 95% completed.

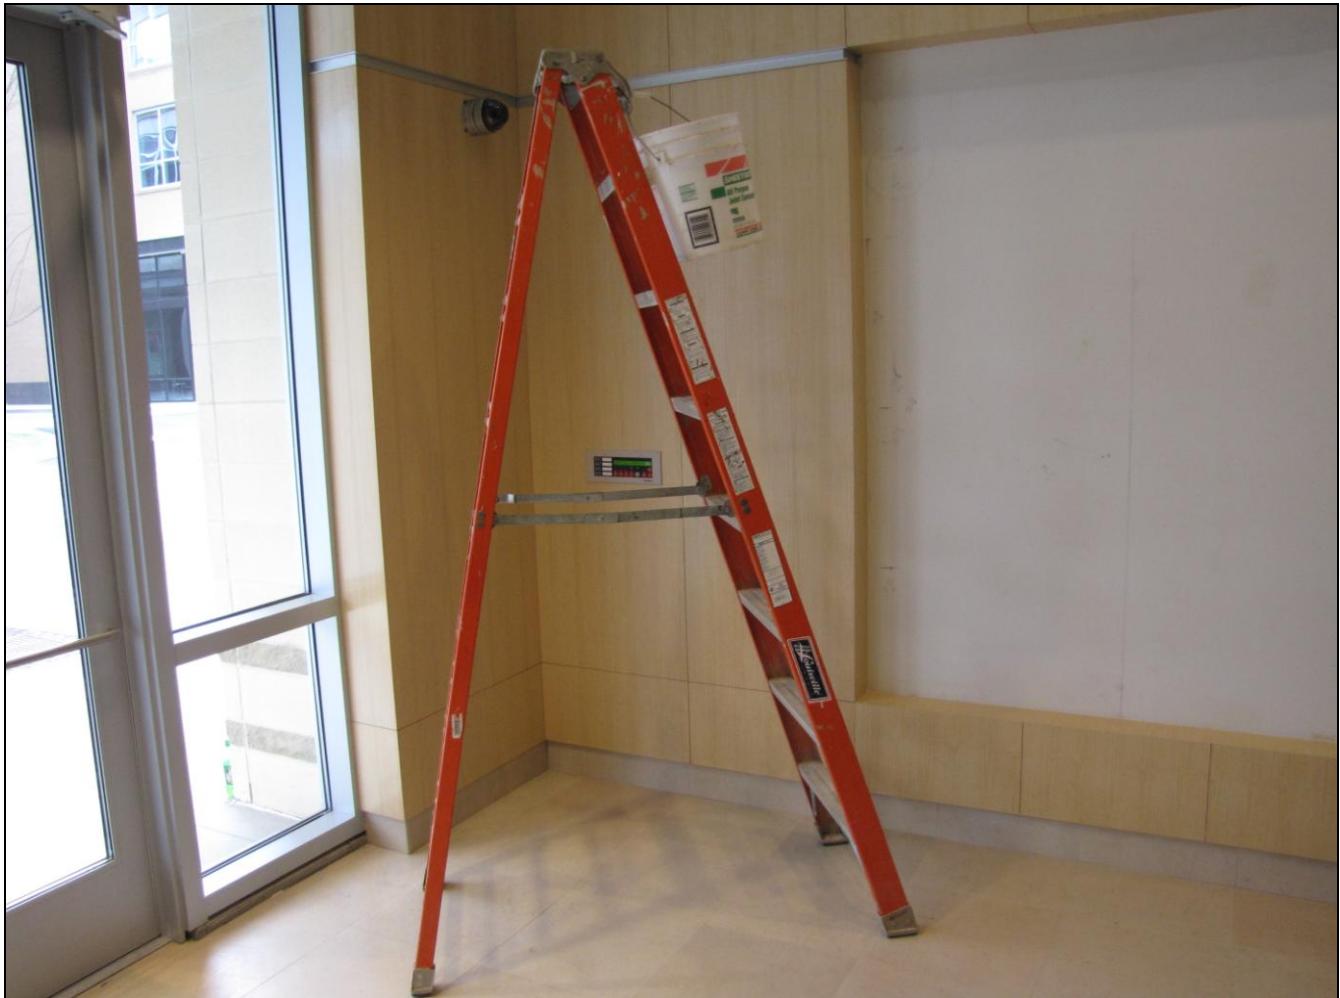
The victim was using a short-handled (approximately 7 inches in length) squeegee, a sponge and rag, and had a bucket tied to the top of the step ladder (Photo 2). The bucket was a 5-gallon capacity (13-inches in depth and 12-inches in diameter) sheetrock type bucket. According to NCOSHA, following the incident, the ladder was undamaged and the bucket was still attached.

Photo 2. A Step Ladder and a Bucket Represent the Items Being Used at the Time of the Incident.

According to NCOSHA, during interviews the employer stated that when the 5 gallon bucket was used it would usually be filled with approximately 2 to 2.5 gallons of window cleaning solution. The corresponding weights for the range of 2 to 2.5 gallons of water is between 16-21 pounds. The NCOSHA investigating compliance officer performed a stability assessment on an 8-foot, A-frame step ladder and used a 5-gallon sheetrock bucket filled with approximately 2.5 gallons of water tied to the top of the ladder. According to NCOSHA, the results showed that a small amount of pressure exerted in a sideways motion rendered the ladder unstable and ready to tip over. The liquid was dynamic which increased the potential for tipping the ladder. In addition, NCOSHA reported that when the liquid was tied on the side of the step ladder, one foot of the step ladder raised off the ground.

Workers should use a tool belt or use a hand line to raise and lower necessary tools or supplies needed for tasks while working on a ladder. Some ladders are designed for small loads to be placed along the center line of the ladder on a pail shelf. Activities that require overreaching should not be performed from any ladder. Examples of the rules/practices and procedures that an employer should ensure workers clearly understand and always follow to minimize exposure to injury include: 1) Never placing heavy items on the top or side of a ladder, 2) Always using and maintaining the three-point contact climbing method (two hands and one foot or one hand and two feet), 3) Never working from the top two rungs of a ladder, 4) Always facing the step ladder treads while using a step ladder, and 5) Never overreaching or leaning to one side while using a step ladder.^{4,5,6}

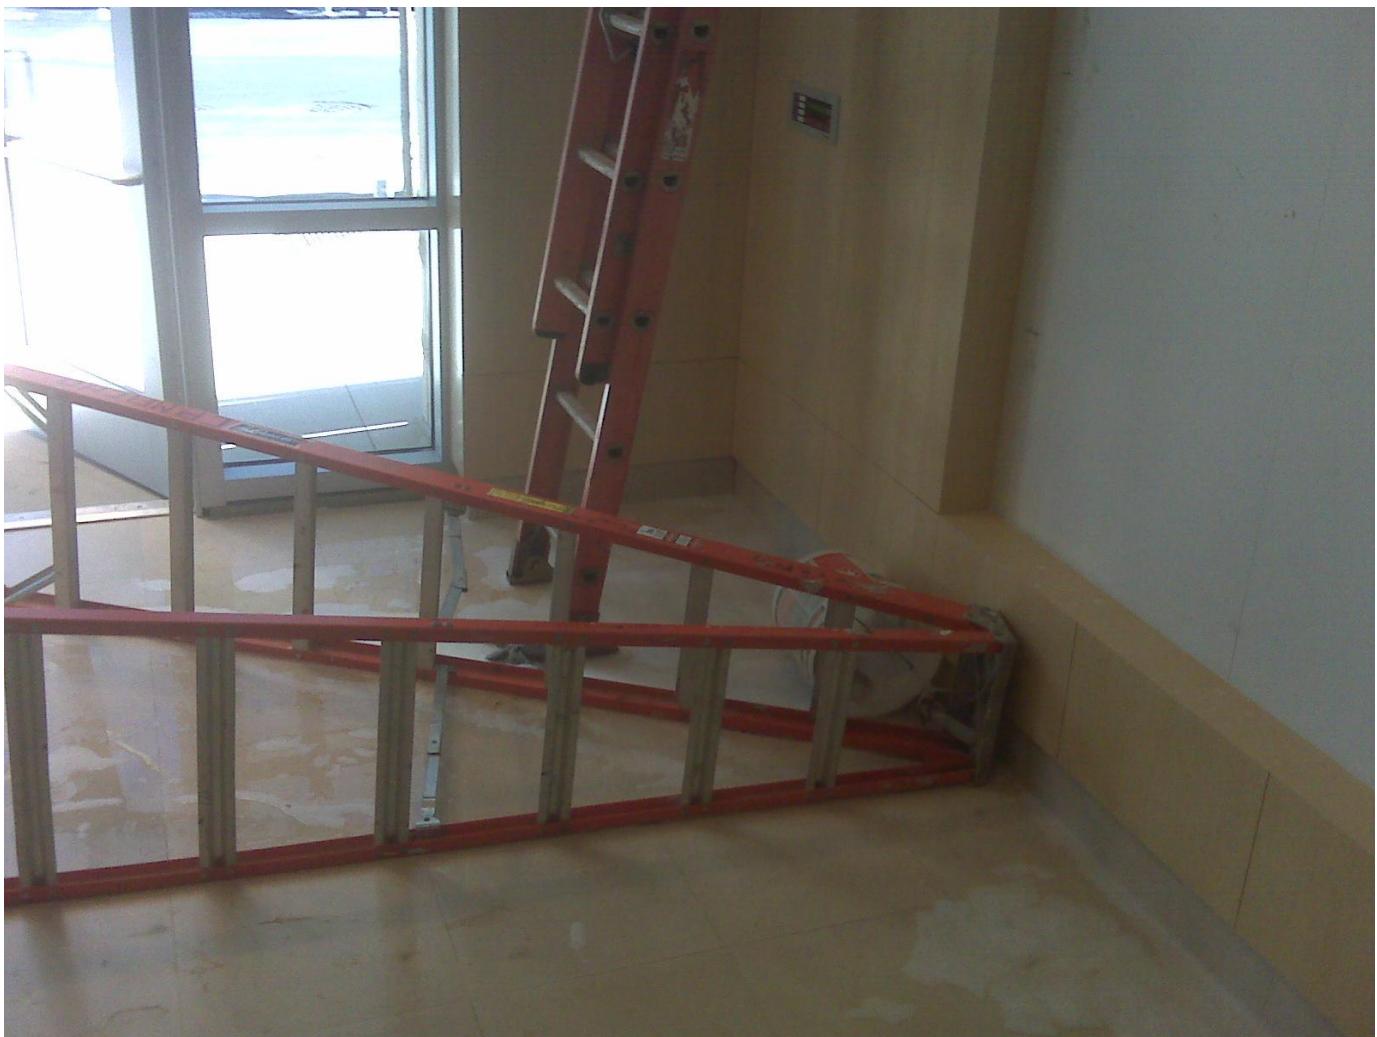
Around 1:00 p.m., as the tile foreman entered the elevator from the second floor, he heard a loud crashing sound. When the elevator doors opened on the first floor, he saw the victim lying on the ground on the right side of the room from entry through the double door entranceway. The step ladder was toppled on the left side of the room and a clear liquid covered part of the floor (Photo 3). The tile foreman found the victim lying on the floor with his body shaking and attempting to get up off the floor. The tile foreman stated to NCOSHA that while looking at the toppled step ladder, he noticed that a bucket was attached to the top of the ladder.

Based on photos taken following the incident and the location of the victim and ladder, the NCOSHA investigating officer determined that the following actions and events likely occurred during the time of the incident. The NCOSHA investigating officer believes that the victim had repositioned the step ladder with the rungs facing towards the windows, and that he stood backwards on the step ladder and gripped the rungs of the ladder with his boot heels while he cleaned a portion of the windows. NCOSHA concluded that the victim working backwards on the ladder, while facing the windows and working from approximately the sixth or seventh step, combined with the dynamic weight from solution in the bucket and the victim's squeegee strokes across the window, resulted in a lateral force to the step ladder that caused it to tip.

Photo 3. Photo of the Incident Scene. This photo was taken while standing in front of the elevator. The ladder is toppled on the left side of room, entry through the double door entranceway.
