## Seventeen Year Old Female Laborer Falls From Residential Roof and Dies Nine Days Later – Connecticut

### SUMMARY

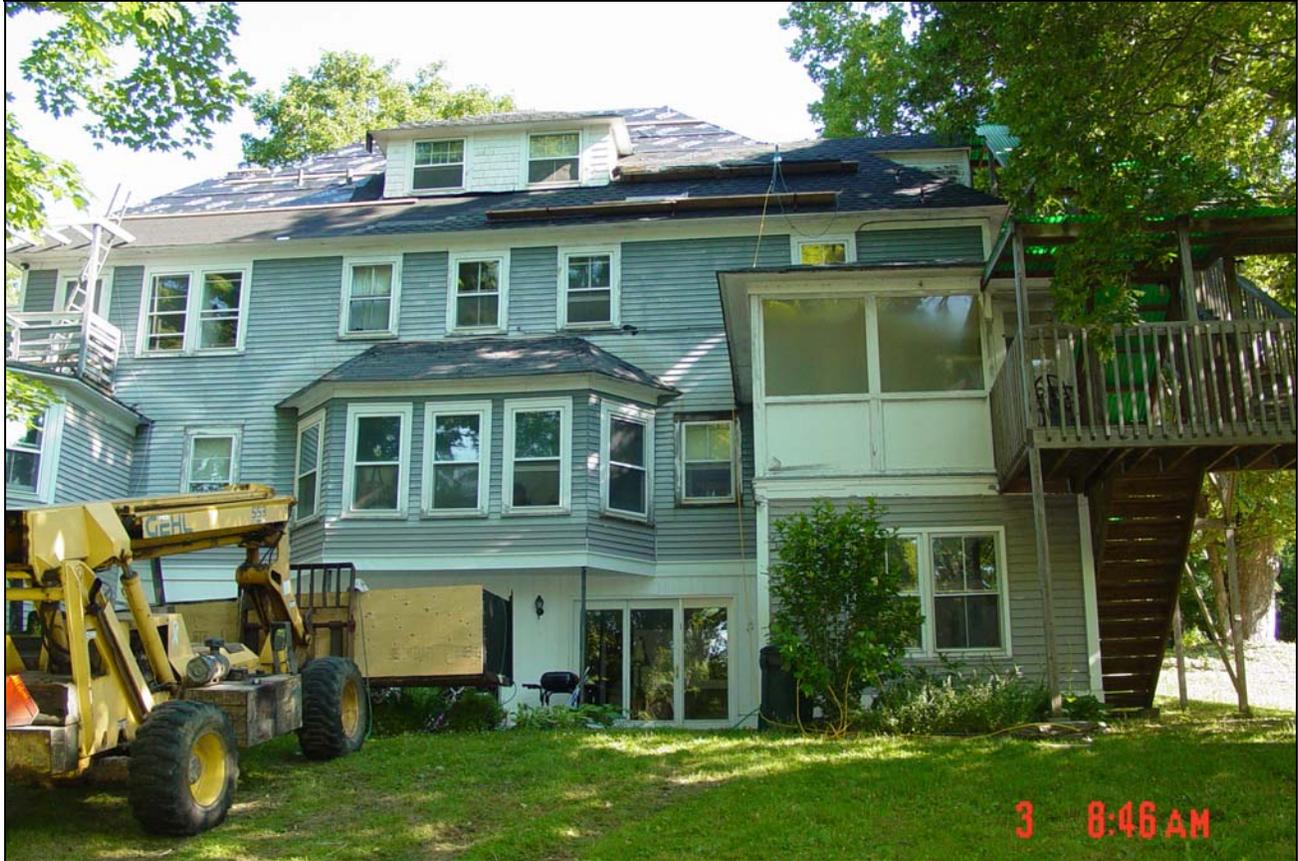
The incident occurred at a residential Victorian-style house that had been converted into a six-unit apartment building. The owner of the building had hired the employer to remove the old roofing shingles and to install a new roof. The building was a three-story structure, 26 feet in height and with a 12 pitch roof. The structure had a fire escape on one side that consisted of three sets of stairs. The construction company had placed two wooden planks secured with roof brackets on the rear portion of the roof. In the rear of the house at ground level, was a flagstone patio.

On July 2, 2007, at approximately 7:00 a.m., Owner 2, the victim, and the male laborer arrived in the same vehicle at a residential house where they were replacing the roof (Photo 1). Owner 1 was already at the site. This was everyone's second day working at this site. According to the OSHA compliance officer, as they began work, the owners verbally reminded the male laborer and the victim to be careful while working.

**Photo 1. The Incident Scene.**  
*(Photo Courtesy of OSHA)*

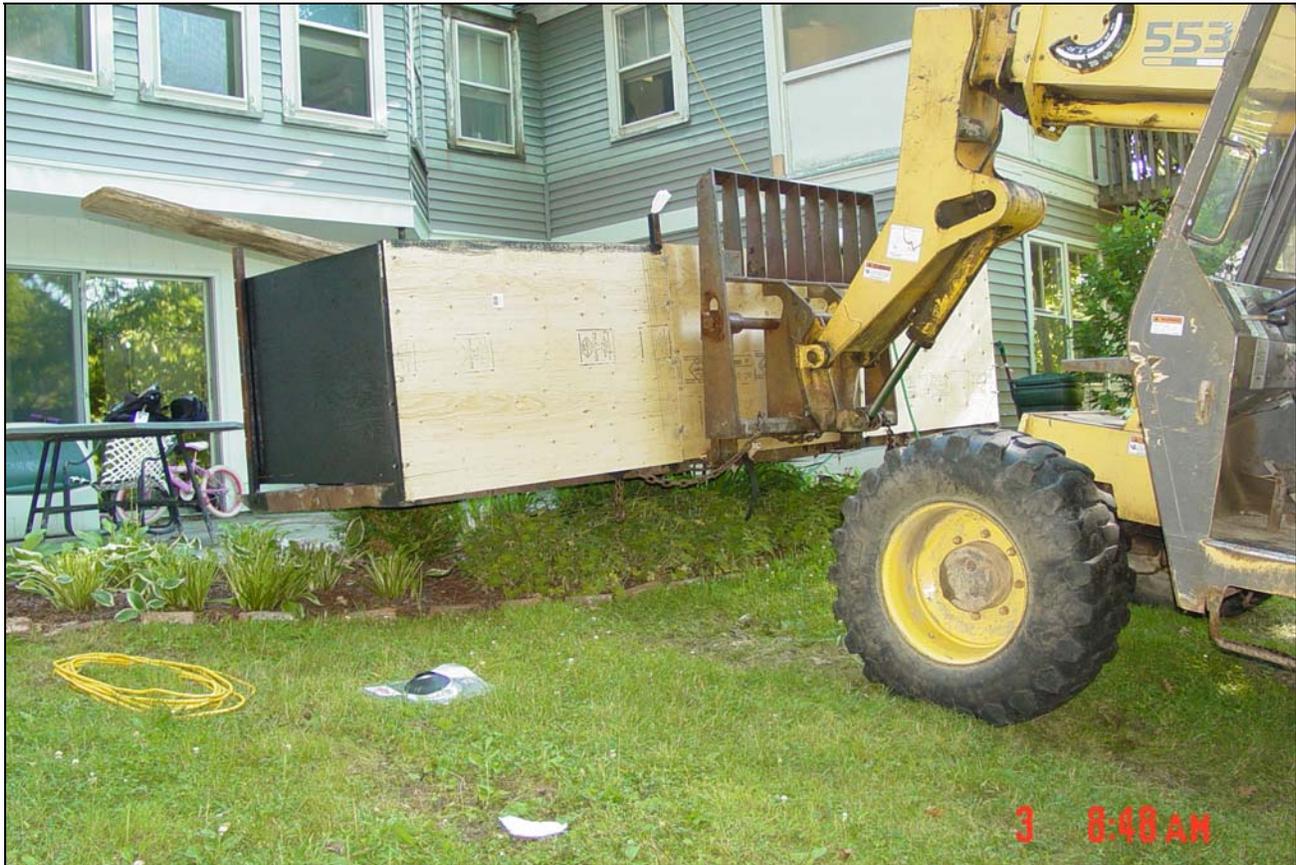
They started the roof work on the rear of the house. In order to access the roof, an extension ladder was set and placed on the third floor fire escape. A construction box was used to haul down used roofing shingles and to bring construction tools and supplies up to the roof (Photo 2). The construction box was attached to the forks of a forklift. The wooden box was homemade and was approximately 14 feet wide with three sides and a diamond plate steel bottom. The victim would use a ladder to climb up onto the roof, and then she would throw trash and used roofing shingles into the construction box. When new roofing shingles were needed on the roof, the construction box would be lowered to the ground and the victim would load the bales of roofing shingles into the box. The owners or the male laborer would move the forklift with the construction box attached and relocate it near the area where the roof work was being done.

On the worksite where this incident occurred, a construction box was used to haul down used roof shingles and to raise construction tools and supplies up to the roof area. The construction box was attached to the forks of a forklift. The wooden box was homemade and approximately 14 feet wide with three sides and a diamond plate steel floor. The victim would climb up onto the roof and throw trash and used roof shingles into the construction box. With the box in a raised position, the victim would climb down into the box to unload supplies and materials.

**Photo 2. The Construction Box Attached to the Forklift.**  
*(Photo Courtesy of OSHA)*

Discussion: Ensuring that a personnel platform used on a forklift has the necessary safety features to protect workers using it and that it complies with the Occupational Safety and Health Administration (OSHA) regulations is paramount. OSHA regulations 1910.178,<sup>11</sup> 1926.602,<sup>12</sup> and 1926.451<sup>13</sup> have requirements for a company to follow in order to properly construct and attach a personnel platform to a forklift. There are rigorous guidelines for this, and it is, therefore, preferred that individuals consult with the forklift manufacturer for assistance. Safety requirements for an approved personnel platform include proper size, gate, approved guard rails, that rated anchor points are provided and properly used by trained workers using fall protection, and that there is a safe method to secure the platform to the forklift.

The forklift operator's manual usually provides some guidance on this issue, therefore, companies desiring a personnel platform for a forklift should study their options carefully.<sup>14</sup> A NIOSH Alert (NIOSH Pub. 2001-109), Preventing Injuries and Deaths of Workers Who Operate or Work Near Forklifts, provides additional recommendations for safe forklift operations.<sup>15</sup>

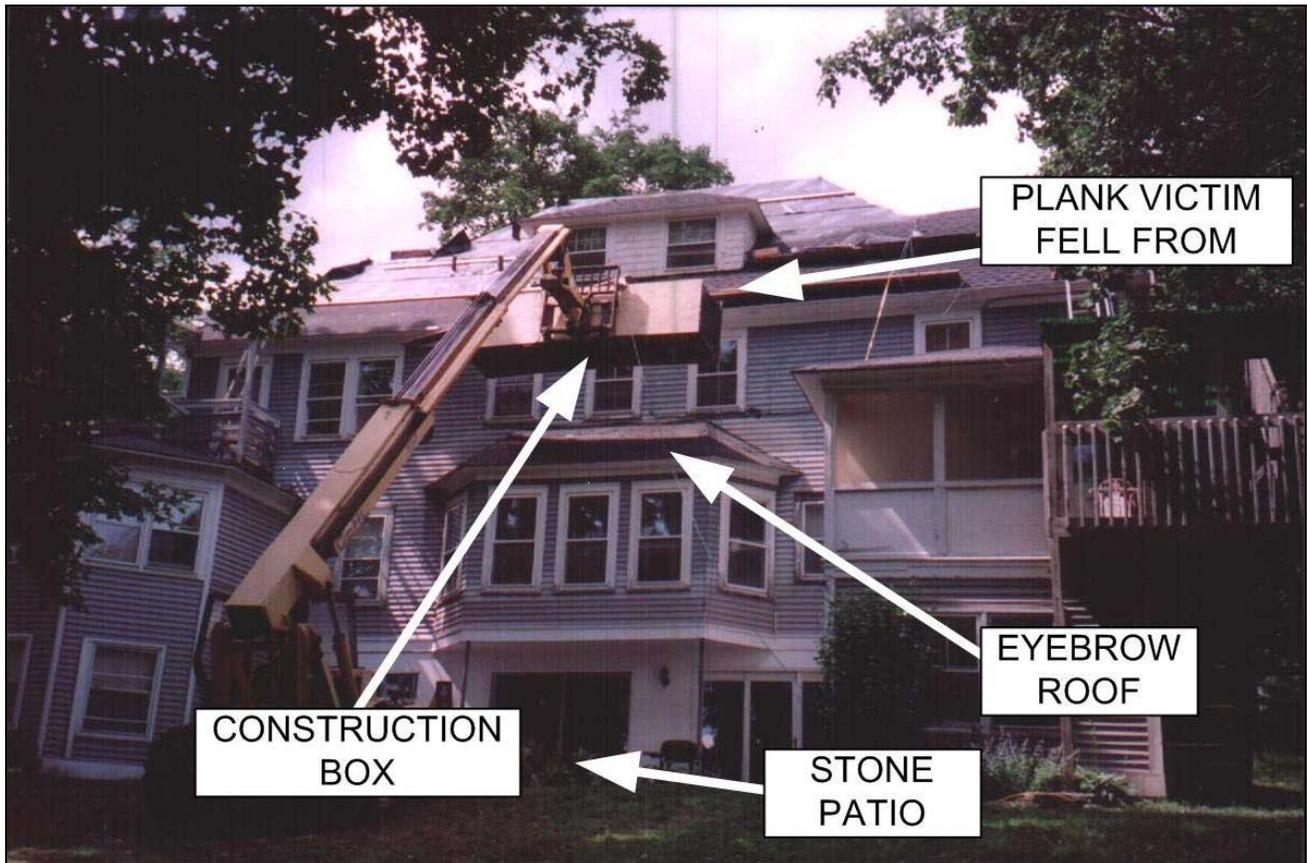
At approximately 2:15 p.m., roofing shingles were needed on the roof. The construction box was raised and positioned approximately 4 feet below the lowest of the two wooden planks (Photo 3). Directly below the construction box was a small protruding "eyebrow" roof, approximately nine feet below the main roof and seventeen feet above the stone patio. The victim accessed the roof from an extension ladder at the fire escape and walked down to the lowest wooden plank; she then sat down on the plank and lowered herself into the raised construction box. While standing in the construction box, the victim picked up new bales of roofing shingles and placed them above her on a wooden plank. After placing the bales on the plank, the victim climbed up and out of the construction box and sat on the plank. The wooden plank was approximately ten inches wide and approximately 12 feet in length. While sitting on the wooden plank, the victim handed roofing bales to Owner 2 and the male laborer working on the roof.

**Photo 3. Approximate Location of the Construction Box at the Time of the Incident.**  
*(Photo Courtesy of OSHA)*

Discussion: When workers are working on a roof and materials need to be unloaded from a construction box that is attached to a forklift, the employer should develop, implement and enforce a buddy system. Having a buddy system on the worksite helps ensure that a worker is not solely responsible for unloading the materials on the roof. When a buddy system is in place and materials need to be unloaded on a roof, one worker can stand in a construction box and hand off the materials to another worker on the roof. A buddy system allows a worker to remain in the box and also does

not require them to have to climb out of the box in order to set the materials somewhere on the roof. For a buddy system to be effective an employer must be vigilant in enforcing it during the entire roofing work.

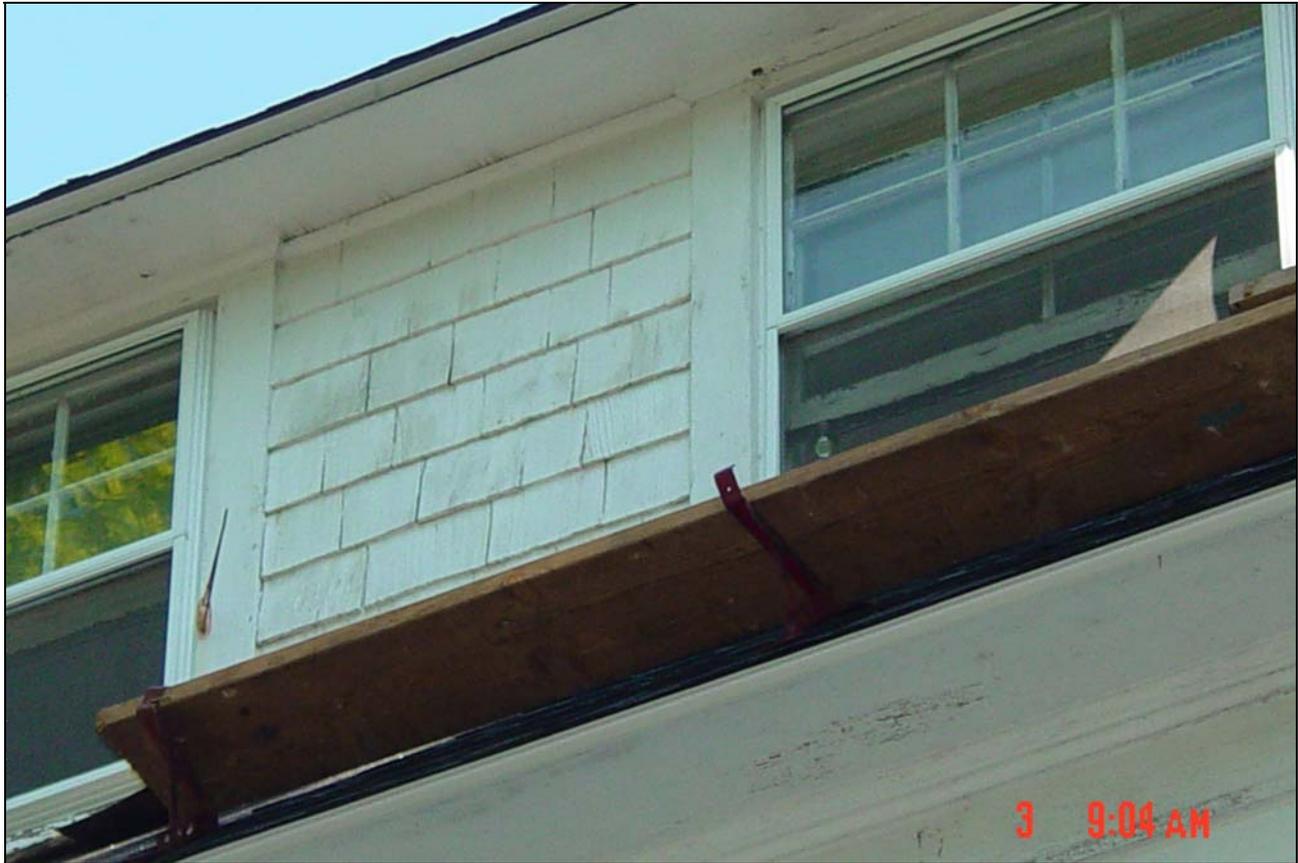
While Owner 2 and the male laborer worked on the roof, they observed the victim sitting on the plank. Approximately two minutes later, Owner 2 and the male laborer were using nail guns when they both heard a "thud" sound. According to the OSHA compliance officer, it appeared that as the victim sat on the wooden plank, she slid forward to get back down into the construction box, when one leg of her shorts got caught on the tip of a roof bracket that was holding the wooden plank, and it caused her to get upended and fall approximately 26 feet to the stone patio (Photo 4). Owner 1 and the male laborer looked over across the roof towards the plank and they did not see the victim, so they crawled over to the edge of the roof. When they looked down to the ground, they saw the victim lying face down on the stone patio (Photo 5). Owner 2 and the male laborer ran to the access ladder

**Photo 4. The Wooden Plank Where the Victim was Sitting Prior to the Fall.**  
*(Photo Courtesy of OSHA)*

While working at the worksite where the incident occurred, the victim, a male laborer and both of the owners were exposed to a fall hazard of approximately 26-feet. No fall protection was provided on the roof area. Every worker exposed to a fall of over 6 feet should be protected from falls by means of a guardrail system, safety net systems, or personal fall arrest systems.

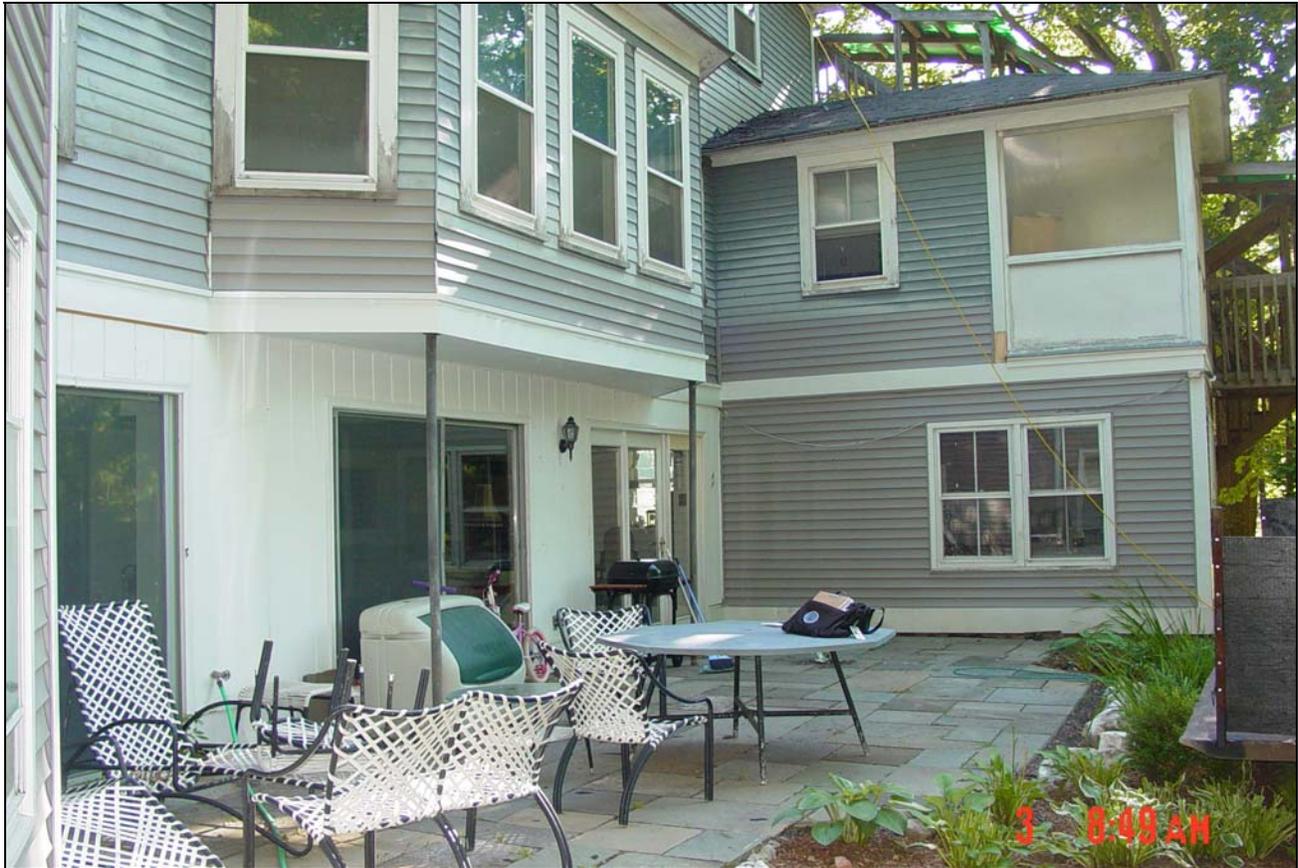
**Photo 5. The Stone Patio Where the Victim Landed After Falling.**  
*(Photo courtesy of OSHA)*
