FACE Report Number 2007-02

## ***Laborer Dies When Backed Over by a Tack Truck in Residential Roadway Construction Work Zone – North Carolina***

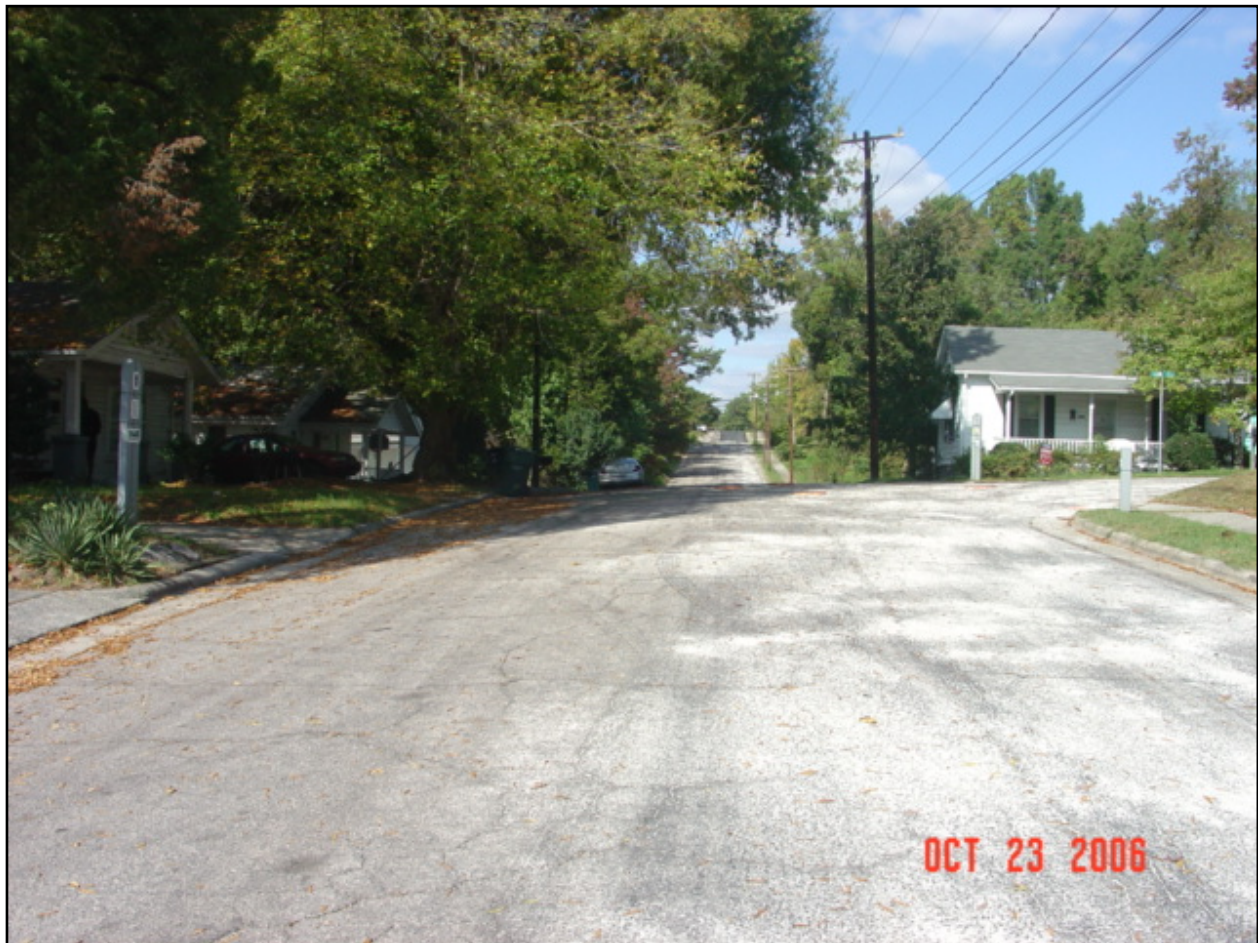
The street where the incident occurred was approximately 33 feet wide and 1,072 feet long (Photo 1). The employer's job process for the asphalt resurfacing required the application of a Cationic Rapid Set Asphalt Emulsion (CR-1) commonly referred to as tack which is used to bond the old and new asphalt together. As part of the work process, workers elevated manhole covers in the roadway areas that needed to be resurfaced. Road work signage was set up according to the specifications in the written work contract with the city. The day of the incident was the victim's second day at this location.

Photo 1. Photo of incident scene. Photograph courtesy of NCOSHA.

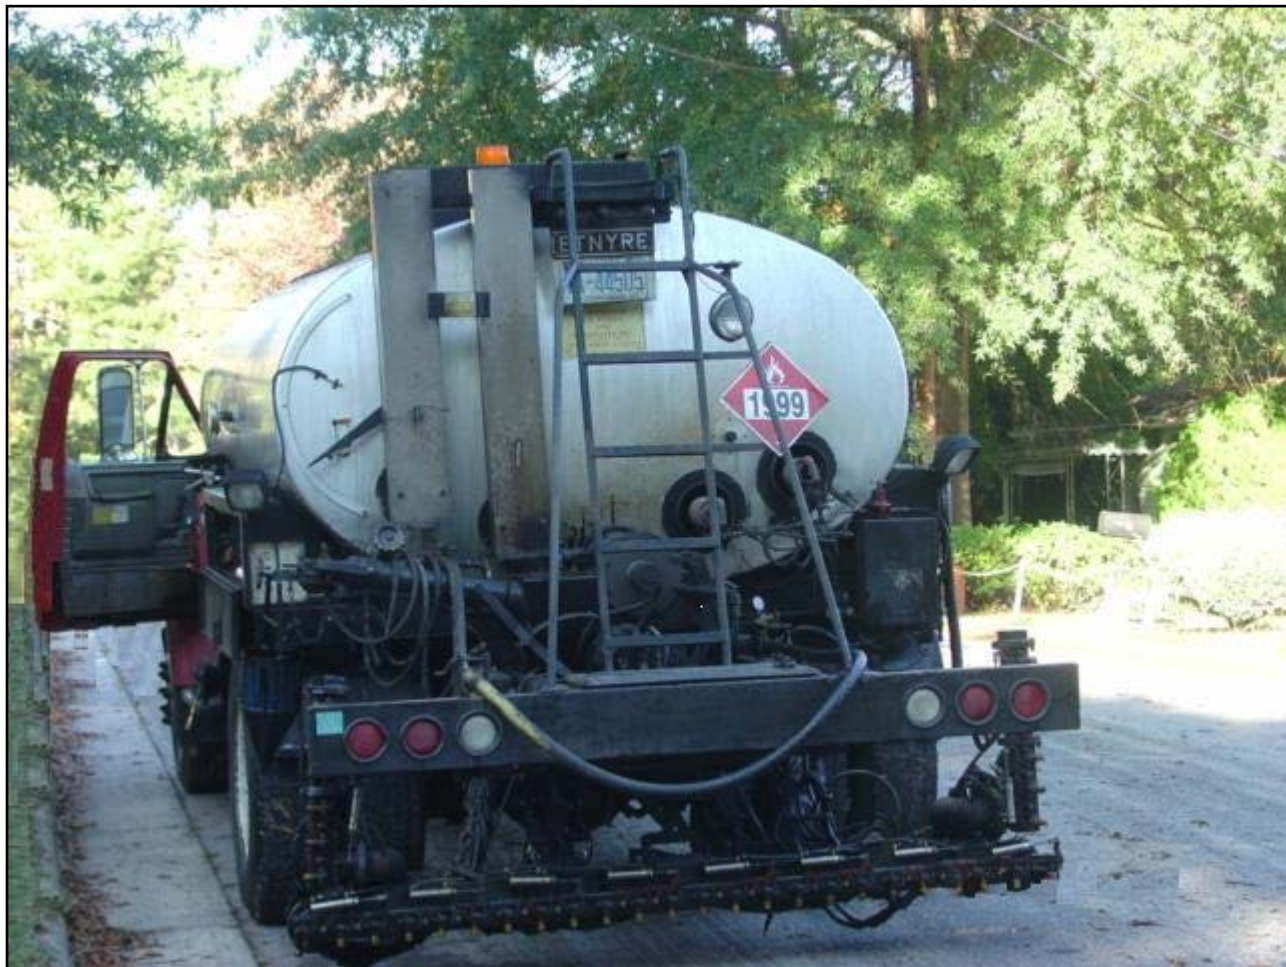
**Equipment:** The tack truck in this incident was a 1998, F-700 Series and had a gross vehicle weight rating (GVWR) of 50,000 pounds (Photo2). The truck was equipped with a 2,000 gallon tank, which had a spray assembly with 30 nozzles attached to distribute the tack solution. The truck had approximately 1,500 gallons of tack solution inside the tank at the time of the incident. Mounted on each door of the truck were large mirrors approximately 7 inches wide and 16 inches high. Additionally, a round spot (convex) mirror was mounted on the large mirror on the passenger side.

The truck was approximately 24 feet long and the rear tailgate was approximately 8 inches above the ground. The spray assembly was in the activated (down) position at the time of the incident, making the width at the rear of the truck approximately 10 feet wide. The employer required that the truck be inspected daily by using an equipment checklist that the driver completed and documented prior to each shift (e.g., brakes, horn, lights, wipers, reverse alarm and safety equipment). The documented checklist was completed by the driver on the morning of the incident. The investigating NIOSHA compliance officer determined that the truck was equipped with a working audible reverse alarm that could be heard from a distance of approximately 30 feet away.

Photo 2. Photo of the Tack Truck. Photograph courtesy of NCOSHA.
