FACE Report Number 2005-04

Hispanic Laborer Dies After Footing Collapse - North Carolina

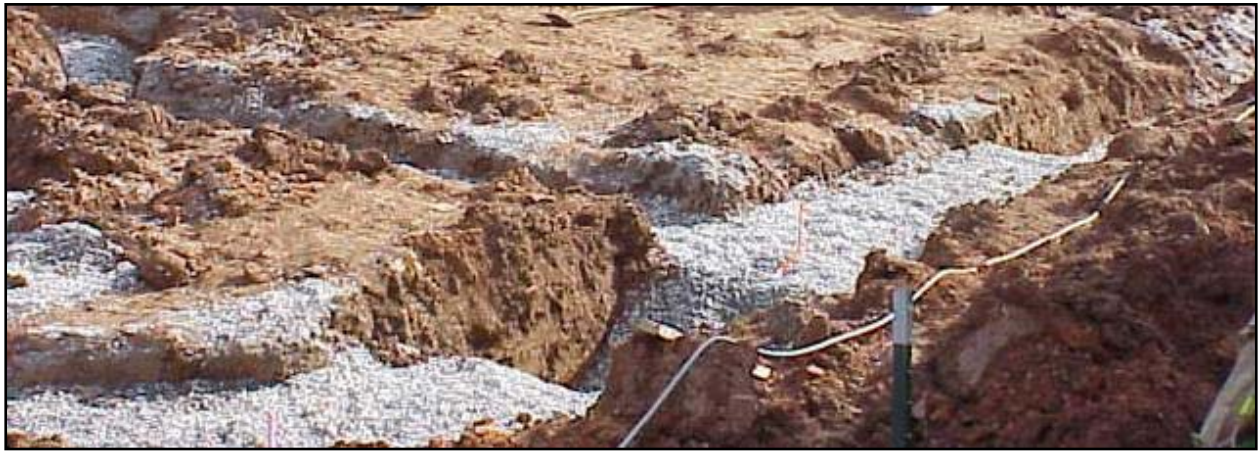
As the owner operated the mini-excavator, the crew leader operated a small tow motor to push the gravel into the excavation in order to keep the floor of the trench level for the footing (Photo 1).

*Photo 1. Illustrates the usual depth of the footings and the gravel fill.
Photo courtesy of NCOSHA.*

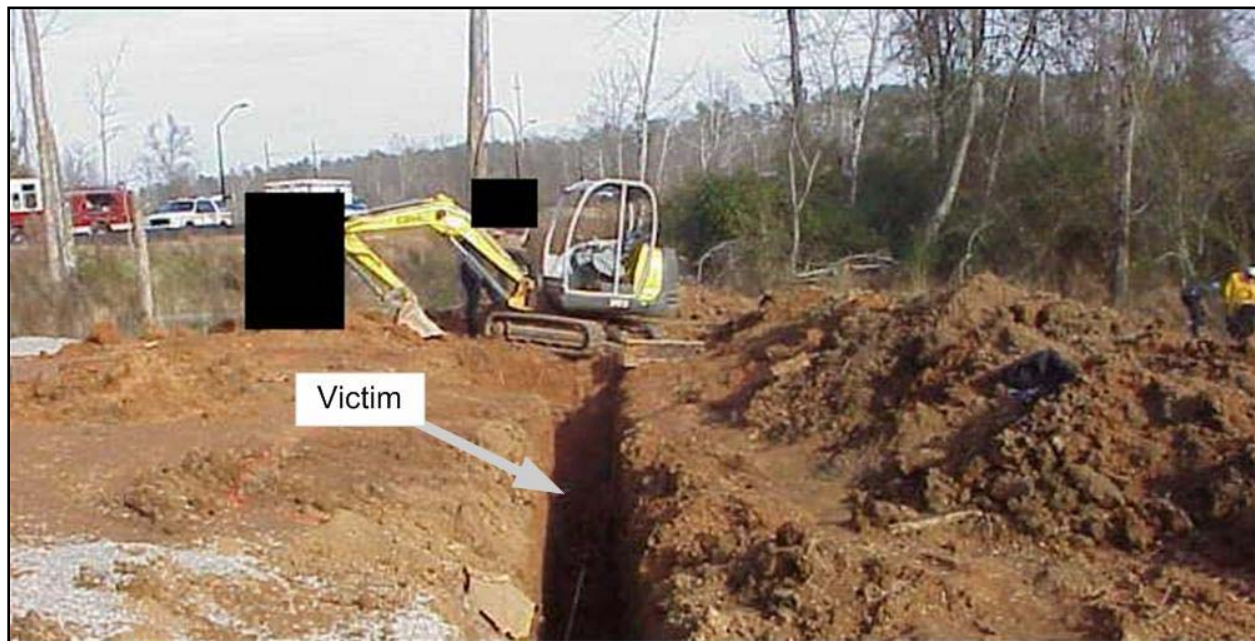
the wall of the trench start to fall away and screamed for the victim to get out. The victim turned and ran about five feet but was covered up when the wall caved in (Photo 2). The crew leader yelled for the other crew members. The owner and homeowner also heard the crew leader and ran to the trench to see what had happened. When it was evident the victim had been covered up, the homeowner called 911. The men tried to dig the victim out while the crew leader used the mini-excavator to remove dirt from the area. The fire rescue squad arrived within minutes and ordered the owner and workers to exit the excavation because of the danger of further cave in. The rescue squad then employed trench plates to secure the sides of the trench and began to uncover the victim (Photo 3). Approximately four feet of dirt had to be removed to completely uncover the victim, who was removed from the trench at 1:35 p.m.

Photo 2. Illustrates the position of the mini-excavator at the time of the incident and the approximate location of the victim.

Recommendation #1: Employers should ensure that a competent person conducts daily inspections of excavations, adjacent areas, and protective systems and takes appropriate measures necessary to protect workers.

Discussion: Although the contractor had not been contracted to perform trenching operations, unusual circumstances were present at the site due to the change in building plans. Regulations and other safety measures pertaining to trenching operations should be followed when excavations exceed four feet in depth. Significant hazards are associated with trenching and similar excavating

operations, including cave-in, positioning of machinery, and changes in environmental and physical conditions. For these reasons, 29 CFR 1926.651 (k) (1)¹ requires that “daily inspections of excavations, the adjacent areas, and protective systems shall be made by a competent person^a for evidence of a situation that could result in possible cave-ins, indications of failure of protective systems, hazardous atmospheres, or other hazardous conditions. An inspection shall be conducted by the competent person prior to the start of work and as needed throughout the shift.” 29 CFR 1926.651 (k) (2)¹ requires that “where the competent person finds evidence of a situation that could result in a possible cave-in, indications of failure of protective systems, hazardous atmospheres or other hazardous conditions, exposed employees shall be removed from the hazardous area until the necessary precautions have been taken to ensure their safety.”

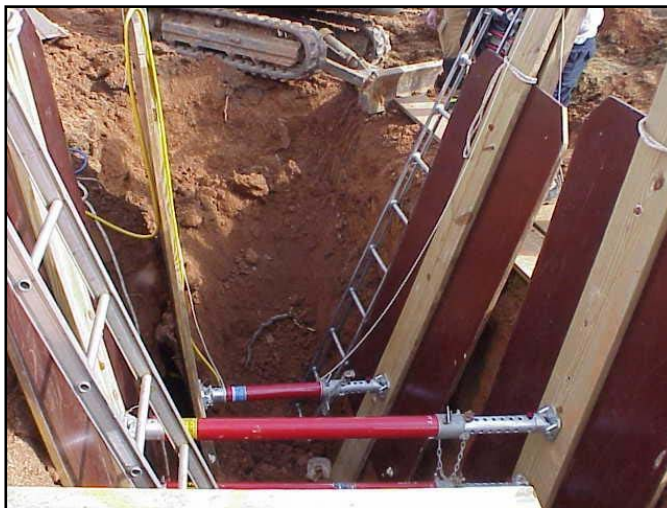
Photo 3. Illustrates the trench plates installed by the rescue squad. Photo courtesy of NCOSHA

Recommendation #2: Employers should ensure that workers are protected from cave-ins by an adequate protective system.

Discussion: Due to the backfilling performed due to the change in building plans, the depth of the excavation had reached eight feet. Although the crew was instructed not to enter the excavation, should the need arise for workers to enter an excavation, the applicable OSHA Excavation Standard, 29 CFR 1926.652 (a) (1)¹ states that “each employee in an excavation shall be protected from cave-ins by an adequate protective system.” A protective system designed for the soil conditions found in this excavation could have included a trench shield (also known as a trench box), shoring, or a combination of shoring and shielding. Sloping would not have been appropriate because of the sandy composition of the back-filled soil. Employers should consult

tables located in the appendices of the OSHA Excavation Standard that detail the protection required based upon the type of soil and environmental conditions present at the site. Employers can consult with manufacturers of protective systems to obtain detailed guidance for the appropriate use of these products. In this incident, no protective system had been placed at any point in the footing excavation.
