Fatality Assessment and Control Evaluation Program

FACE Report Number: 2004-08

Fifteen-Year-Old Hispanic Youth Dies After Entering the Hopper of a Bark Blower - Maryland

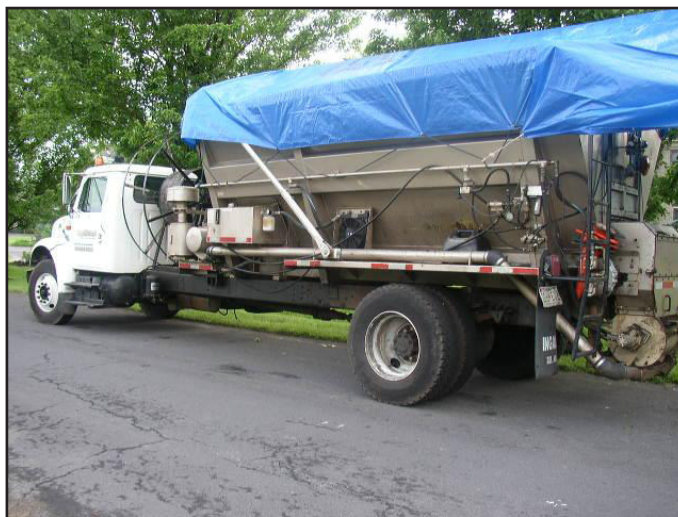
Photo 1. Bark blower involved in incident, photo courtesy of Maryland Occupational Safety and Health Administration

The victim and a foreman were dispatched to a new private residence to dispense mulch around various trees and shrubbery in the yard of the residence. To dispense the mulch, the workers used a truck-mounted bark blower (Photo 1).

The bark blower was approximately eight feet wide, 15 feet long, 6½ feet high and was powered by an 80-horsepower diesel engine. The weight of the bark blower was 8,000 pounds and its hopper had a capacity of eight cubic yards. The mulch was dispensed through a blower with a capacity of 830 cubic feet of air per minute at 12 pounds per square inch of pressure. The bark blower had the capacity to dispense 15 cubic yards of bark mulch per hour. The power box for the blower was located on the rear of the passenger side of the hopper approximately 5½ feet above ground. The blower was started by inserting the key, turning it to the on position, then pressing the start button. The blower was deenergized by pressing the stop button, then turning the key to the off position and removing it from the power box. The sides of the hopper converged from seven feet wide at the top to approximately three wide at the bottom. An auger/agitator and drag

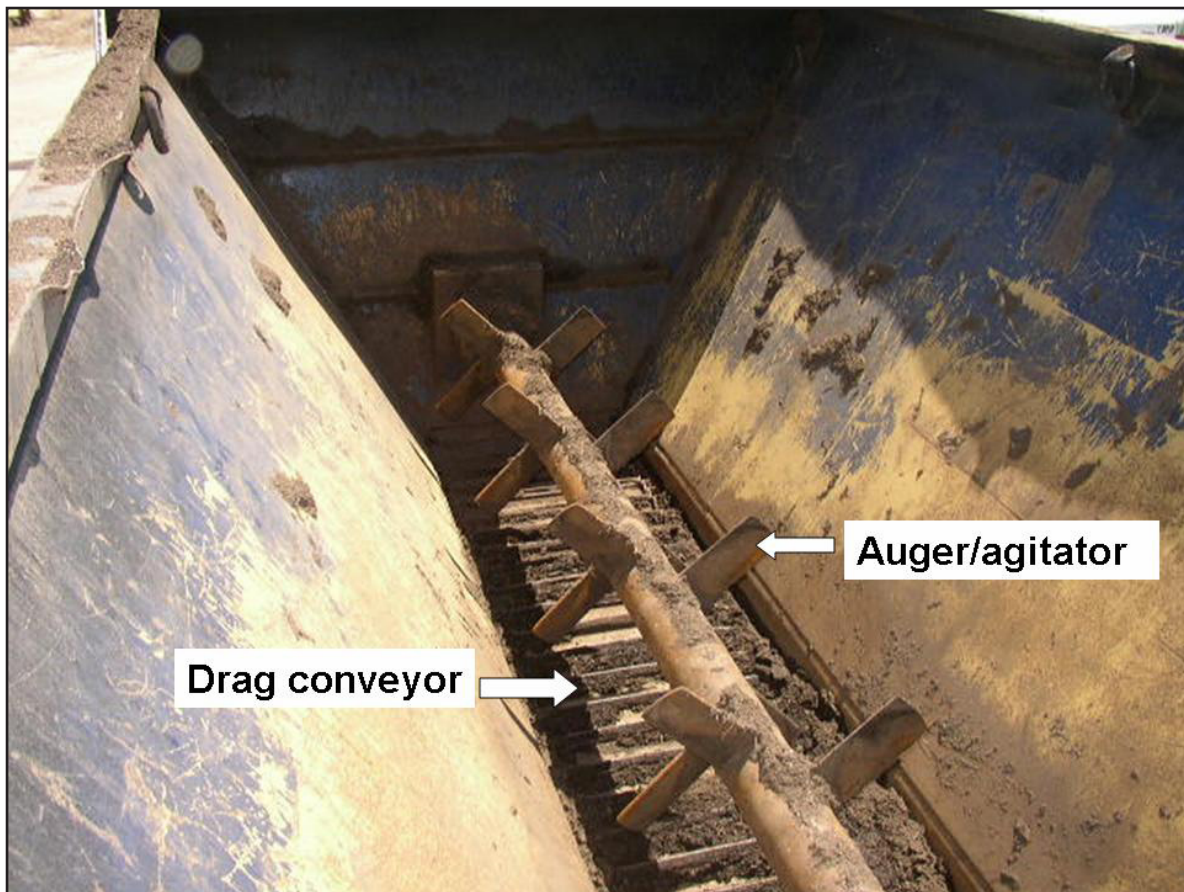
conveyor were located at the bottom of the hopper (Photo 2). As the auger/agitator turns it breaks larger pieces of mulch into smaller pieces that the drag conveyor carries to an opening containing a feed roller. The feed roller then transports the mulch into a rotary air valve that channels the mulch into a pressurized air stream created by the blower. The mulch is then dispensed through a four-inch diameter reinforced flexible rubber hose to the desired location.

Photo 2. View of the bark blower from the top of the hopper; Photo courtesy of MOSH

Manufacturers should consider and evaluate the installation of grid-shaped guards at the top of bark thrower hoppers and over the auger and drag conveyor during the manufacturing process. Ladder locks to prevent unqualified workers from accessing the top of the hopper should also be evaluated and installed if feasible.

Discussion: In this incident, the victim entered the wide-open hopper of the bark blower. Manufacturers of the bark blower should consider evaluating some sort of grid-shaped guard system that could be incorporated into the design at the top of the bark blower hopper and over the rotating auger and drag conveyor. This system should be designed to allow for the free flow of mulch while the bark blower was being loaded and would prevent inadvertent entrance into the hopper of the bark blower and contact with the auger. The design of the grid system could include a door equipped with a locking device that would allow for entrance for maintenance operations. An interlock system that would automatically shut down the blower system, auger, and drag conveyor if the grid-shaped guard were opened would provide a redundant and more effective safety feature. At the time of the investigation, the manufacturer did not offer any type of guarding system for the top of the hopper or the auger/agitator and conveyor. Additionally, fixed ladders on the bark thrower blower should be equipped with locking devices that would block the ladders and prevent unqualified workers from accessing the top of the hopper.

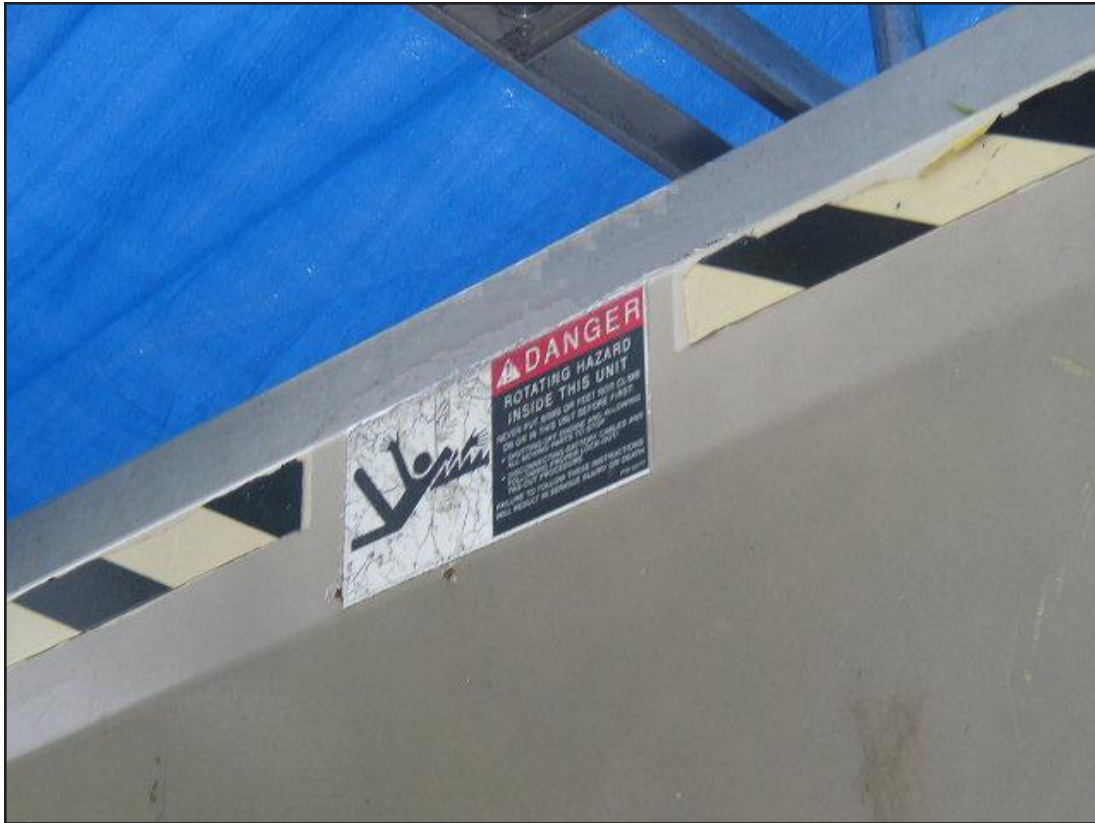
Photo 3. Safety label (in English) warning of the entanglement hazard inside the hopper; Photo courtesy of MOSH

Manufacturers should consider affixing dual language labels with graphics to provide hazard warnings and instructions for safe use of equipment.

Discussion: Having employees who speak limited or no English presents unique challenges. It is important for Spanish-speaking employees to be able to interpret instruction and warning labels on work equipment such as the bark blower hopper in this incident. While some equipment is bought or shipped with manufacturers' documentation in at least one language other than English, many instruction and warning labels on the equipment are only in English. The machine had labels affixed to the hopper detailing the operating instructions of the machine and the entanglement hazard inside the hopper; however these labels were in English (Photo 3). A dual language label with a graphic or picture label could offer an additional warning to workers of potential hazards.
