# FACE

FACE Report Number: 2005-06

***Hispanic Worker Dies After Falling From a Pile of Construction Debris in the Bed of a Trash-Style Body Truck to a Paved Driveway Below - North Carolina***  
***Revised September 6, 2006 to correct the name of a web site.***

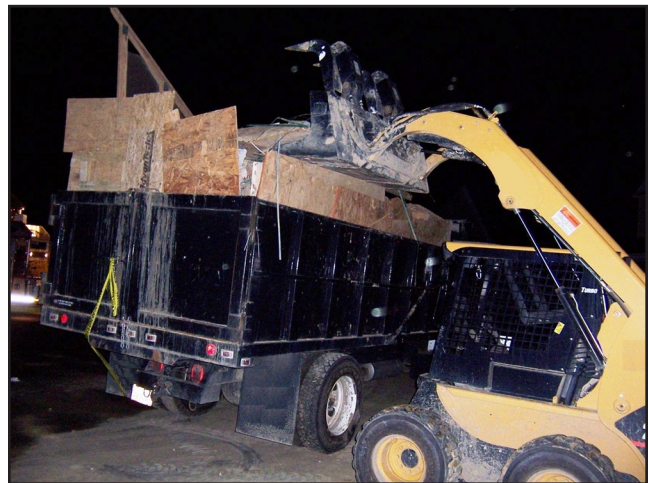
*Trash truck involved in the incident*

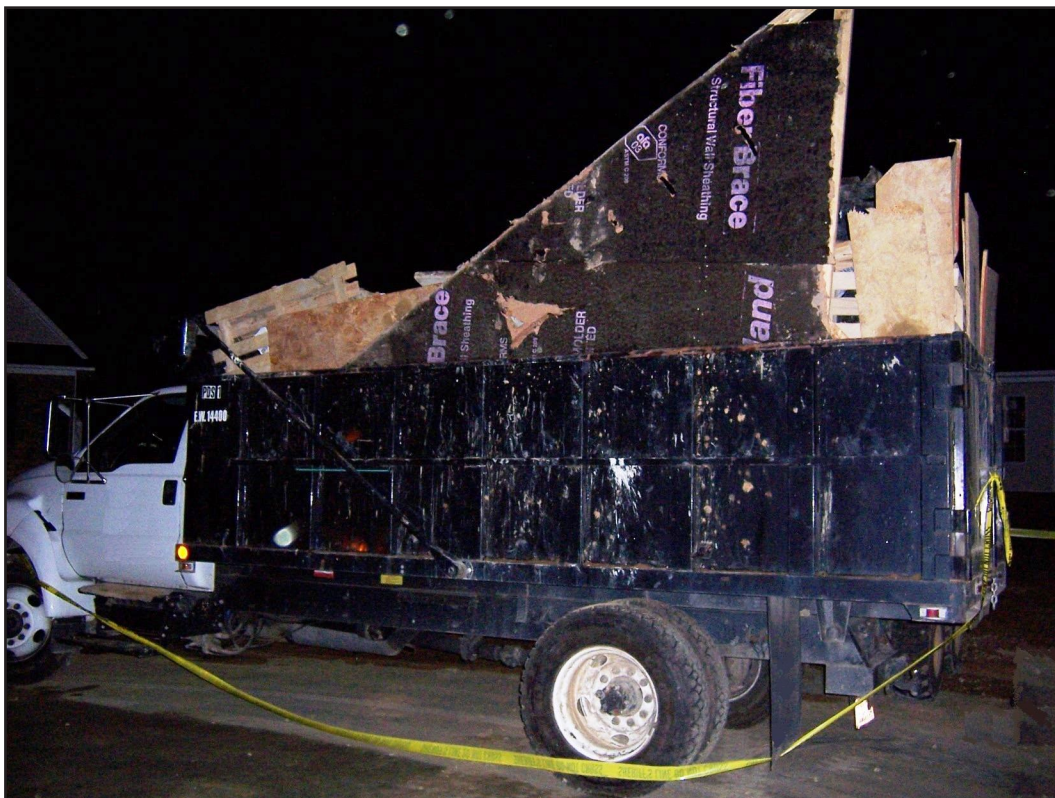
Equipment: The single axle dump truck (trash truck) used at the time of the incident (Photo 1) was purchased new in 2005. The bed of the truck was 16 feet long by 8 feet wide and had 40-inch high solid sides. The foreman and his crew had inserted sheets of scrap plywood (side height extensions) that extended approximately 24 inches above the 40-inch sides of the truck bed so that more construction debris could be carried in each load. The foreman was an experienced long distance truck driver and was the designated operator for the trash truck and skid steer loader used to load debris into the truck bed.

*Photo 1. This photograph illustrates the trash truck used on the day of the incident. Scrap plywood pieces had been used to extend the truck bed height an additional 24 inches. [Photograph courtesy of NCOSH].*

***Recommendation #2: Employers should contact equipment manufacturers before making any modifications or additions to purchased equipment, such as extending the side height of trash truck beds.***

Discussion: According to the trash truck manufacturer's sales representative, the manufacturer does not manufacture side extensions to increase the height of truck beds and recommends that they not be used. Instead, the manufacturer sells truck beds in a variety of bed lengths and in 40

and 42-inch side heights. The manufacturer recommends that buyers purchase trucks that are properly sized to meet their needs.

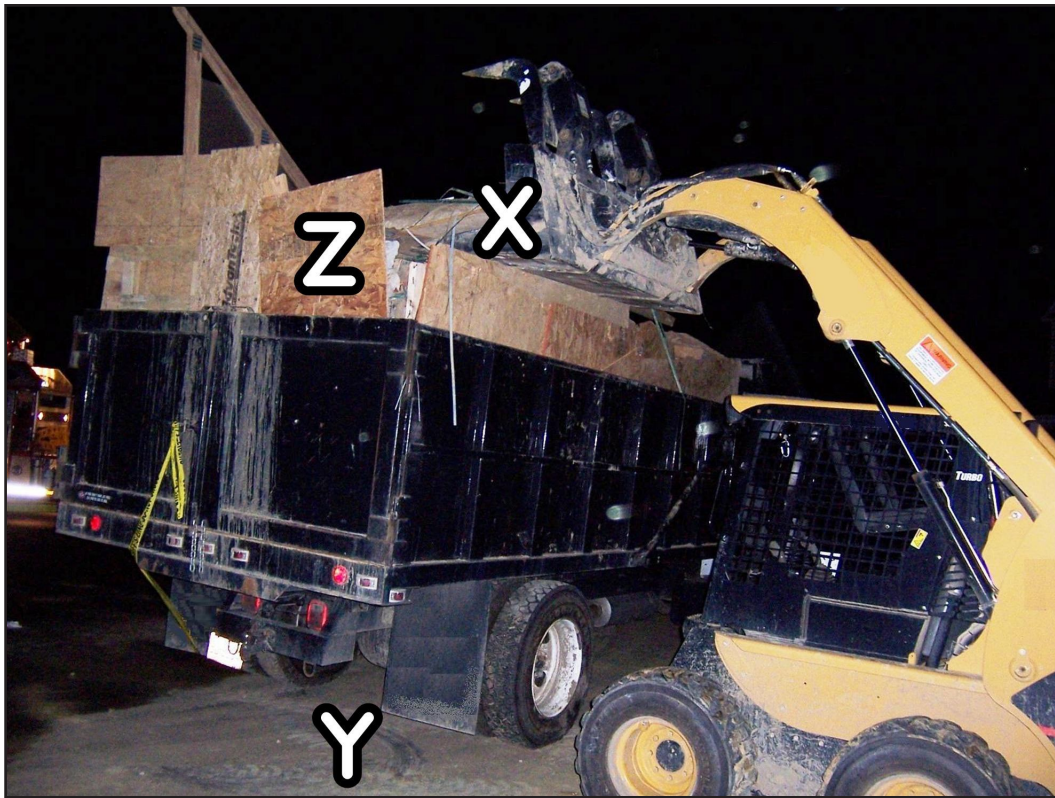
*Photo 2. This photograph illustrates the trash truck used on the day of the incident. An X has been placed on the photograph to identify the victim's approximate location before his fall; a Y to identify the victim's approximate location after this fall; a Z to identify the scrap plywood pieces used to extend the truck bed height and additional 24 inches. [Photograph courtesy of NIOSHA].*

to its capacity in order to save on trips. To get more of the large, oddly shaped materials into the bed of the trash truck, the owner and crew placed large scrap pieces of plywood along the sides and back of the truck bed. Because the pieces of scrap plywood had been placed in the bed, the load could be piled inside the truck bed 24 inches higher than the trash truck's 40-inch sides would have normally allowed. According to the employer/foreman, these scrap plywood pieces were not secured but remained in place due to the weight of the load against them. They always secured a tarp over the load before the trash truck departed for the landfill. Because the odd shapes and sizes of the construction debris left open spaces in the bed of the truck, the victim and his coworkers routinely climbed into the bed of the truck and used their hands to place debris into empty areas. Weight allowances for these types of trucks are set and enforced by the United States Department of Transportation (USDOT). The USDOT also requires that loads be covered when transported over-the-road. The foreman reported to investigators that his loads were near capacity but that he had not received fines for being over capacity and his loads were regularly weighed and checked at the landfill. The foreman said that the skid steer loader was purchased new and that he had not considered using any other type of equipment to fill the truck bed. The DSR investigator concluded that the weight of the load on the truck at the time of the incident was not a factor in this incident. The height of the load, made possible by placing scrap plywood pieces in the bed and

extending the side height an additional 24 inches, was considered an important factor as it placed the victim 8.5 feet above the paved driveway without fall protection.

***Recommendation #1: Employers should establish work procedures that would eliminate the need for workers to enter the trash truck bed during and after loading operations where they are exposed to potential fall hazards.***

Discussion: Employers are required under OSHA's General Duty Clause to furnish a place of employment which is free of recognized hazards that are causing or likely to cause death or serious physical harm to employees.<sup>1</sup> To eliminate the need for workers to stand on debris during and after loading where they are exposed to a potential fall hazard, all loading and leveling of loads should be done by equipment alone. Skid steer loaders basically tilt back and forth and move up and down, and are not equipped to move items around in the truck bed to utilize space. If employers choose to use skid steer loaders for this work, they should load the trash truck without use of plywood to extend the side height and without placing workers into the truck bed. Employers may have to plan for additional trips to the landfill, understanding that the bed space will not be completely utilized when filled using the skid steer loader alone. The skid steer loader operator should ensure that workers are not in the truck bed during any phase of the loading and hauling process and should always lower the bucket of the skid steer loader to the ground before exiting the machine for any reason. A trash truck with a larger bed can be utilized and loaded by the skid steer loader so that more debris could be carried on each trip to the landfill.
