Hispanic Laborer Electrocuted When Crane Boom or Load Line Contacts 7,200 Volt Overhead Power Line - North Carolina

Fatality Assessment and Control Evaluation (FACE) Program

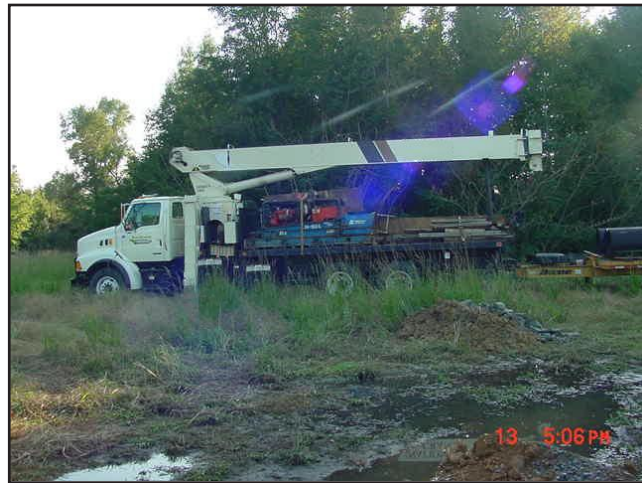
Photo 1. This photograph illustrates the truck-mounted crane that was used on the day of the incident. [Photograph courtesy of NCOSH].

Equipment: The truck-mounted crane used at the time of the incident was an articulating telescopic boom crane (Photo 1). The truck crane was operated by the employer's foreman, but was owned by the other jack and boring subcontractor that had been contracted for the project. The foreman (crane operator) had worked for the employer for 7 years. His training was not documented.

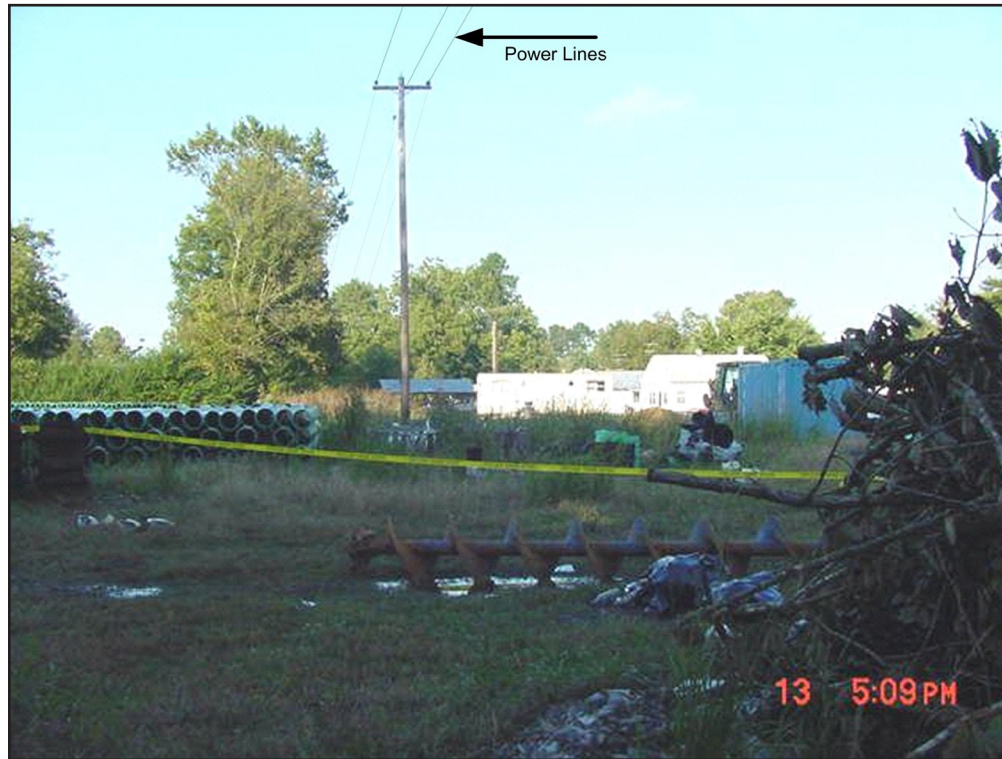
Photo 2. This photo illustrates the overhead power lines located at the materials storage yard. [Photograph courtesy of NCOSH].

Incident site: A 5-acre, flat, vacant lot owned by the city was provided as a materials storage yard to the contractor and subcontractors working on the water utility project. There was a 7,200 volt power line running through the middle of the materials storage yard approximately 27 feet above ground level. The yard was used to store materials and equipment for the water utility project such as augers, carrier pipes, and steel pipes.

At approximately 2:00 p.m., the jack and boring crew finished jack and boring operations under a section of state highway and returned to the materials storage yard (Photo 2) to load pipe and augers for the following day's work. The crew manually loaded three 20-foot sections of steel pipe onto a truck trailer (Photo 3). Because the 20-foot augers (Photo 4) were too heavy to manually move, the company's crane operator or a crew member had hooked a crane cable line to one of several augers lying on the ground and the crane operator had started extending and raising the boom to make it easier for laborers to slide the auger into the steel pipe already on the truck trailer.

The city engineer responded to the incident before the EMS arrived and observed the location of the crane boom, cable line, and power lines. At the time of his arrival, the crane boom was 4-5 feet above the closest power line phase. There was approximately 3-4 feet horizontal separation between the crane cable and the closest power line conductor. The city engineer contacted the power company and the power lines were de-energized and not returned to operation until the victim, injured workers, and emergency responders were out of the area. While the power lines were de-energized, the augers and pipes were moved to another location and the city engineer measured the distance from the earth to the power lines above. The conductors were located approximately 27 feet above ground level. The city engineer reported that contractors had been warned verbally about the power lines overhead, but since the area was so large and there were areas for storage away from the power lines, the location was suitable for equipment and materials storage. The DSR safety and occupational health specialist noted that the storage yard was quite large and there were large, unused spaces well away from the power lines. Also, there was standing water noted on the ground under the power lines.

Discussion: Before beginning work at any construction site, a competent person should evaluate the site to identify any potential hazards and ensure appropriate control measures are implemented. At the materials storage yard, a 3-phase 7,200 volt overhead power line was located directly above the area where steel augers and steel pipe had been stored. Materials and equipment should be stored a safe distance away from all power lines, if possible.

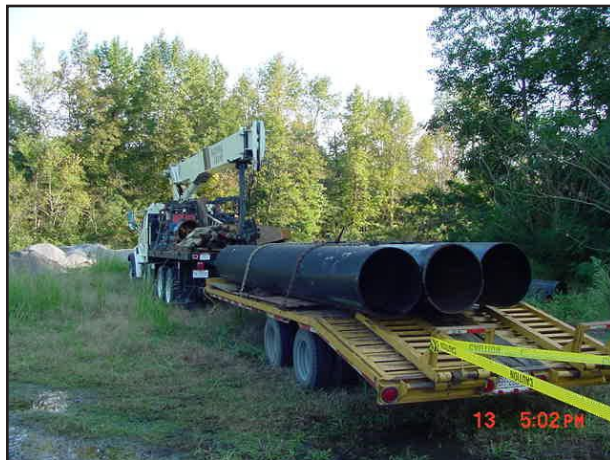
Photo 3. This photo illustrates the sections of pipe on the truck trailer into which the steel augers were to be inserted. [Photograph courtesy of NCOSH].

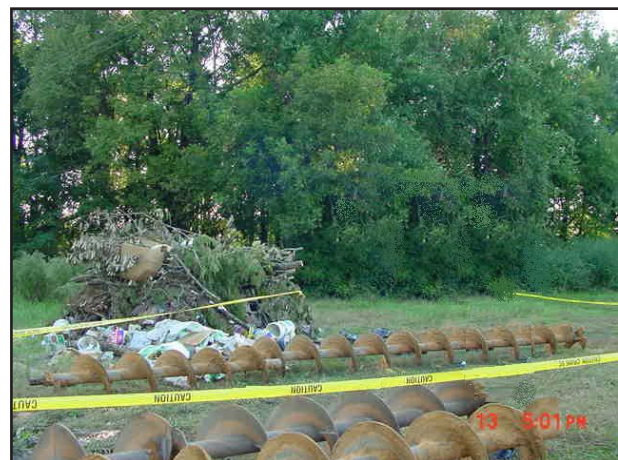
Photo 4. This photo illustrates the steel augers that were being lifted with the truck crane and inserted into sections of steel pipe located on the truck trailer. [Photograph courtesy of NCOSH].

The victim was holding on to the auger when the truck-mounted crane boom apparently moved, causing the crane boom or load line to contact the overhead power line, and the electricity to flow through the victim's body. Two workers employed by another subcontractor that were assisting the victim were also shocked and knocked to the ground by electricity. They were not permanently injured. The crane operator saw that the three employees had fallen to the ground. He came down from the crane operating position and ran to check on the men and look at the crane boom, the load line, and the power lines. [Since the crane operator was not shocked, it is assumed that he moved the boom away from the power lines before exiting the crane cab.] He then ran back to the operating position, lowered the auger to the ground, and then returned to the men. Finding that the victim had no apparent pulse and did not appear to be breathing, the crane operator began cardiopulmonary (CPR) resuscitation efforts. One of the workers who had been shocked ran to a nearby building to call 911, while the other waited for Emergency Medical Services (EMS). EMS personnel responded within approximately 20 minutes and continued CPR on the victim. The victim remained unresponsive and was transported by ambulance to a nearby hospital, where he was pronounced dead by an emergency room physician. The two injured workers were transported
