***Chain Saw Operator Dies After Being Struck by Excavator Bucket During Site Clearing - North Carolina*****SUMMARY**

On July 27, 2004, a 46-year-old chain saw operator (victim) was cutting root balls from trees pushed over during site clearing, when he sustained fatal crushing injuries after being struck by the bucket of a track-mounted hydraulic excavator. The excavator operator was using the bucket on the excavator to push over trees, straighten downed trees for stumping, and move damaged trees to a large burn pile. When he realized he had not seen the victim for approximately 15 minutes, he moved the excavator to get a better view of the area and saw the victim on the ground. He jumped out of the excavator and ran to the victim. Unable to get a response when he called to the victim, he ran to his employer who called 911 on his cell phone. The employer drove to the main road to help emergency medical service personnel (EMS) locate the incident site. Police officers responded within minutes and the excavator operator accompanied them to the incident site. The victim was pronounced dead at the scene at 10:30 a.m. by EMS personnel.

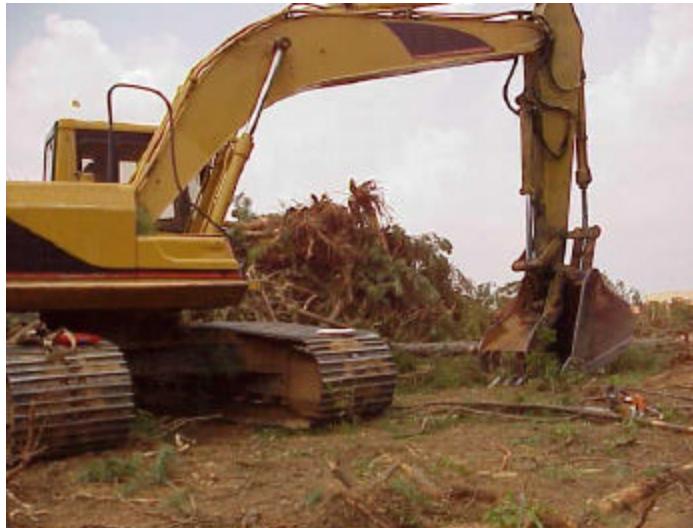
*Excavator involved in the incident***Fatality Assessment and Control Evaluation (FACE) Program**

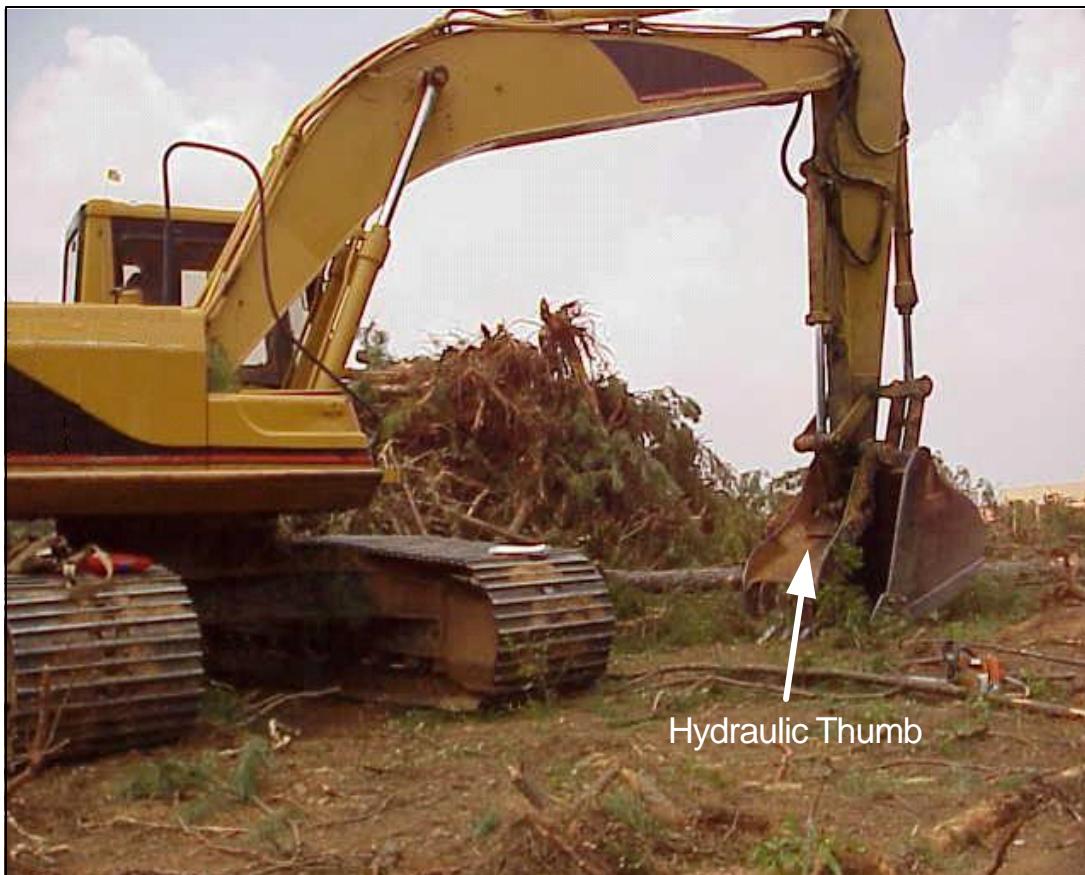
Equipment: The hydraulic excavator had been purchased by the grading subcontractor and was five years old. The excavator's reach capacity was between 32 and 34 feet at ground level. A hydraulic thumb (photo 1) had been attached to the excavator so that it could be used for handling felled trees. The equipment operator had been employed by the company for 7 years and operated this excavator and other heavy equipment on a regular basis.

*Photo 1. this photo illustrates the excavator used at the incident site. [Photograph courtesy of NCOSHA].*

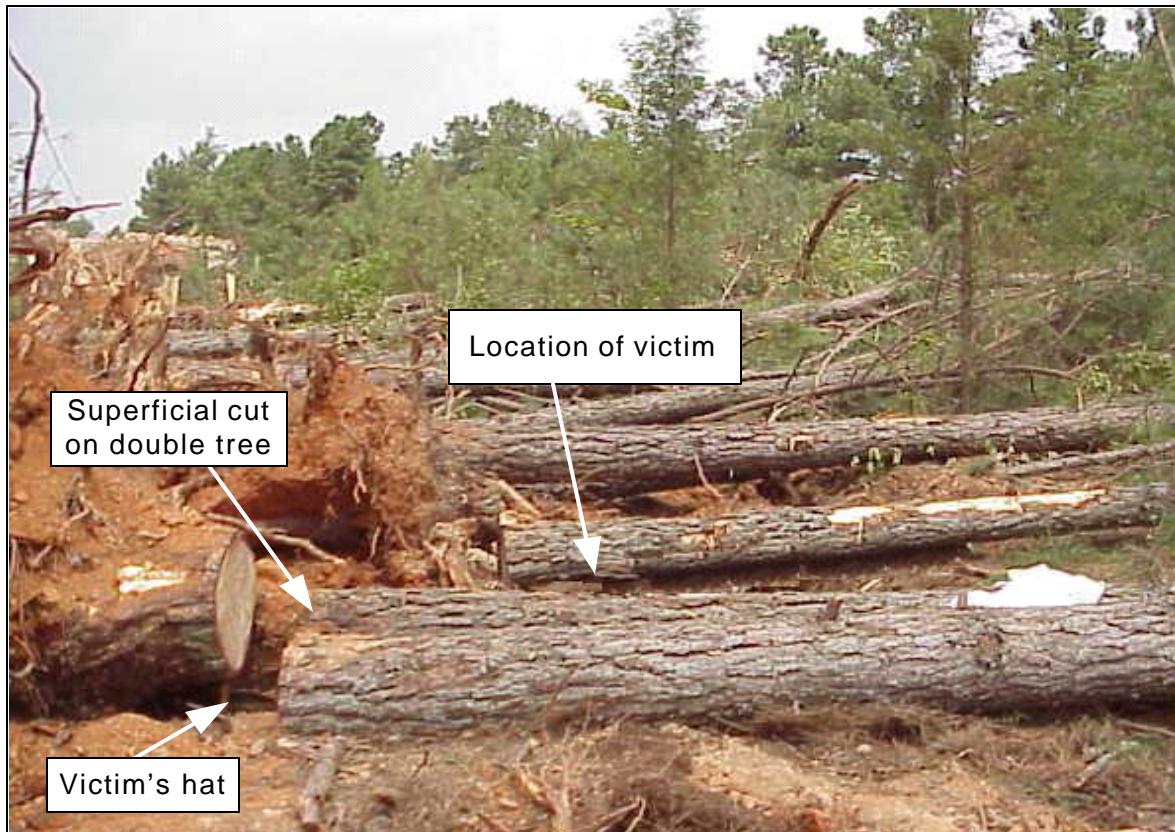
According to statements taken from those who responded to the incident, the victim's body was found beside a downed double tree (two trees on one root ball). One of the trees on the double tree had been cut from the stump and the other had a superficial saw cut on it. The chain saw was located under the victim's body as was a large limb. The switch was in the "on" position and the chain brake was not engaged. The employer reported that he thought the double tree may have rolled and struck the victim when it became

Photographs of the site taken immediately after the incident indicate that the victim's body was found in an impression approximately 18-20 inches deep. There was a downed double tree with a large single root ball between the victim and the excavator. It is unlikely that the victim was visible to the excavator operator because of the site characteristics and because the victim wore dark clothing and was bending over to cut downed trees. Distance estimates made by NCOSHA indicate that the victim's body was located within reach of the excavator bucket. Police personnel noted marks on the victim's body that they believed were made by the bucket of the excavator.

after the incident and reported to DSR investigators that it appeared that the double tree had rolled toward the victim.

*Photo 2. This photo illustrates the location of the victim next to a double tree that rolled. The excavator is not pictured but was located on the root ball side of the downed trees [Photograph courtesy of NCOSHA].*

Discussion: The site clearing and tree harvesting work conducted on the incident site involved pushing over trees and brush with an excavator bucket and separating downed trees that were to be cut and sold for saw timber from those that would be burned as waste. Employers should inspect the worksite and plan work tasks in phases to eliminate the need for workers on foot, such as chain saw operators, to be working in an area where machines are being operated. All phases of work should be planned to maintain required distances between workers and machines and between various machines operated on site. NCOSHA has a special emphasis program (SEP)<sup>a</sup> for tree felling and related activity that identifies the federal OSHA logging standard as applicable to the type of work performed in this incident.<sup>1</sup>

Workers performing site clearing and logging operations should be trained to recognize and avoid hazards associated with site clearing and logging operations. Safety regulations can be found in 29 CFR 1910.266 Logging operations.<sup>2</sup> OSHA requirements for training loggers are very specific and employers are required to certify compliance with employee training [29 CFR 1910.266 (i) (1-11)].<sup>2</sup> Appropriate safety training may have helped the excavator operator and chain saw operator (victim) avoid hazards associated with working near moving machinery, and hazards associated with stumping a double tree that may roll toward a chain saw operator after one part is cut free. The OSHA compliance officer observed the site shortly
