***ROPS Equipped Soil Compactor Overturn Kills Operator - Tennessee*****SUMMARY**

*Photo 1. Compactor involved in the incident*

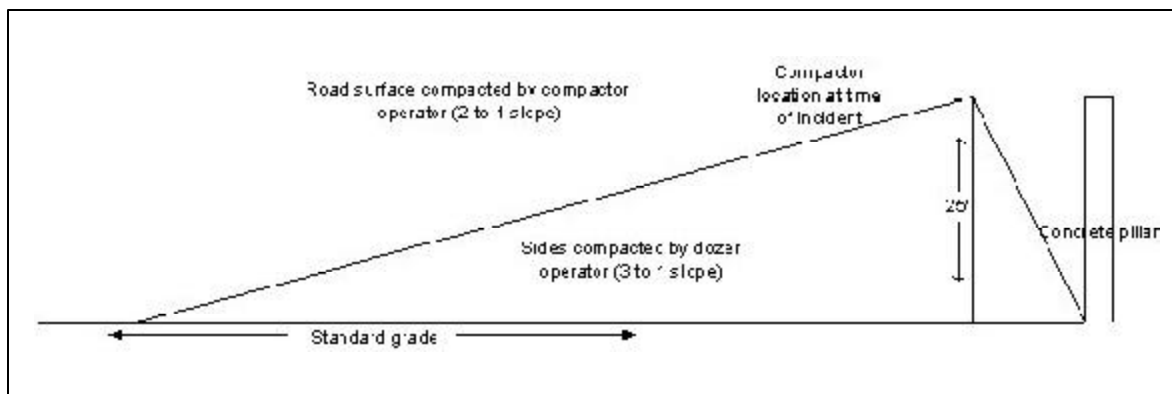
Construction of the built-up ramp involved a four step process. First, a load of soil is dumped where the slope was to be created. Second, the dozer operator pushes the dirt to a gently sloping grade. Third, the tractor operator pulls a disc behind the tractor, breaks up large clumps of dirt, and levels the surface. Lastly, the compactor is driven over the smoothed surface. The process is repeated until the sloping dirt mound reaches 25 feet above standard grade and a width of approximately 85 feet. A profile of the ramp is shown in Figure 1.

Figure 1. Profile of work site

At the time of the incident a dump truck used to deliver fill dirt and a dozer used to spread the dirt were also on the ramp. As the dump truck pulled up the slope to empty a load, the victim backed the compactor to the side of the ramp to allow the dump truck driver sufficient room to empty the load. The five-foot-four inch tall 175 pound victim was wearing a hard hat and was wearing the seatbelt on the compactor. According to a witness, the victim was looking over her left shoulder as she was backing the compactor. As the right rear tire went over the edge she called for help and appeared to be ‘trying to get up and out of the cab,’ but remained restrained by the seatbelt. It is not known if the seatbelt was loose or tight at the time. Tracks made by the compactor indicated the unit backed approximately 30 feet up the sloping surface prior to backing off the edge, rolled two and a quarter times and came to rest on its side.

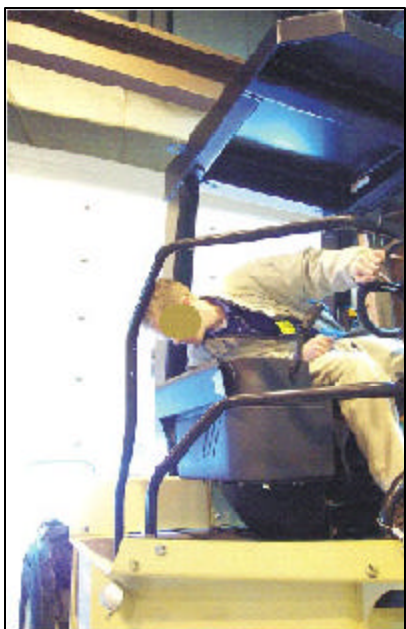
*Photo 2. Seat belted operator on a compactor similar to that involved in the incident*

During the field investigation, a 5-foot-9 inch DSR staff member was able to demonstrate how the head of an operator can move laterally outside of the DLV (See photo 2) while properly restrained with a lap-type

seat-belt. If an operator's body is outside of the DLV designated area it may be subject to hazardous contact with the roll-bar uprights, compactor surfaces, and the ground.

A product safety or human factors engineering design evaluation should be conducted to determine if the DLV needs to be changed. This type of evaluation would assess the safety of operators (over a range of human body sizes) when protective equipment is properly installed and used. This type of evaluation should also assess the need for more effective operator restraint systems, such as a type-2 (shoulder) restraint, or the need for more effective seat and seat-back designs for better operator protection during a rollover event.

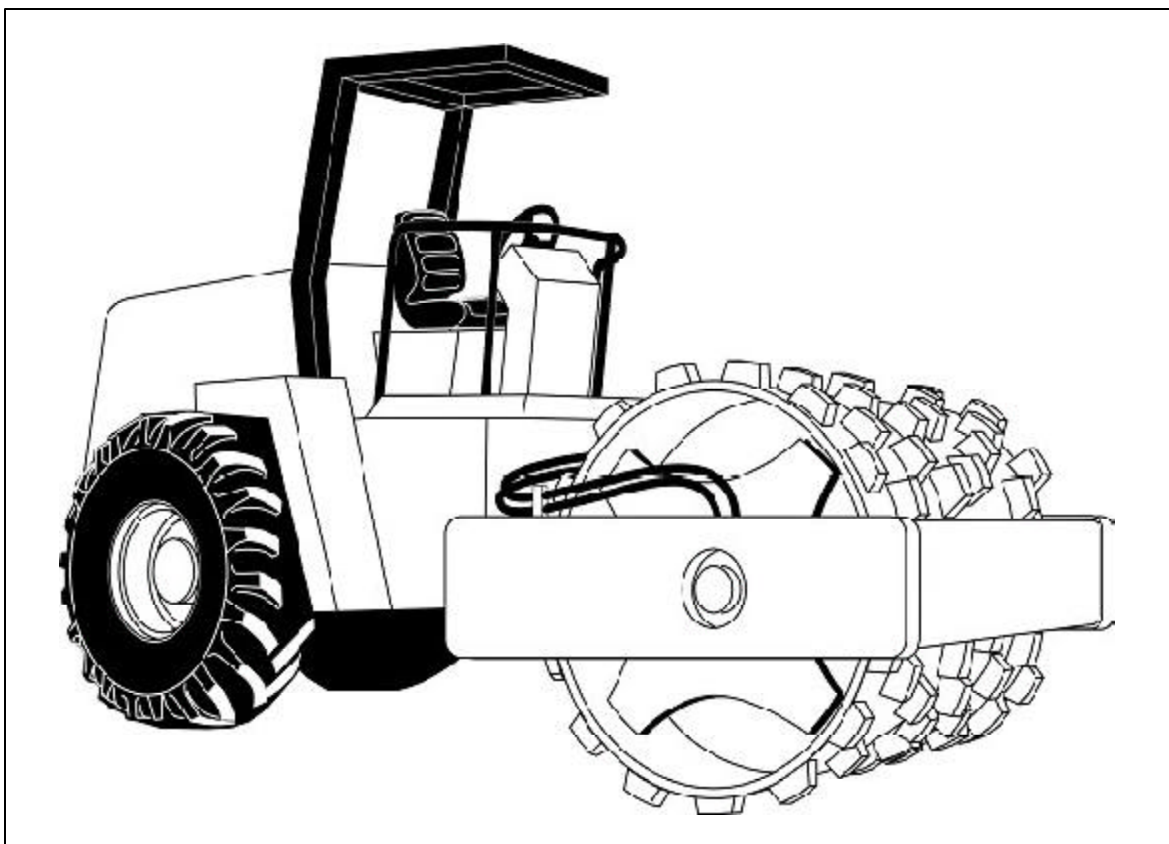
The compactor, a self-propelled articulated-frame design with an operating weight of 23,000 pounds was equipped with a ROPS and seatbelt and powered by a 125-horse power diesel engine. (Figure 2 and Photo 2) Its total height is ten feet, width seven feet nine inches, and length nineteen and a half feet. The variable vibrating drum is five feet five inches in diameter, and seven feet wide mounted on the front of the machine. Inside the drum a variable speed eccentric shaft rotates to create additional force on the ground up to 50,500 pounds. A single lever controls the compactor's direction, speed and braking from a forward facing (toward the drum) bucket seat. The unit operates in two speed ranges, low for compacting and high for transporting. Maximum speed in low range is 4 miles per hour in both forward and reverse.

*Figure 2. Compactor (permission to use this drawing was given by manufacturer)*
