Hispanic Logger Struck and Killed by a Falling Tree Cut by a Feller Buncher Machine - North Carolina**SUMMARY**

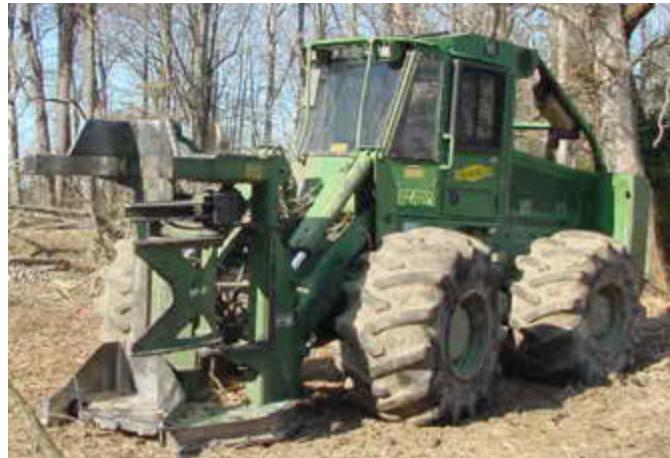
Photo 1. Photo of feller buncher. Photograph courtesy of the NCOSHA

Equipment. The feller buncher used in this incident is a mobile machine, rubber tired, with a power plant, operator enclosure, and an articulating extendable arm onto which a felling head is attached (Photo 1). The felling head consists of grab arms and a high speed^a disc saw. The operator moves the machine into position in front of a tree and maneuvers the felling head to the tree trunk. The grab arms wrap around the tree and the saw severs the tree from the stump. According to a service representative from the machine manufacturer, the grab arms on the model in this incident would expand to hold a tree that is at maximum approximately 18-inches in diameter. The machine then cuts the tree and takes the severed vertical tree with its accumulator arms and lowers it into a horizontal position onto a pile or bunch of trees on the ground.

Discussion: Manufacturers should identify the cutting capacity and include it on a machine label and in the operator’s manuals, specifications on the size of a tree that the machine can be used to cut while operating the machine properly. According to a service representative from the machine manufacturer, the grab arms on the model in this incident would only expand to hold a tree that is, at maximum, approximately 18-inches in diameter. In this incident, the feller buncher was being used to cut a tree 36-inches in diameter. Due to the size of the tree, the feller buncher had to make 2 cuts to fell the tree. After the final cut, the feller buncher could not hold the tree in a perpendicular position to the ground, due to its size. In the operator’s manual for the feller buncher used in this incident, there was no mention of any specific tree size limitations for the feller buncher. Labeling the machine with size limitations for cutting and carrying would also help ensure the machine is used as designed. The manual only provides a caution “to avoid carrying trees which are too large for the machine and/or attachment.”

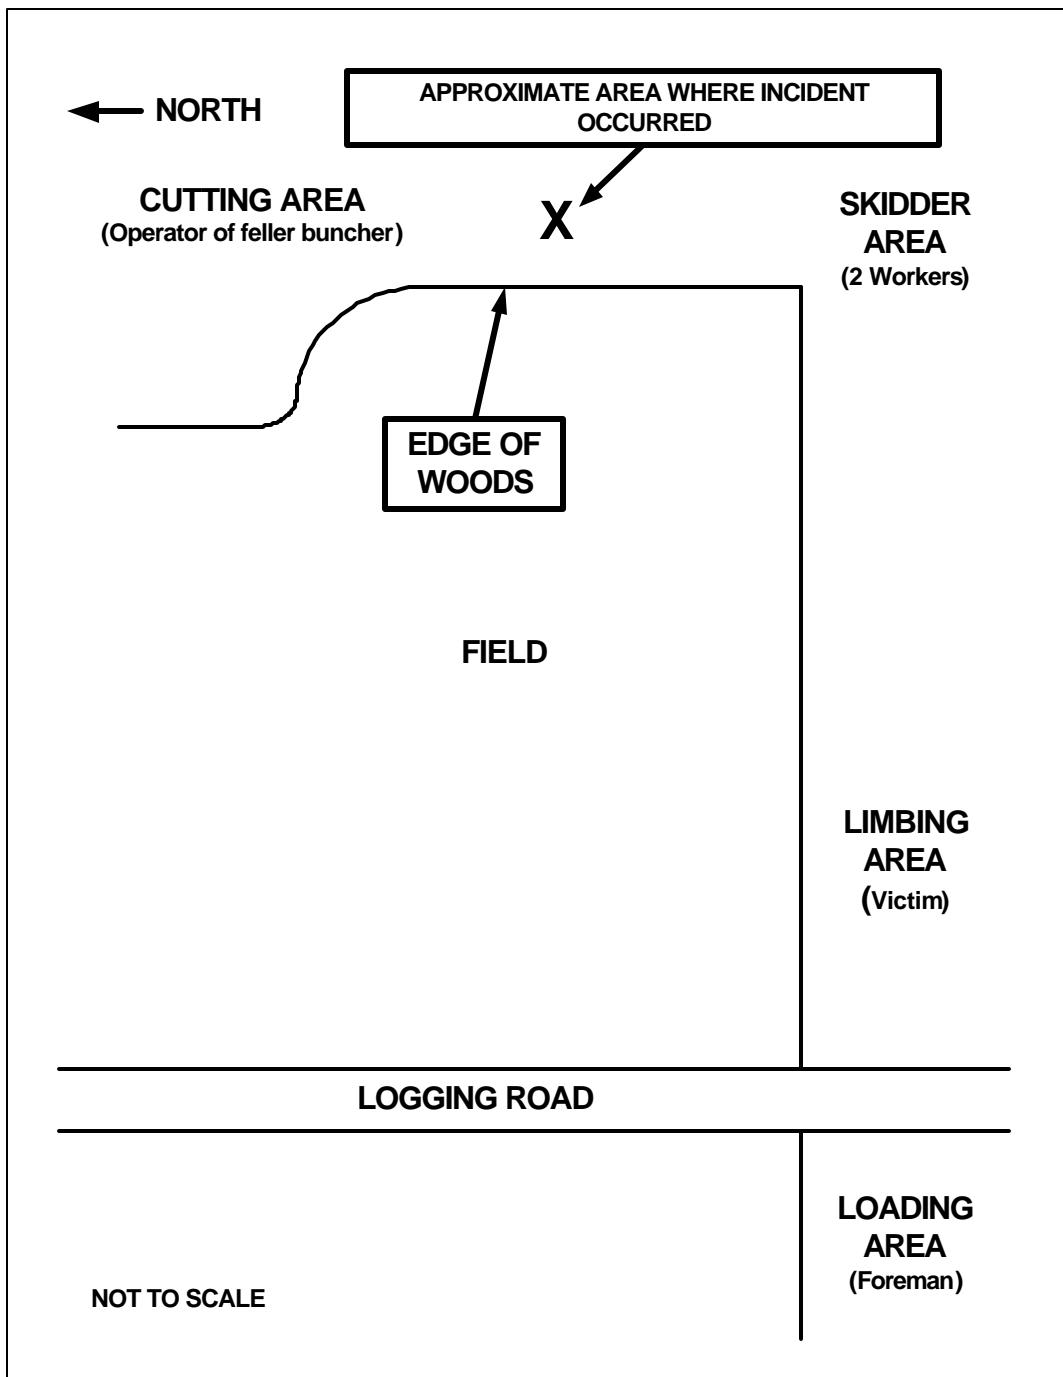
Incident Scene. The employer was subcontracted to cut 30-acres of privately owned timber. The timbering operation on the site consisted of four areas; cutting, skidding, limbing, and loading (Diagram 1). The incident occurred in the cutting area where a feller buncher machine was being used to cut trees. The tree that struck the victim was approximately 104 feet in height (from the cut) and approximately 36-inches in diameter at the trunk; the larger branches were approximately 4-inches in diameter.

Diagram 1. Aerial View of Work Site

The foreman and crew of 4 Hispanic loggers arrived on site at approximately 7:00 a.m. on the day of the incident. This was the foreman's second time working at this site. This was the victim's first day working at this particular logging site. Once on the site, the foreman positioned himself to work on the loader in the loading area and assigned the four logging workers to their specific job duties (Diagram 1):

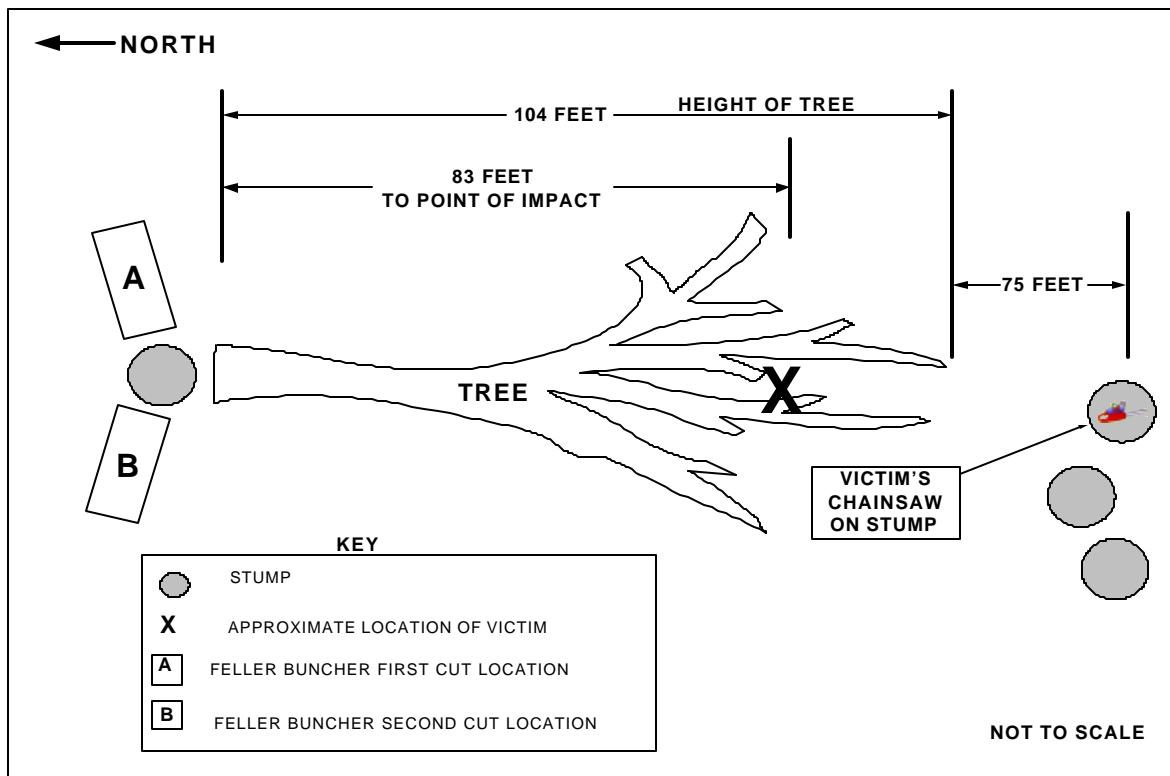
Diagram 2. Aerial View of Incident Site

After the tree fell, the feller buncher operator turned to view the tree lying on the ground and observed the victim lying face down and oriented with his feet to the north and head to the south under the tree (Diagram 2). The tree's point of impact with the victim was approximately 83 feet in length from where the cuts were made.

Following the incident, the victim's chain saw was found on a stump, 75 feet beyond the end of tree which struck him. According to police, the victim was believed to have been struck from behind by the tree. Due to the victim's location and position, the theory suggested by the NCOSHA, is that the victim was approaching the feller buncher operator, most likely attempting to get his attention in order to communicate with him. It is theorized that the victim may have thought that the tree being cut would fall in a different direction from the intended path of the fall. It was also theorized by NCOSHA, that the victim turned away to run, once he saw the direction the tree was falling, and he was struck from behind as he ran.

Discussion: Workers should always maintain a 300-foot separation between themselves and high speed mechanical felling operations and should not approach until the machine operator has acknowledged that it is safe to do so. Employers should ensure that employees understand that it is sometimes difficult for workers to make their presence known before entering an active felling area, particularly during mechanical-felling operations and/or where ground cover is dense. In such cases, workers must position themselves out of the active falling area and wait for the signal from the feller-buncher operator that the felling operations have ceased and that it is safe to approach. The manufacturer's operator's manual states and the feller buncher had warning decals that state "**keep back 300 feet**" (Photo 2). As a safety precaution, if the terrain is steep and there are workers downslope of the felling activities, this distance should be increased.

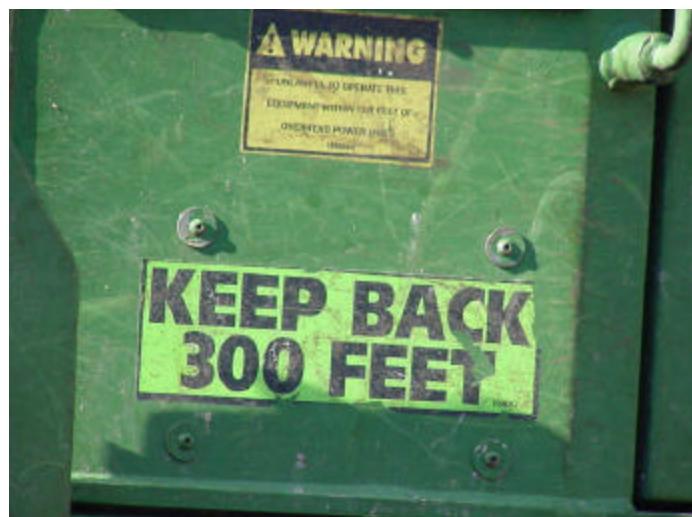
Discussion: Employers should ensure that equipment operators properly use the equipment they are assigned to operate in accordance with manufacturers' operational guidelines. The employer acknowledged the tree was too large to fit into the feller head, and that was the reason the feller buncher operator had to make two cuts. According to the feller buncher operator's manual, the proper use of the machine with the feller head saw attachment was to have both the accumulator arms and grab arms opened when approaching a tree. After centering the tree in the attachment, the operator would then depress the grab-arm "**Closed**" side of the attachment foot

Photo 2. Hazard warning on the feller buncher in this incident. Photograph courtesy of the NCOSHA

According to a safety manual on feller bunchers produced by the Equipment Manufacturers Institute, a recommendation is made to “**Never**” double cut trees that are too large to fit into the felling head.
