**Roadway Construction Worker Dies From Crushing Injuries When Backed Over by a Dump Truck - Virginia****SUMMARY**

**Fatality Assessment and Control Evaluation (FACE) Program**

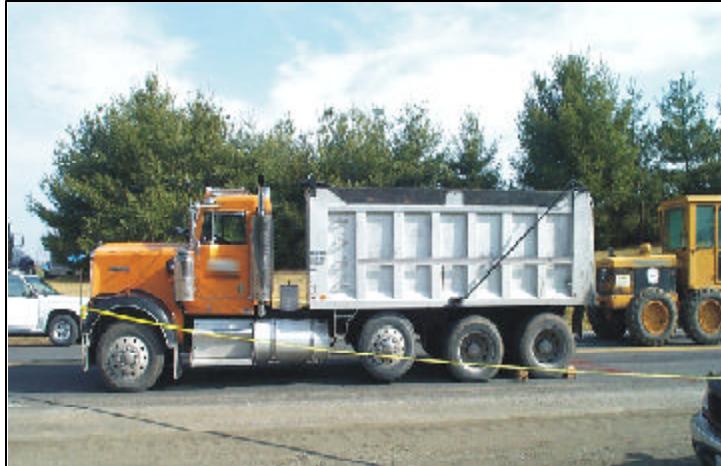
On January 29, 2002, a 34-year-old roadway construction worker (the victim) was killed when he was backed over by a dump truck. (Photo 1) The victim was walking along the side of a road grader picking-up centerline lane reflectors when a dump truck loaded with asphalt backed over him. When notified by CB radio that the paving machine was ready for him, the driver exited the staging area, entered the work zone and started backing-up towards the paving machine. As he backed, he reported that he did not see the victim and thought that the victim had moved out of the way. While backing, the dump truck operator said that he heard a voice over his CB radio yelling for him to stop because he had hit someone. Instead of stopping, the truck driver moved his truck forward approximately 20-feet, and again was told to stop because he had hit someone. Local Emergency Medical Services (EMS) responded within minutes. EMS determined that the victim was deceased and contacted the county coroner who pronounced the victim dead at the scene.

*Photo 1. Dump truck involved in incident*

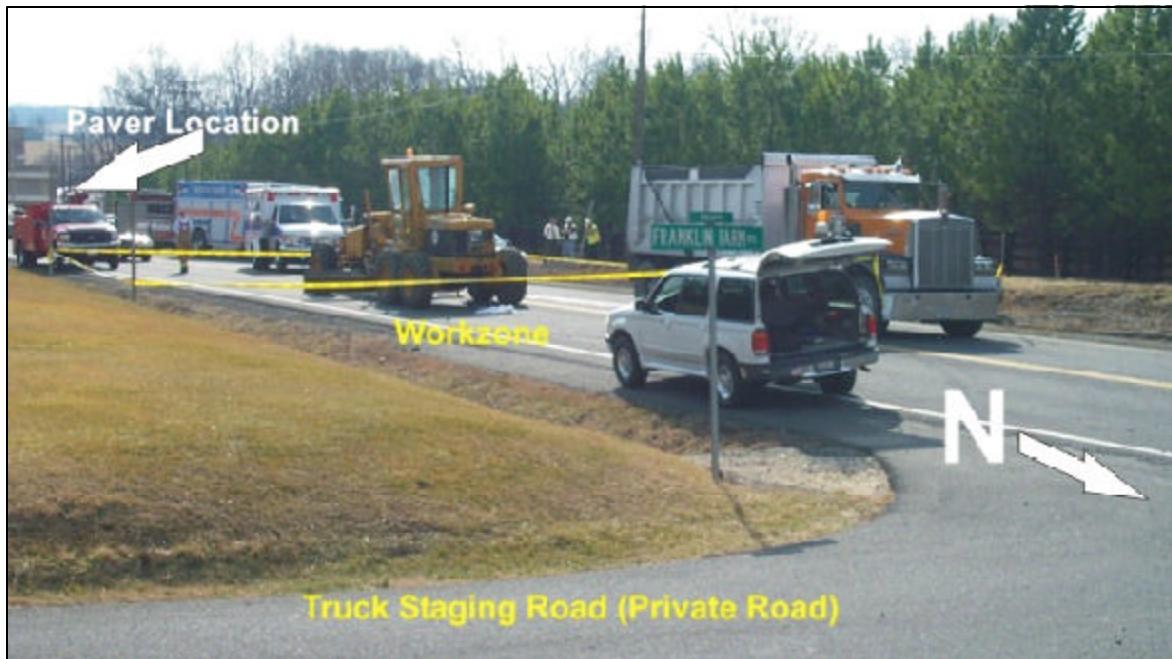
*Photo 2. Workzone layout*

The work zone was set-up according to the Manual on Uniform Traffic Control Devices (MUTCD) for a typical two-lane paving operation.<sup>1</sup> The work zone was established so that trucks hauling asphalt would enter the work zone from the road north of the paving operations (Photo 2). The trucks would then back into a private staging road (facing west) that intersected the work zone and sit waiting their turn to back and unload at the paving machine. When called by CB radio to unload at the paving machine, a truck would pull out of the private staging road with its front facing north and back-up (south) towards the paving machine and unload (Diagram). After unloading, the truck would drive forward to leave the site. The paving process was to continue until resurfacing operations reached the interstate entry and exit ramps, which at the time of the incident, were only a few hundred yards away to the south.

Discussion: In this incident, paving operations were moving away from the staging area as work progressed, increasing the backing distances for the truck drivers. At the time of the incident, the truck driver was backing an approximate distance of 200 feet past other vehicles, machines and workers on foot. During the planning stages of roadway construction projects, employers should ensure that truck staging areas are

located in such a manner that backing distances are minimized. This might entail the use of multiple staging areas, but would reduce the exposure of workers on foot and other machinery in work zones to backing trucks.

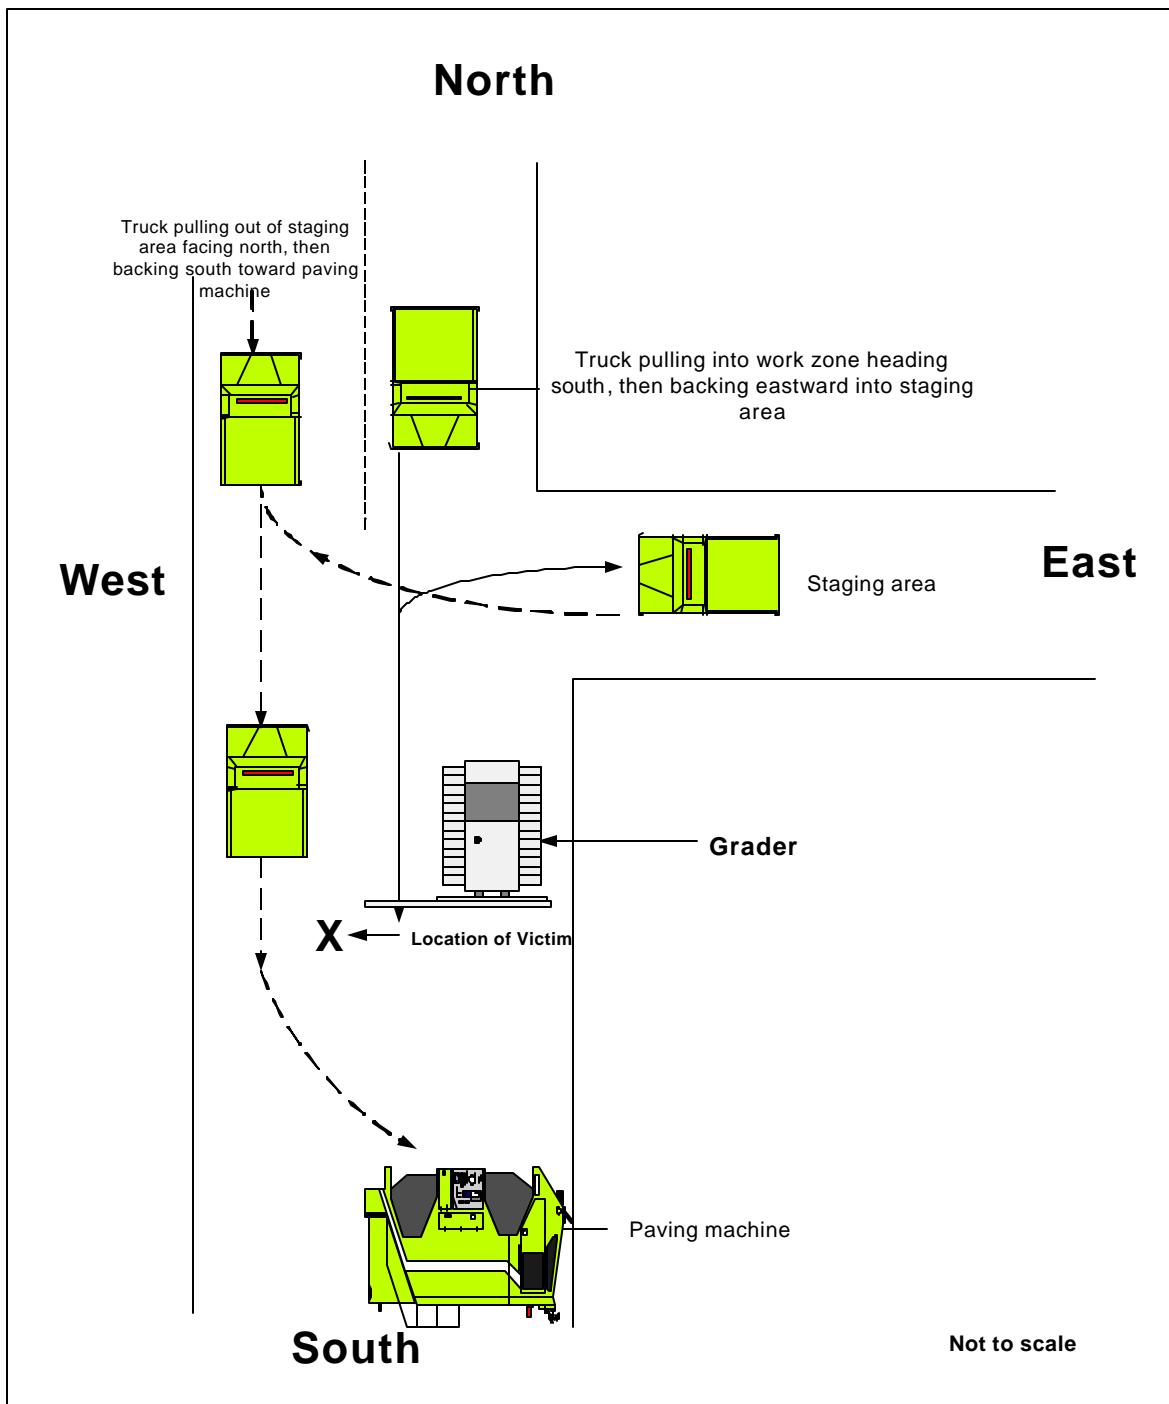
At approximately 10:20 am, a dump truck loaded with asphalt entered the work zone and deviated from the established vehicle entry and exit pattern. The truck entered the work zone driving in the southbound lane, and drove directly up to and in front of the victim. The truck driver reported that he deviated from the established vehicle entry pattern in order to get the victim's attention because he had thought that the victim

Diagram. Overhead view of the interior workzone

was standing in a bad location. The driver reported that he made eye contact with the victim, thinking that he had alerted the victim that he would be backing into the work zone. He then reversed his truck and backed towards and into the private roadway staging point. When notified by CB radio, the driver repositioned his truck by pulling out into the work zone and started backing-up towards the paving machine. He reported that he did not see the victim and thought that the victim had moved as he started to back his truck. While backing, he said that he heard a voice over his CB radio yelling for him to stop because he had hit someone. The backing truck had struck the victim, who fell under the truck. As the truck continued to back-up, the victim was dragged approximately 22 feet. Instead of stopping, the driver pulled his truck forward approximately 20 feet, now dragging the victim forward. He again heard a voice yelling for him to stop. When he finally came to a stop, he exited the truck as other workers rushed to the aid of the victim. The victim could not be freed from under the truck by co-workers. EMS was called by another truck driver and responded to the site within minutes. EMS staff assessed the victim's condition as being deceased and contacted the county coroner, who pronounced the victim dead at the scene.

The victim in this incident was a worker on foot walking along the side of a road grader, assisting the grader operator in the removal of reflective road markers. Due to the size of the grader, the victim was forced to walk in the lane of the road designated for trucks backing toward the paving machine, exposing himself to moving vehicles. Road surface preparation (in this case removing reflectors) should be done during periods of limited activity, such as in the evening prior to the incident, provided adequate lighting was present. In this instance, procedures called for backing the loaded asphalt trucks long distances in proximity to other construction vehicles and heavy equipment. During the planning phases of construction projects, alternative methods of removing the reflective markers should be evaluated to determine the safest possible method to be used that would not involve the use of heavy equipment, and/or conditions that would minimize the exposure of a worker on foot to moving equipment and vehicles. Additional safety information and recommendations for protecting roadway construction workers can be obtained from the NIOSH document entitled “Building Safer Highway Work Zones: Measures to Prevent Worker Injuries from Vehicles and Equipment.”<sup>2</sup>

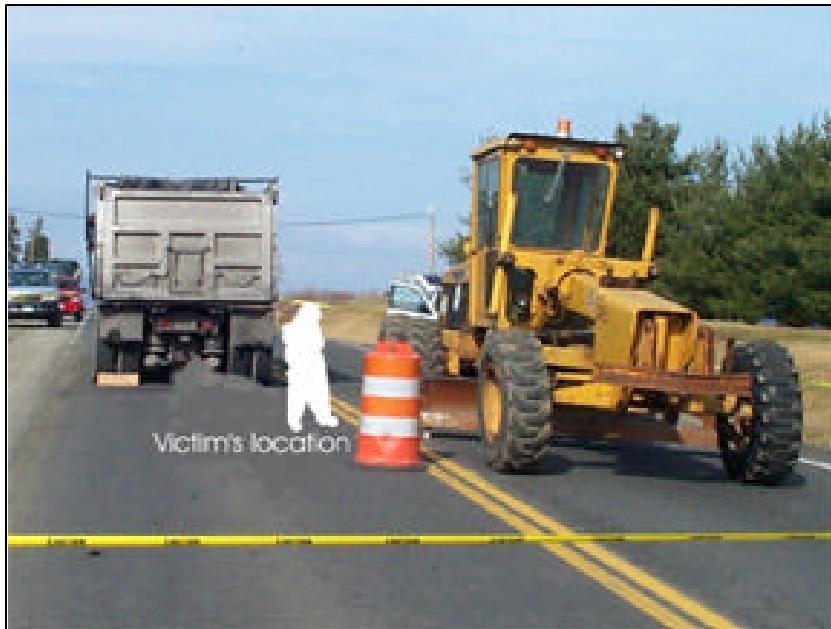
In prepping the roadway for resurfacing, the victim was assigned to assist in removing the centerline lane reflectors. To remove the embedded reflectors, a road grader was used to pop the reflectors free. The grader operator would lower the grader blade on the reflector and dig it free from the preexisting asphalt. The road grader was in the northbound lane traveling south, and the victim was observed to be approximately 3-feet inside center of the southbound lane (Photo 3). Once the reflector was free, the victim would pick it up from the ground and deposit it in a bucket on the grader.

*Photo 3. Approximate location of victim near grader.*

The truck's back-up alarm was tested by police and VOSHA and found to be in working order. Sound pressure measurements taken of the alarm were 76 dB(a) at the rear of the truck, and 60 dB(a) measured 20-feet from the rear of the truck. Sound pressure measurements taken next to the road grader, at the approximate location where the victim was standing, measured 89 dB(a), louder than the truck's back-up alarm. From that testing it was concluded by police and VOSHA that the victim most likely did not hear the truck's back-up alarm until it was too late to move out of the path of the truck.

Discussion: The “Internal Traffic Control Plan” (ITCP) defines processes and procedures for worker safety within the work zone. The elements of the ITCP should indicate where and how construction equipment, vehicles, and workers on foot interact within the work zone. The plan must also take into consideration the changing aspects of a work site and possible emergency situations that might occur.
