FACE Report Number: 2004-01

May 14, 2004

Hispanic Laborer Dies After Being Crushed Between the Frame of a Skid Steer Loader and the Scraper Attachment on the Loader Lift Arms - Ohio**SUMMARY**

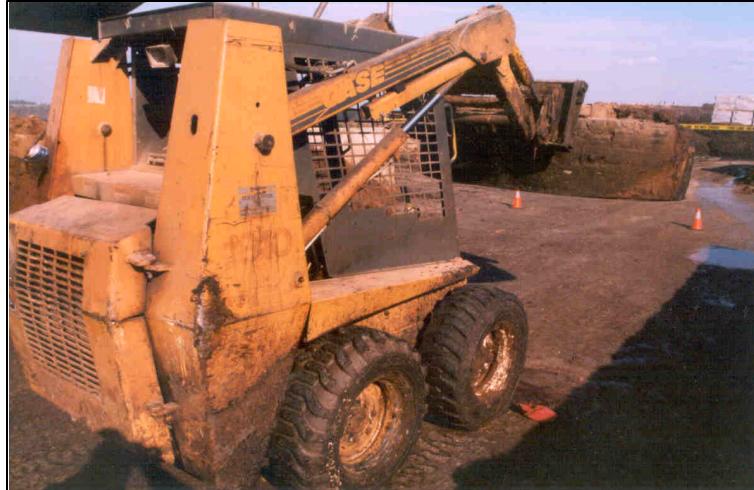
*Skid steer involved in the incident***Fatality Assessment and Control Evaluation (FACE) Program**

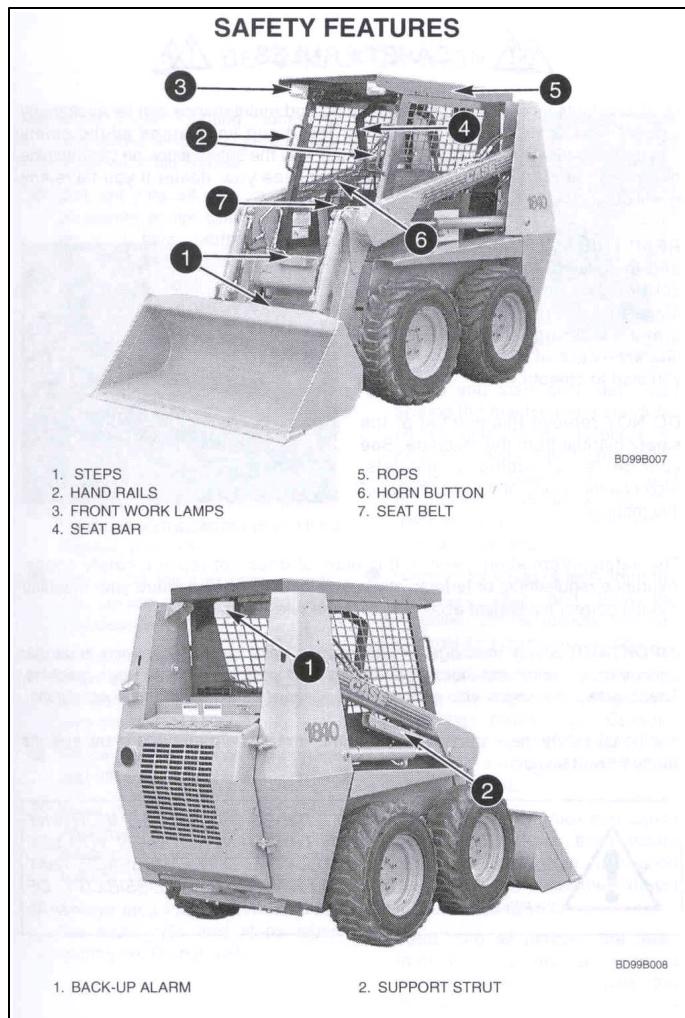
Equipment: The skid steer skid loader had been purchased new by the owner and was approximately 2 years old. It had a gasoline powered engine and was operated completely through the use of hand controls. It was equipped with a rollover protective structure, side screens, a seat belt, a seat bar (control interlock), hand rails, and lift arm support struts (Figure 1). According to the operator's manual, when the seat bar is functioning correctly and is in the "up" position, it prevents forward/rearward movement of the machine and also prevents movement of the loader arms and bucket.

Figure 1. Safety features on the loader [used with permission of manufacturer]

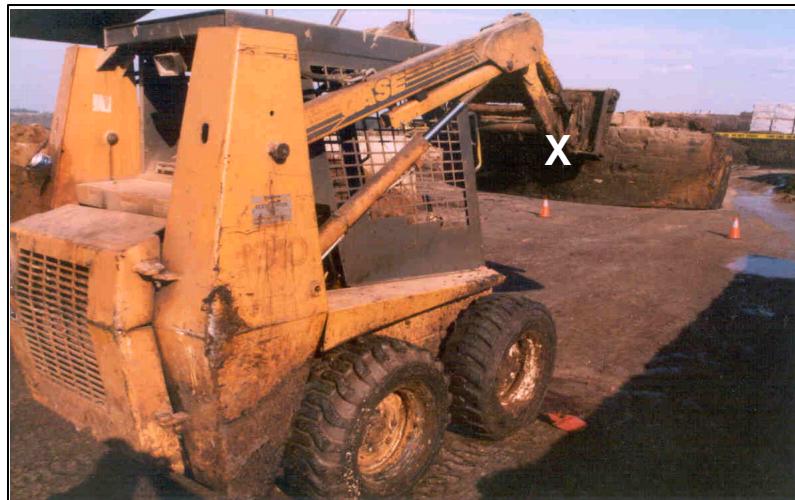
Photo 1. This photo illustrates the skid steer loader used on the day of the incident. An "X" marks the approximate location on the horizontal bar of the scraper attachment which came down and crushed the victim's head between it and the frame of the skid steer loader marked with a "Y" on photo 2. Photograph courtesy of the County Sheriff's Department.

County sheriff's department officers requested a demonstration of the skid steer loader. They noted that when the seat bar was lifted, the loader lift arms dropped rapidly without any movement of the hand controls. According to the police findings, it appeared that the victim's head was pinned between the cross member of the scraper attached to the loader arms and the frame on the right entry-exit area of the skid

steer loader. They surmised that the victim lifted the seat bar while sitting in the operator's seat and leaned over and/or attempted to exit the vehicle and was fatally injured when the lift arms holding the scraper attachment dropped. The report indicated that the results of the tests they conducted were contrary to a coworker statement about the safety bar being down on the operator when he was found.

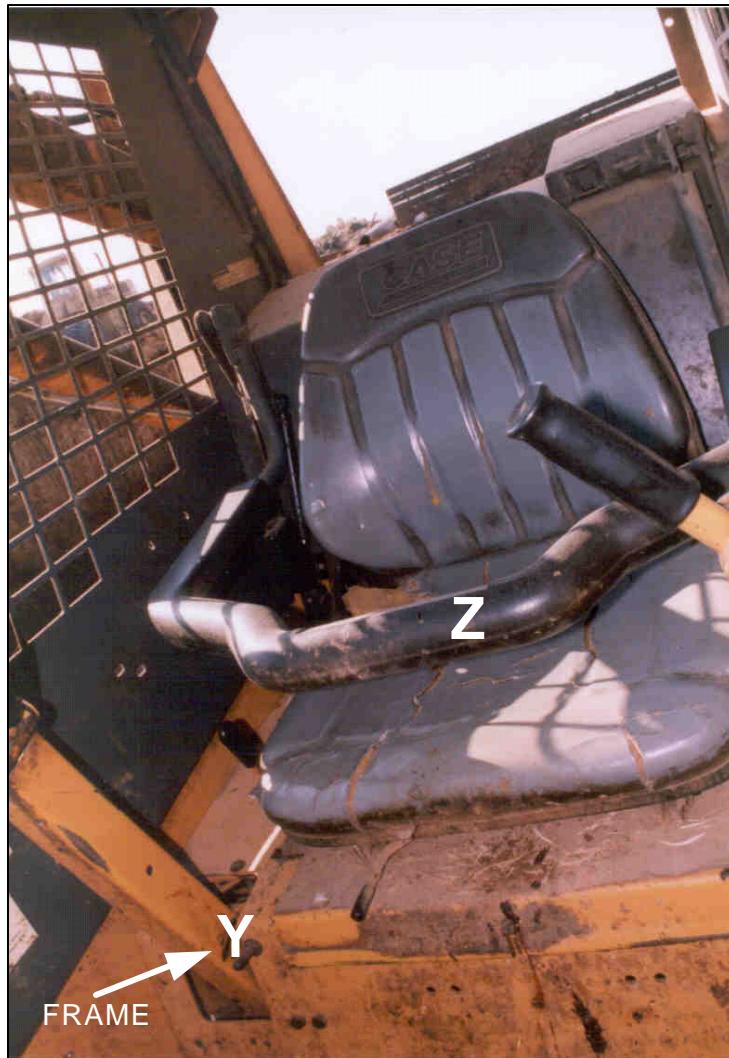
The OSHA inspection revealed that the seat bar on the skid steer loader was not functioning properly and that bulbs were missing in the head and tail lamps. There were no maintenance records for the skid steer loader.

Following the incident, the company mechanic examined the seat bar on the skid steer loader used by the victim and determined that it was not adjusted properly. The company manager removed it from service until repairs were made.

Photo 2. This photo illustrates the skid steer loader used on the day of the incident. A "Y" marks the area on the frame where the head injury occurred. A "Z" marks the seat bar. Photograph courtesy of the County Sheriff's Department.

The inspection should include testing the function of all safety equipment installed on the equipment. When an inspection reveals, for example, that the seat bar is not operating correctly, equipment should be removed from service until repairs are made. When operating and used correctly, the seat bar protects workers from injury by locking controls. The controls that move the lift arms and that move the equipment back and forth are locked in place when the seat bar is lifted.

The company's general manager told the DSR investigator that the seat bar was tested and adjusted to ensure proper function, and that missing bulbs were replaced in both head and tail lamps following the incident before the skid steer loader was returned to service. The operator's manual provides the following instructions regarding testing the seat bar: "After each work day and after servicing the seat bar, test the seat bar and loader controls for correct operation." Page 128 of the operator's manual goes through steps for checking the seat bar for effectiveness in locking the loader controls and locking against machine movement.

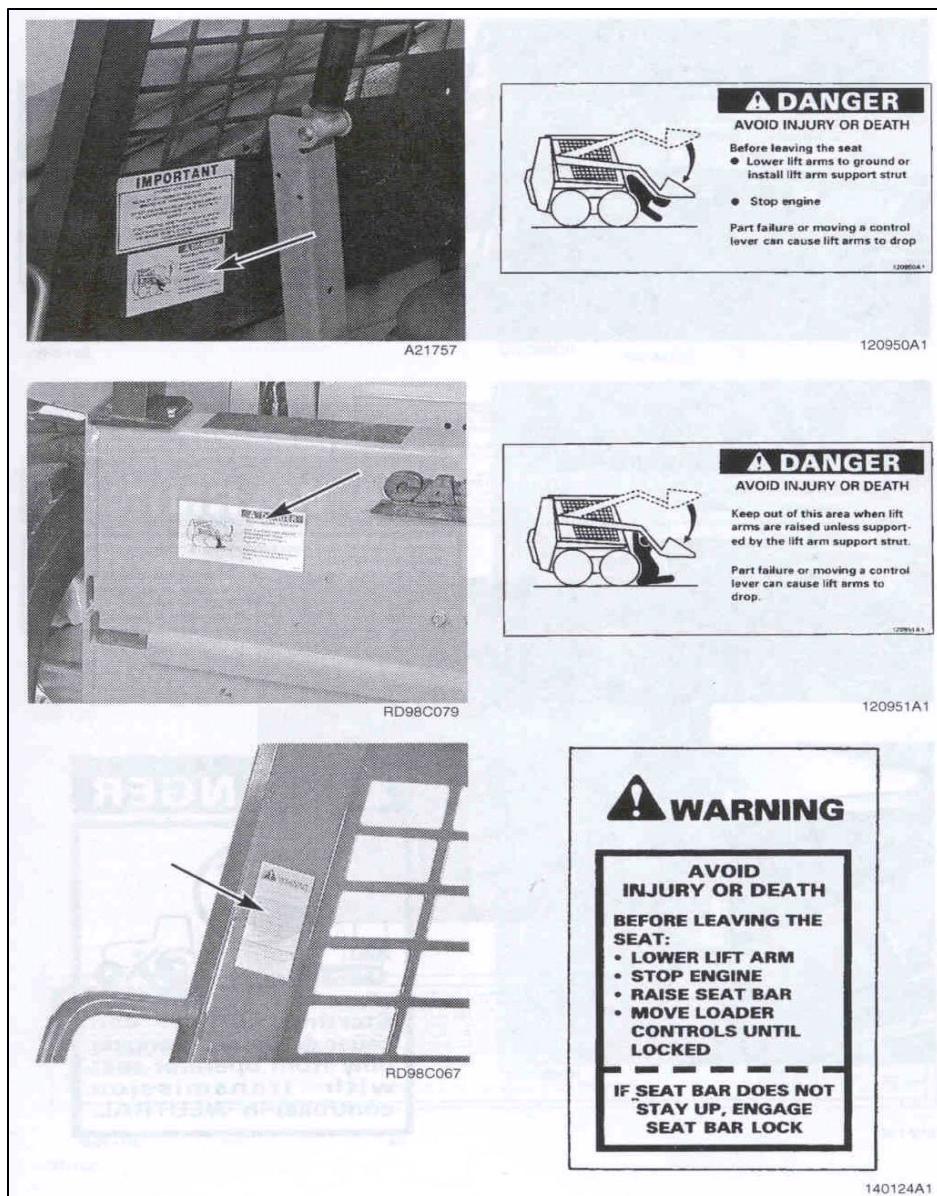
The operator's manual includes a copy of safety warning labels on the machine (Figure 2), including the label which is placed on the skid steer loader next to handrails designed for use during exit and entry.

Figure 2. Safety warning labels on the skid steer loader, including the label next to the hand holds regarding exiting the machine [used with permission of manufacturer].
