Fifteen -Year-Old Laborer Dies After Falling Through a Skylight—Florida**SUMMARY**

Fatality Assessment and Control Evaluation (FACE) Project

Fatality Assessment and Control Evaluation Program
Investigative Report #2001-04

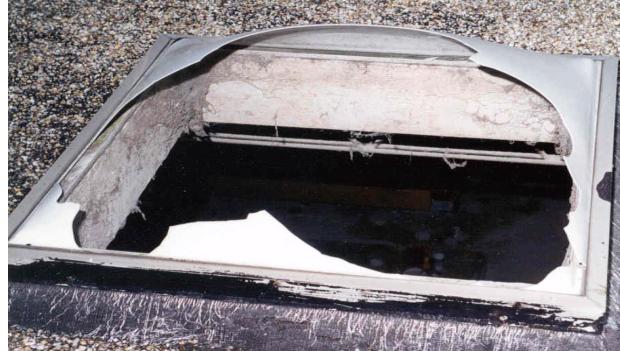
Skylight through which the victim fell.

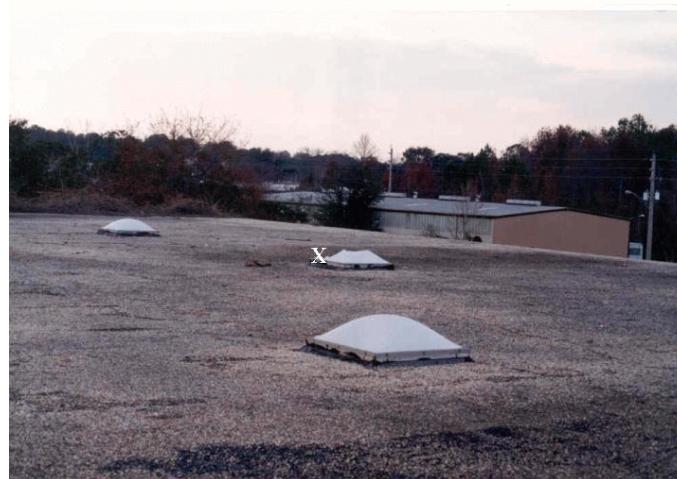
The incident occurred on the flat roof of a three-sided open warehouse that was used to store equipment and ornamental concrete objects manufactured by the employer. The company's handyman had requested and obtained approval to fix a section of the warehouse roof located above an out-of-service forklift parked inside the warehouse. He had been asked to repair the forklift and wanted to fix the roof first so rain would not leak through the roof and onto him when he performed the forklift repairs. The roof of the warehouse was approximately 23 feet 9 inches above ground level and was 152 feet long by 92 feet wide. According to official OSHA findings, there was obvious and severe damage to the roof and ceiling of the warehouse. Ten unguarded skylights spaced intermittently over the roof appeared to be old and deteriorated. The exact age of the building was unknown, but the present owner had stated that it was at least 20 years old and that the skylights had not been replaced. The skylights were the non-opening type and had no warning labels or manufacturer information affixed to them. Examples of the skylights, including the skylight involved in the incident, are depicted in photographs 1 and 2.

Photo 1: This photograph illustrates the warehouse roof with 3 of the 12 skylights that were located on the roof. An X is placed on the skylight the victim fell through.

Additionally, building owners should consider installing permanent railings around skylight perimeters or protective covers over individual skylights to guard against falls through skylights by maintenance or other personnel who must access the roof.

Unprotected skylights present a fall hazard to anyone who must access the area in which skylights are located. Building owners should consider installing permanent guardrails around the perimeter of the skylight or protective covers, such as screens or metal grills, over individual skylights to eliminate the hazard of falling through the skylights. Guidance for installing permanent railings around skylights is outlined in 29CFR1910.23 (e)(2) (i through v).⁷ In summary, the railing must be installed so that it can withstand a load of at least 200 pounds applied in any direction at any point on the top rail.

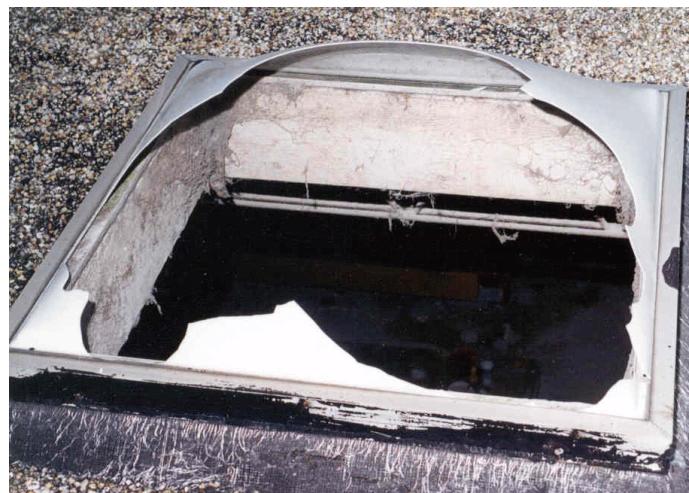
Photo 2: This photograph illustrates a close-up taken from the roof of the skylight through which the victim fell.

To protect workers from falls, a "competent person" * should conduct a hazard assessment prior to starting work in order to identify fall hazards and eliminate or control them before work begins (e.g. provide an adequate skylight cover, such as a properly sized and installed screen, metal grill work, or plywood cover that could withstand, at minimum, 200 pounds of downward pressure, to prevent employees from falling into or through a skylight or opening; provide barrier protection (railings/guardrails) to prevent workers from falling through skylights or openings or over roof edges; provide adequate fall protection at all other exposed areas on the roof surface). According to OSHA regulations (29CFR 1926),¹ employers are required to protect employees from falling when working from heights greater than 6 feet above the next lower level. Protection against falling through skylights can be accomplished by covering the skylight with an adequate cover or by installing protective barriers around them. A personal fall arrest system (PFAS) can also be used. When a PFAS is used, extreme care must be given to the correct choice of harness, lanyard, and anchor point so that the worker is adequately protected given the fall distance present.

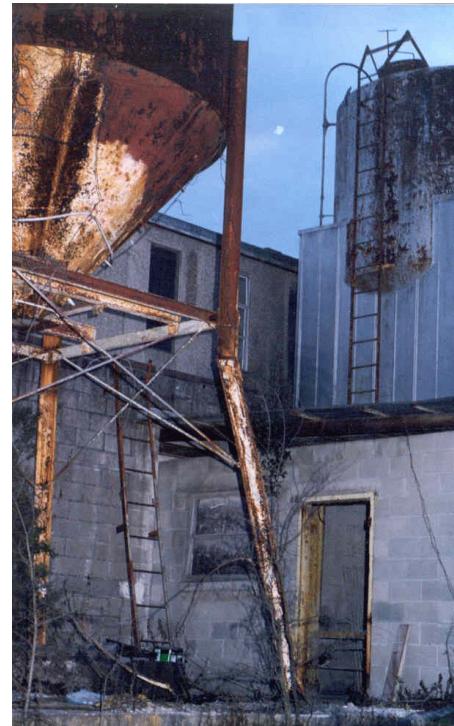
building attached to the warehouse. He walked 8 to 9 feet on the tin roof until he reached a fixed ladder on an adjacent cement silo. He climbed the fixed ladder, stepped over onto a steel ledge on the silo, then stepped over onto the roof of the warehouse (Photo 3). Official OSHA findings indicate that the handyman was shown this roof access route by the supervisor. Once on the warehouse roof, the handyman held onto one end of a rope, letting the opposite end fall to the victim. The victim tied his end of the rope around a series of buckets of tar, gravel, and equipment. The handyman used the rope to hoist each item to the roof. After all the materials and equipment had been hoisted to the roof, the victim joined the handyman on the roof using the same access route as that used by the handyman. Roof repairs were expected to take 1 to 2 days. The two workers spent the morning patching cracks in the roof with tar and gravel. They came off the roof at approximately 12:30 p.m., went off-site for lunch, and then returned to the job site. The handyman returned to the roof. The victim remained in the handyman's truck until approximately 2 p.m., then he climbed to the roof. At approximately 3:15 p.m., the handyman told the victim they were done with the repairs and that he should throw anything they no longer needed to the ground while he used a leaf blower to finish cleaning off another part of the roof. While waiting for the handyman to finish his work, the victim either sat or fell back onto the skylight, which broke, causing him to fall through to the ground, 23 feet, 9 inches below. The handyman did not see the victim fall, but upon hearing the sounds produced when the skylight dome shattered, climbed off the roof to help the victim. Five workers who were working inside the warehouse looked up when they heard cracking sounds above, and saw the victim as he fell through the skylight to the dirt floor below (Photo 4). One of the workers ran to get a supervisor while another ran to the office which was located approximately 100 yards away, to report the injury. Office personnel immediately called 911.

Photo 3: This photograph illustrates the ladders workers used to gain access to the roof.

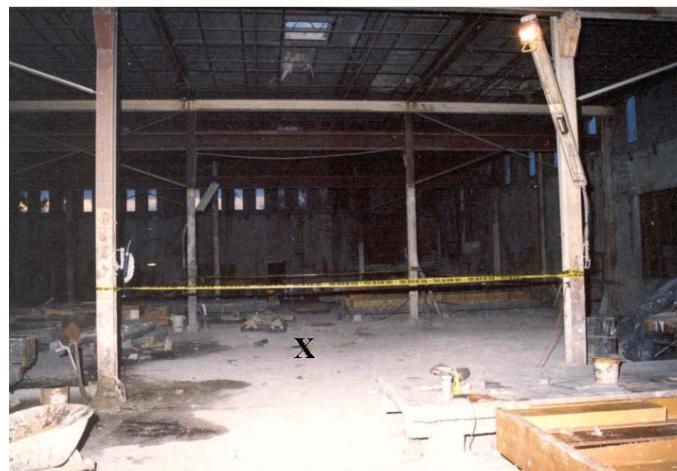
Photo 4: This photograph illustrates the broken skylight viewed from the floor of the warehouse. An X marks the area where the victim landed after falling through the skylight.

The official cause of death was listed as multiple injuries, which included a fractured skull, broken ribs, and a punctured and lacerated lung.

Designers/manufacturers of skylights should evaluate load capacities of current designs and consider strengthening skylight components and incorporating safeguards, such as protective screens, into skylight designs.

Designers/manufacturers of skylights should evaluate the materials used to fabricate skylights, and also evaluate current skylight designs, to determine the feasibility of increasing the load capacity. If an individual falls against a skylight or skylight screen, the load transferred to the skylight or screen from his impact can be several times his body weight. For example, a 200-pound individual could
