28-year-old Laborer Dies After Being Struck by Excavator Bucket - North Carolina**SUMMARY**

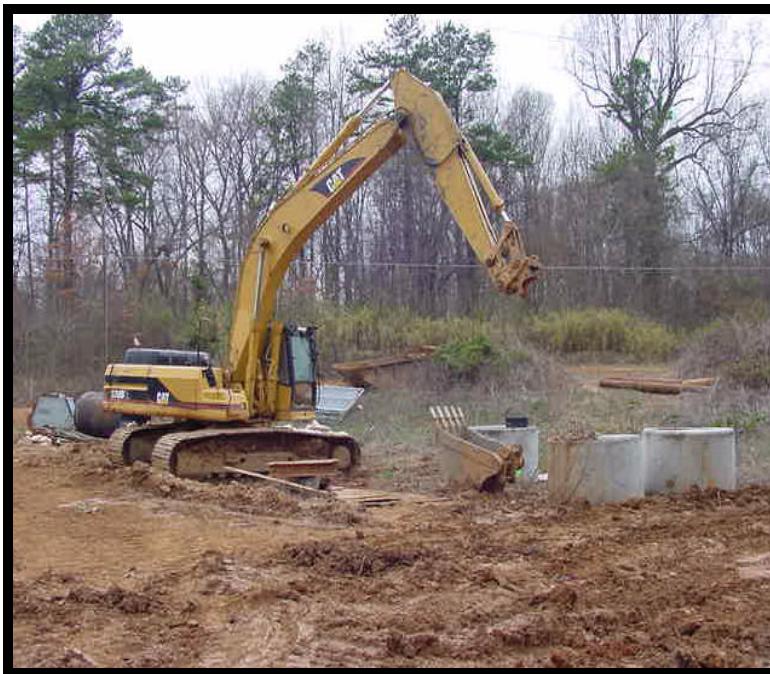
the truck bed. The operator had positioned the excavator's bucket near a manhole section and was waiting while the victim attached a three-leg bridle to the manhole section for lifting. The victim had connected two bridle legs and was connecting the third when the bucket suddenly disconnected from the excavator stick, fell onto the manhole section, and struck the victim, knocking him to the ground. Emergency responders were notified immediately. The victim was pronounced dead at the scene from blunt trauma to the head.

Photo: Excavator and manhole sections shortly after incident
