18-year-old Dies After Being Entangled in a Portable Mortar Mixer - South Carolina**SUMMARY**

Fatality Assessment and Control Evaluation (FACE) Program

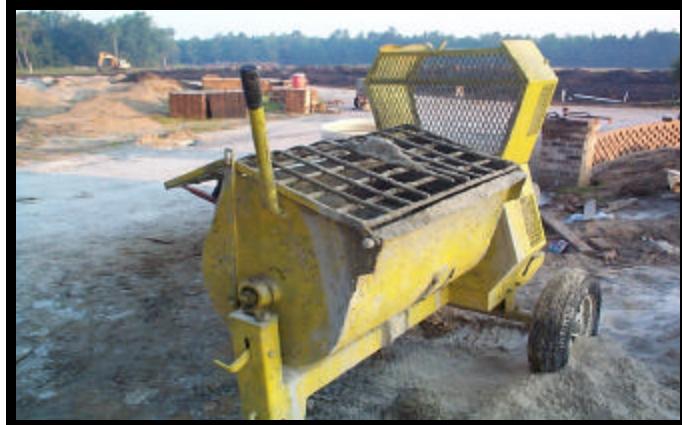
*Portable Mortar Mixer*

On May 15, 2003, an 18-year-old laborer (the victim) died after becoming entangled in a portable mortar mixer. The victim was cleaning the mixer at the end of his shift at a residential construction site to prepare it for the following day while a co-worker was brushing down the recently laid brick wall nearby. A painter working near the victim heard yells for help and saw the victim's arm stuck in the machine and his body being pulled into the rotating mixer paddles. He ran to the mixer and attempted to turn it off but could not disengage the gears so he yelled for help. The co-worker

heard the commotion, ran to the machine, and shut it off. Emergency Medical Services was called and responded within minutes. Rescue workers dismantled the drive mechanism to reverse the mixing paddles and extricated the victim. The victim was pronounced dead at the scene. NIOSH investigators concluded that, to help prevent similar incidents, employers should:

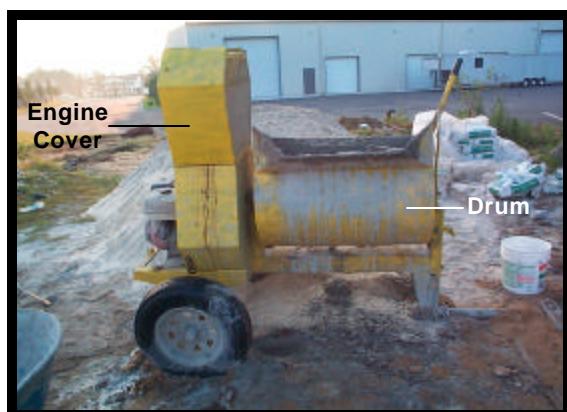
Photo 1. Mixer with drum guard fully open

The machine, an 8-cubic-foot portable mortar mixer with a gasoline powered 8-hp engine was purchased new by the company in 1998 (Photo 1). It is equipped

Discussion: In this case, the mixer was running with the guard in the open position while the drum and paddles were being cleaned. The operator's manual warns to "Never operate the mixer with the drum guard open or removed." It further states "The guard and guard lifter system is designed for your safety and convenience, please do not operate the mixer with the guard lifter disconnected or the guards removed." The operator's manual also instructs to "disconnect the spark plug wire when cleaning inside drum" and "Never stick your hands or any solid object into the drum while it is in operation."

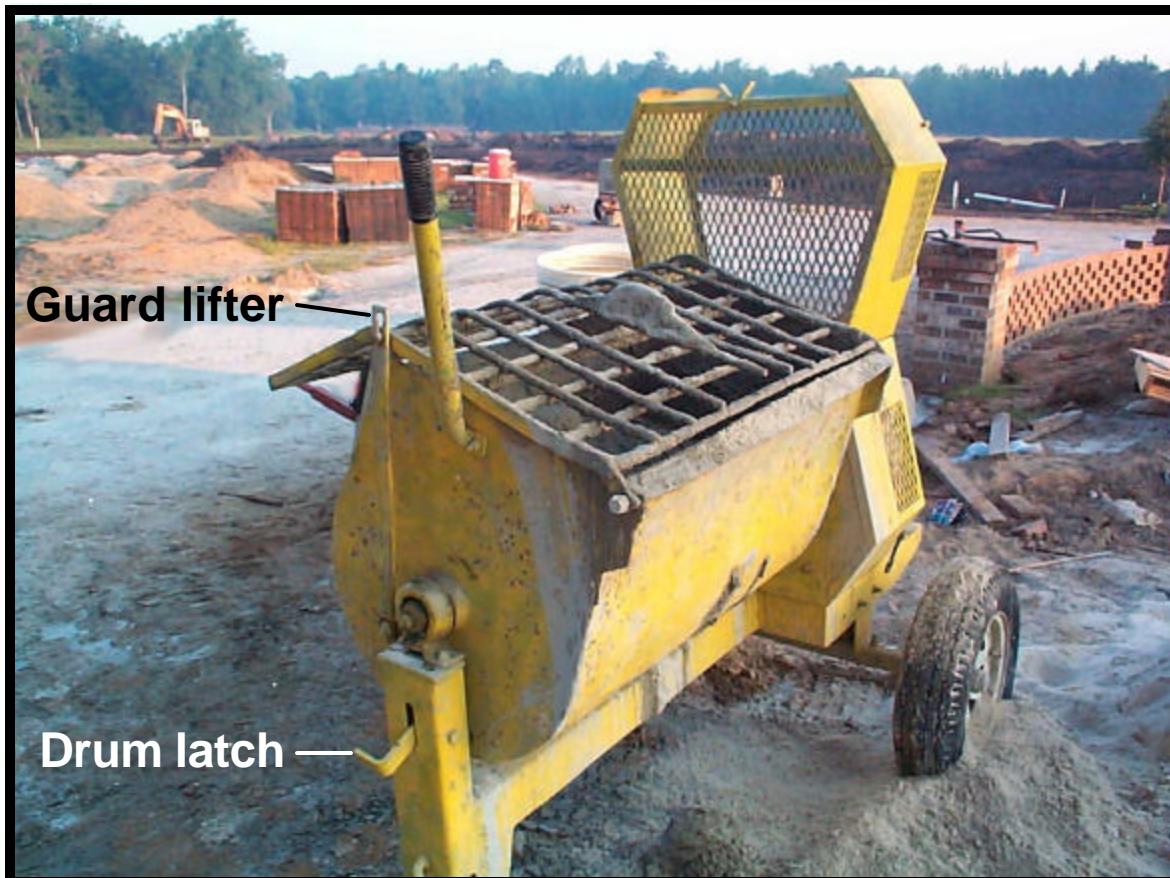
Photo 2. Guard lifter attached with guard in closed position

with an automatic guard lifter which lifts the drum guard as the drum is emptied to prevent mortar from being poured through the guard and causing build up. In normal operation, lifting the drum guard gives about eight inches clearance for the mortar to pour through. Photo 2 shows the mixer drum in an upright position with the guard in place. The mixing paddles in the drum are engaged by moving the clutch lever [located on the vertical support on the right side of the drum] to the right (downward) (Photo 3). An upright (disengaged) lever position is shown in Photo 4. Moving the clutch lever downward engages the paddles regardless of the drum position. A drum latch (Photo 2) in the downward position secures the drum upright while the rubber tipped paddles rotate between 33 and 35 revolutions per minute to mix the mortar. The machine was in fair condition and had the manufacturer's installed guarding at the time of the site visit. It had been repainted and a gear replaced since the incident.

Discussion: An interlock switch activated by disconnecting the drum guard lifter (refer to photo 2) or by lifting the guard greater than 8 inches would have stopped the rotating paddles and mitigated the immediate hazard by cutting off the engine. “An interlock switch is a device or mechanism used to connect individual components so that the action of one part of the equipment is constrained by, or dependent on, another. In general, its purpose is to prevent or interrupt the operation of machine components under specified conditions, usually when a hazard is present” (NIOSH 2003). In this case, a switch, similar to a cut off switch on a power mower, would have eliminated the hazard by not allowing the engine to rotate the paddles.

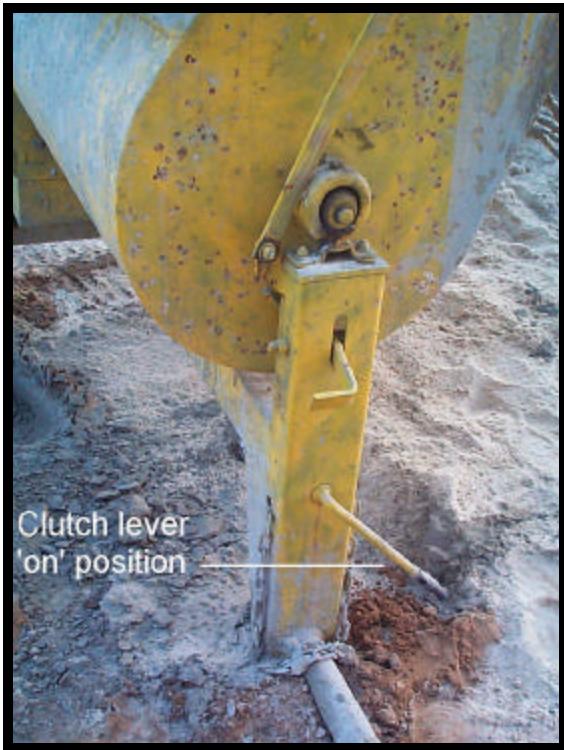
*Photo 3. Clutch in the 'on' position,
paddles rotating*

The victim had turned the drum so the opening was directed toward the ground allowing water to drain out. Using a garden hose in his right hand, the victim sprayed the paddles and inside of the drum loosening the mortar and allowing the residue to drain out. During this procedure the engine was running, mixing blades rotating, guard lifter disconnected and drum guard fully open. The victim then rotated the drum upright and continued spraying water into it. The painter reported that he heard a scream, saw the victim's arm get caught, and ran to the mixer attempting to shut it off. He could not shut the engine off so he called for others to help. By this time the victim had been pulled into the machine.

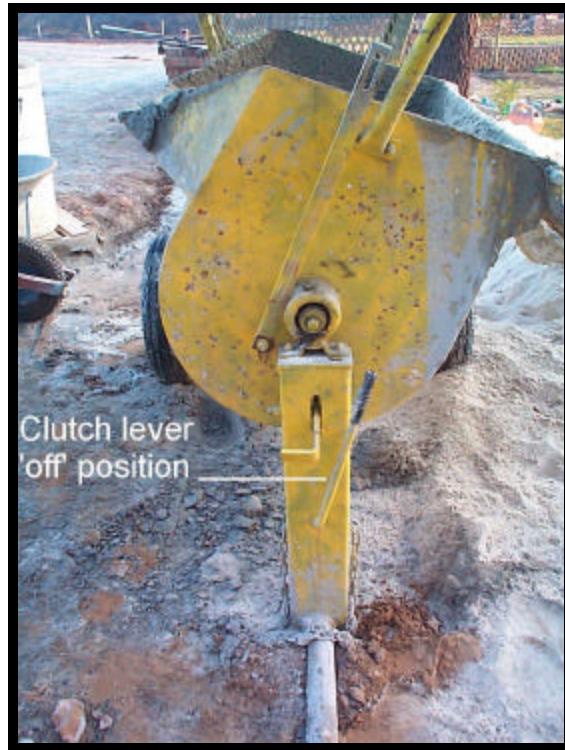
Photo 4. Guard off, clutch in the 'off' position

Discussion: In this case, the guard should have remained over the drum when the engine was running and the paddles rotating. Further, the procedures for cleaning the unit, which requires access to the inside of the drum, should only be attempted if the engine is off. Had a person been assigned safety responsibilities at the job site and enforced the safety guidelines, the incident may not have occurred.

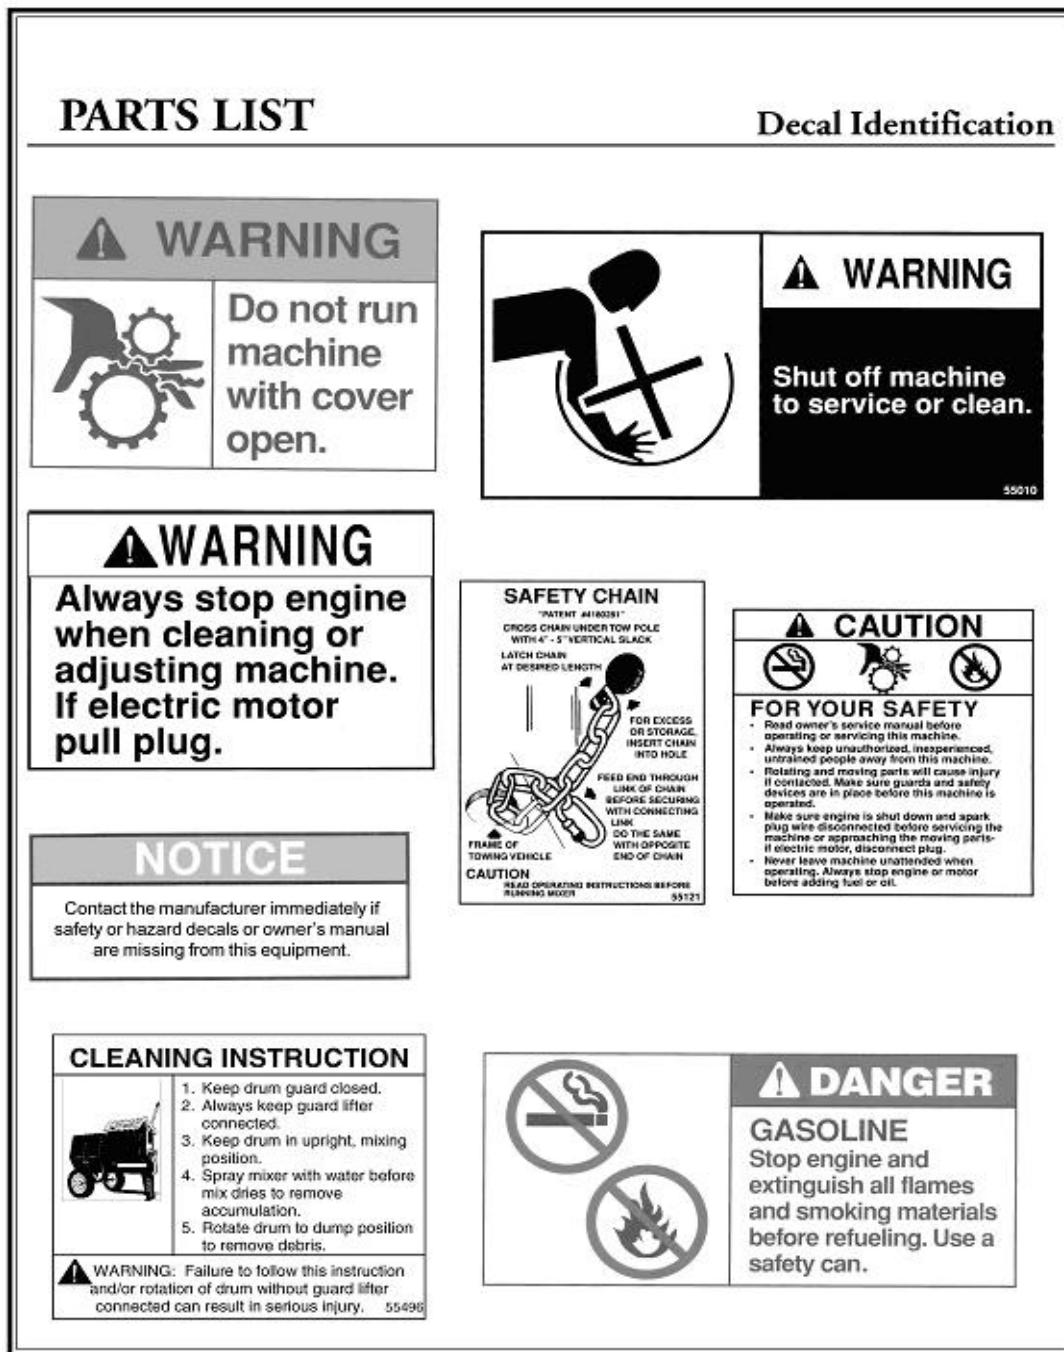
Figure 1. Manufacturer's Warning labels

Discussion: The day of the incident, police photographed the machine. These photos did not show any warning labels on the machine. The day of the site visit, no visible warning labels were affixed to the unit. The original equipment comes with labels and the operator's manual instructs owners to call for replacement decals should the originals become defaced or destroyed and provides a toll free number for owners to request replacement decals. The unit had been re-painted between the time of the incident and the site visit and replacement decals were not in place. Warning labels provided by the manufacturer are shown in Figure 1.
