Seventeen-Year-Old Lifeguard Dies After Falling Into a Nearly Empty Swimming Pool - Pennsylvania

Fatality Assessment and Control Evaluation (FACE) Project

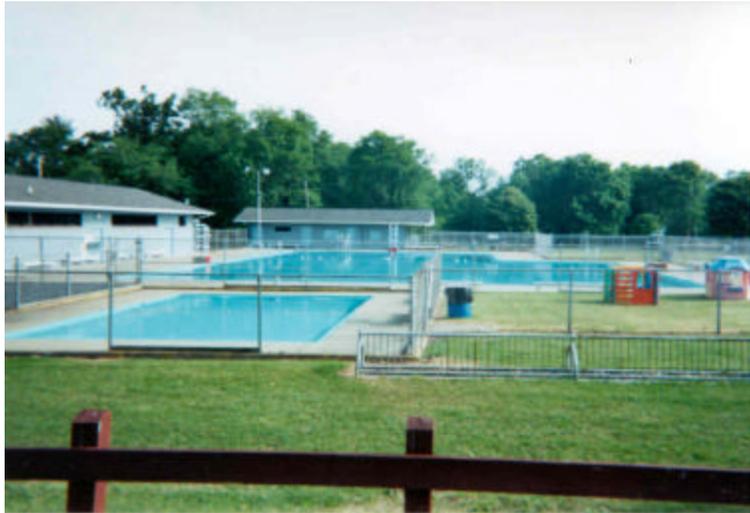
Community Pool Where Incident Occurred

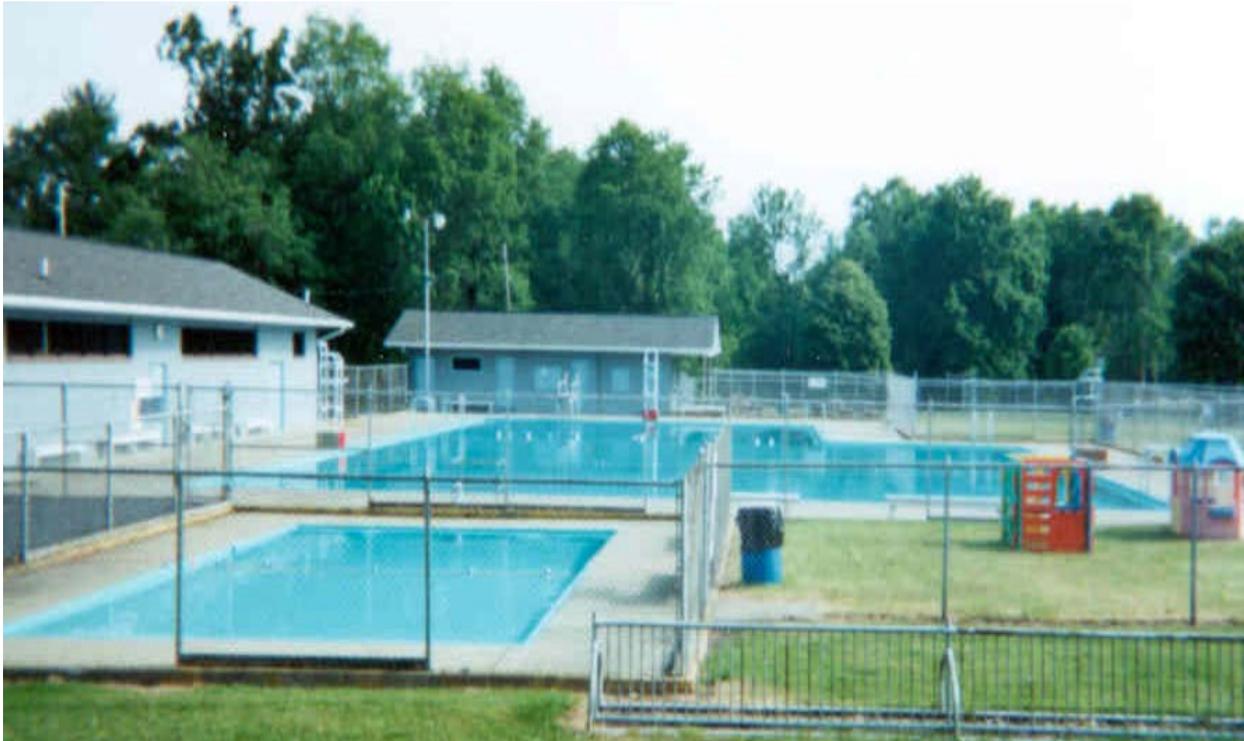
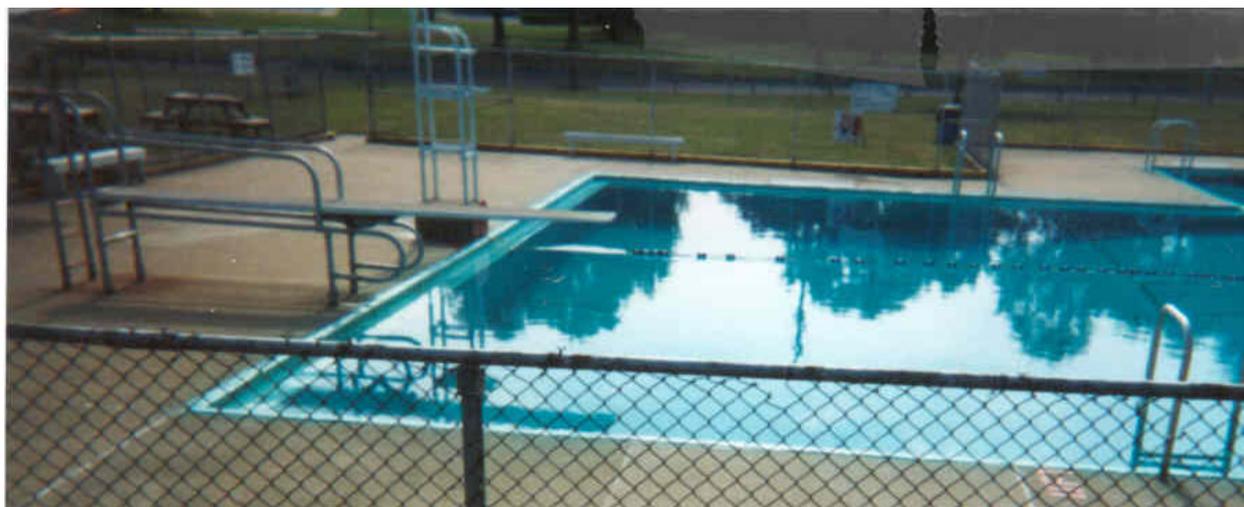
Figure 1. *Photographs of the Community Pool Where Incident Occurred.* The pool was made of stainless steel, was L-shaped, and had a chain link fence completely surrounding it. The photographs shown were taken several days following the incident, after the pool had been filled. The top photograph shows a distant view of the pool. The bottom photograph shows a closer view of the pool and shows the placement of the diving board after it had been secured in place after the incident.

The outdoor pool where the incident occurred, was part of a large recreational facility owned and operated by the community (see Figure 1). The pool director estimated that the staff for the community recreational facility included 6 full-time year-round staff and 80 part-time staff. There were 12-15 lifeguards on the pool staff each year. This year's staff of lifeguards included five 17-year-olds and one 16-year-old. Training was provided by the pool engineer who had worked for the recreational facility for 40 years. Training included safe methods to climb ladders, recognition and avoidance of heat stroke, life guard refresher training and testing, annual adult and infant cardiopulmonary resuscitation (CPR), first aid (every 3 years), safe handling of chlorine, and safe handling of chlorine tanks. A training day for all lifeguards was held each year the day before the pool opened and periodic training was given several times over the summer. The victim had worked at the community pool the summer prior to the incident as a lifeguard but had never performed seasonal pool maintenance. The incident occurred on the victim's first day of seasonal work and at that point no training had been given. Training for the season was scheduled to begin after seasonal work was completed when the full lifeguard staff was available. The pool had been in service since 1953 and there had never been a serious injury at the pool.

north (deep) end of the empty pool. The diving board was placed to the rear of its mounting position with the bolt holes exposed as a visual reminder that it had not been bolted down, and was to be bolted in place the following day. No one was able to provide information as to why the board had not been secured at the time it was placed on its rack.

The coroner determined from the victim's injuries that she had died as a result of a fall. Although the incident was unwitnessed, evidence collected during the course of the FACE investigation suggests that the victim climbed out of the pool to the deck and then onto the unsecured diving board. As she walked out toward the end of the diving board, she lost her balance and fell into the nearly empty swimming pool. The diving board then fell into the pool. The fall distance for a standing position on the diving board to the grate-covered drain at the bottom of the pool is approximately 14 feet.

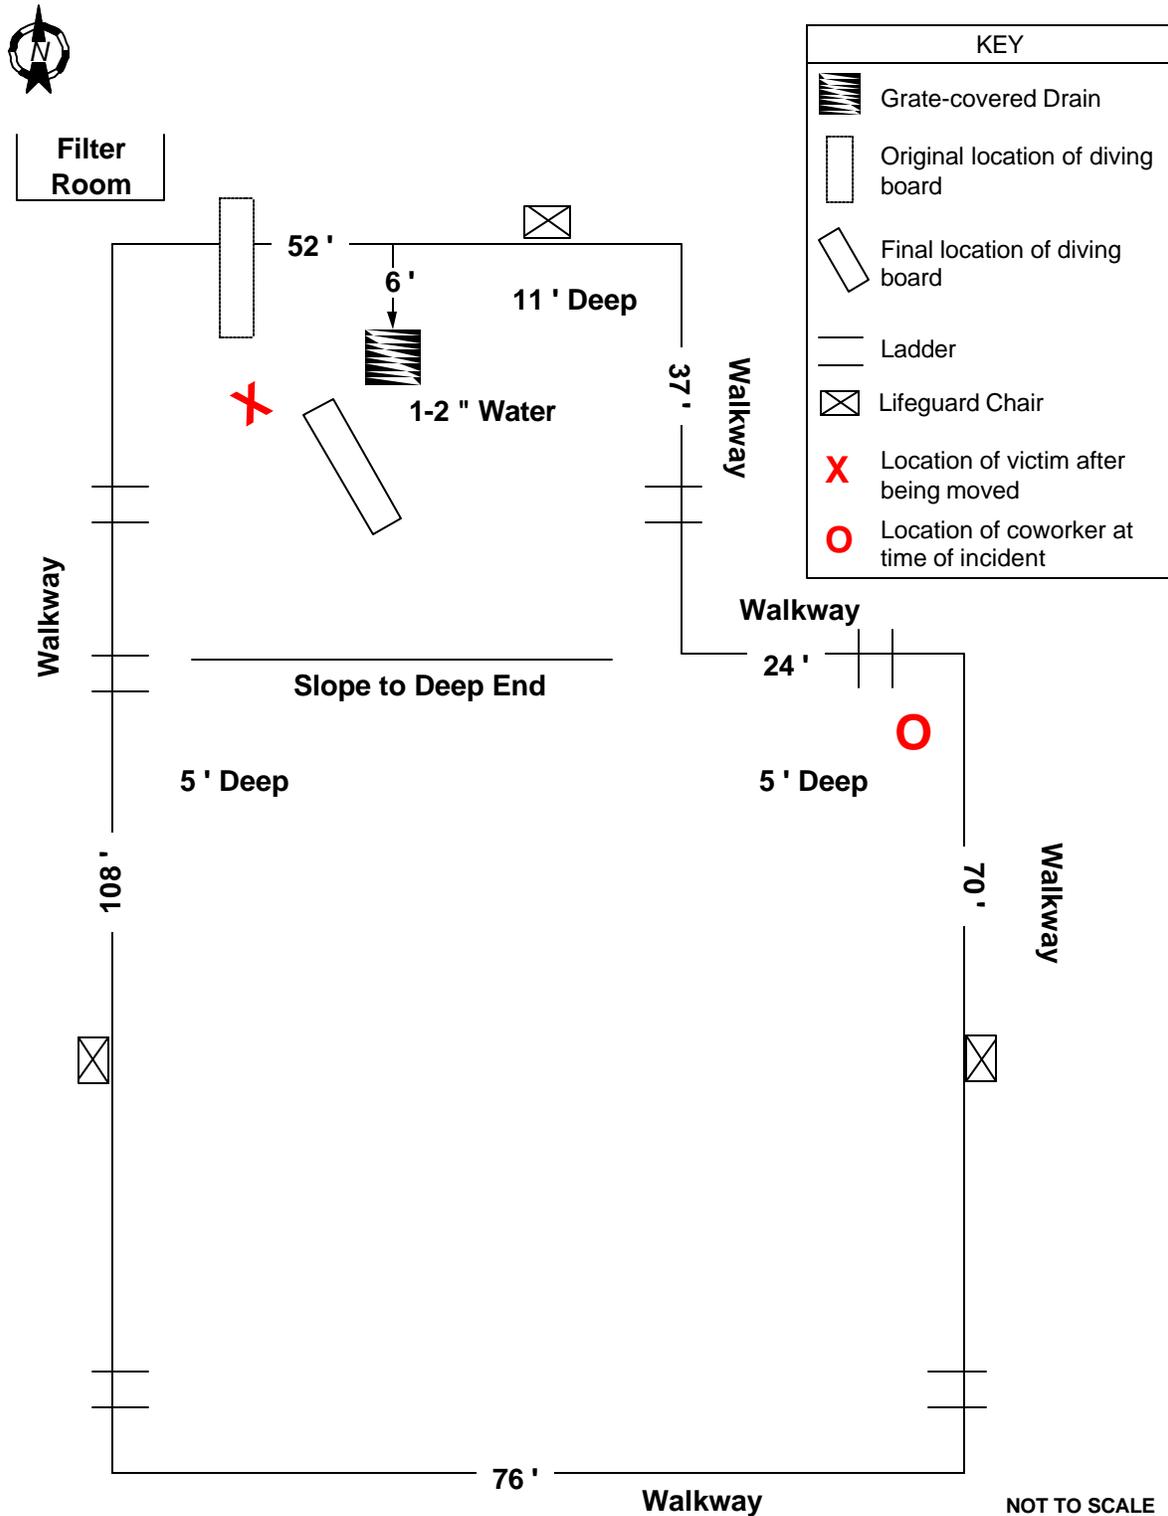
Figure 2. Drawing of Community Swimming Pool Where Incident Occurred

The potential fall distance from the pool deck to the pool floor in this incident was 5 feet at the shallow end, increasing to 11½ feet at the deep end. The distance from the diving board to the pool floor was approximately 14 feet. The potential fall distances from attached ladders ranged from 1 to 11 feet. Minimizing the fall hazard requires the development, implementation, and enforcement of standard operating procedures (SOPs) designed to protect workers while performing seasonal pool maintenance. The SOPs should clearly state that no one is allowed anywhere near the edge of the pool deck while performing maintenance, including cleaning, when the pool is empty. The access point to the pool should be limited to the shallow end. That access point should be clearly marked as the access point for maintenance, such as pool cleaning, painting, etc. The SOPs should also require that the pool is cleaned from the pool floor only. Once the inside of the pool is cleaned, the pool should be completely filled before workers are allowed on the deck areas to perform other cleaning activities or to place and secure the diving board. SOPs should clearly state that diving boards are to be moved into position on their racks or removed from their racks only when the pool is full. Working near an unsecured diving board over an empty pool exposes workers to both a fall hazard and to the hazard of being struck by the board should it slip from its rack. Employers can eliminate the hazard created by an unsecured diving board, by establishing and enforcing SOPs that require that diving boards be secured immediately after they are set in place for the season and removed immediately after they are unsecured at the end of the season. Pools should be filled before workers are allowed to work on the deck before the beginning of the swimming season and drained after all work has been completed on the pool deck at the end of the swimming season.
