Fatality Assessment and Control Evaluation Program

FACE Report Number: 2002-10

Youth Farm Worker Dies After Falling Into Operating Feed Grinder/Mixer - Ohio

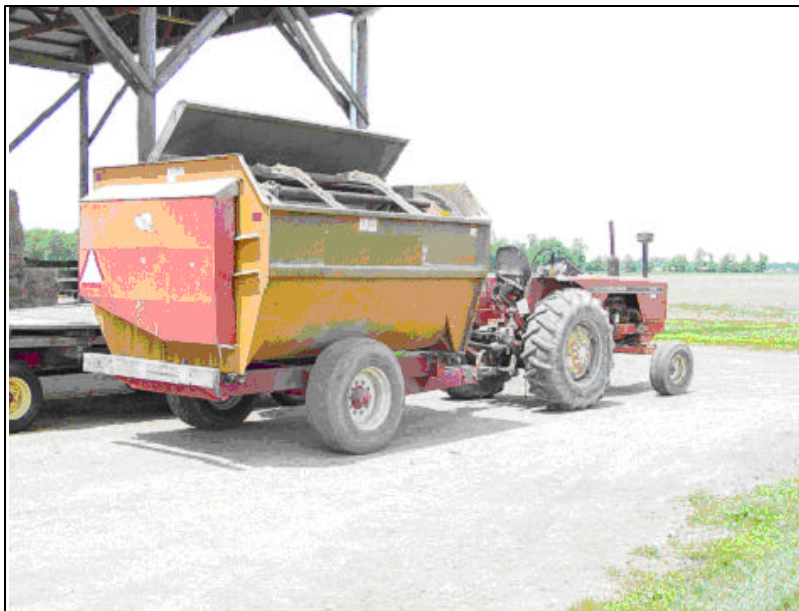
On August 15, 2002, a 14-year-old male farm worker (the victim) died after falling into an operating cattle feed grinder/mixer. The victim was using a handheld hay hook to drop hay bales into the operating grinder from the top of a stack of hay bales. He apparently lost his footing, slipped, and fell into the grinder. Approximately 20 minutes later, a coworker entered the area and noticed that the grinder was running unattended. He then called out to the victim and received no response. After looking into the mixing/grinding area of the machine he realized that the

Machine used during the incident

- *ensure that machinery such as top-loading feed grinders are positioned away from upper level work areas where employees could slip and fall into or onto it, and that the machinery is not operating during manual loading*

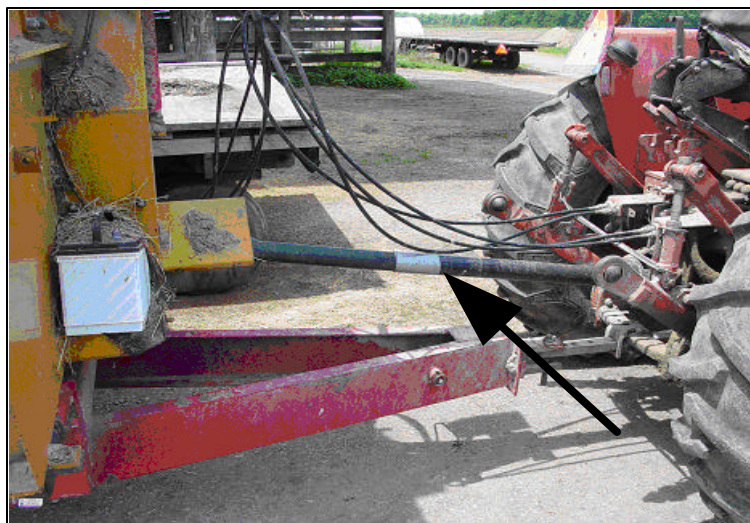
The feed grinder/mixer (feed grinder) involved in this incident was approximately 5 years old and had been purchased from the manufacturer new. The portable feed grinder was hitched to and powered by the power take-off (PTO) of a tractor (Photo 1). The tractor was operated by key, which was left in the

Photo 1. Depicts the power-take-off shaft engaging the feed mixer-grinder from the rear of the tractor

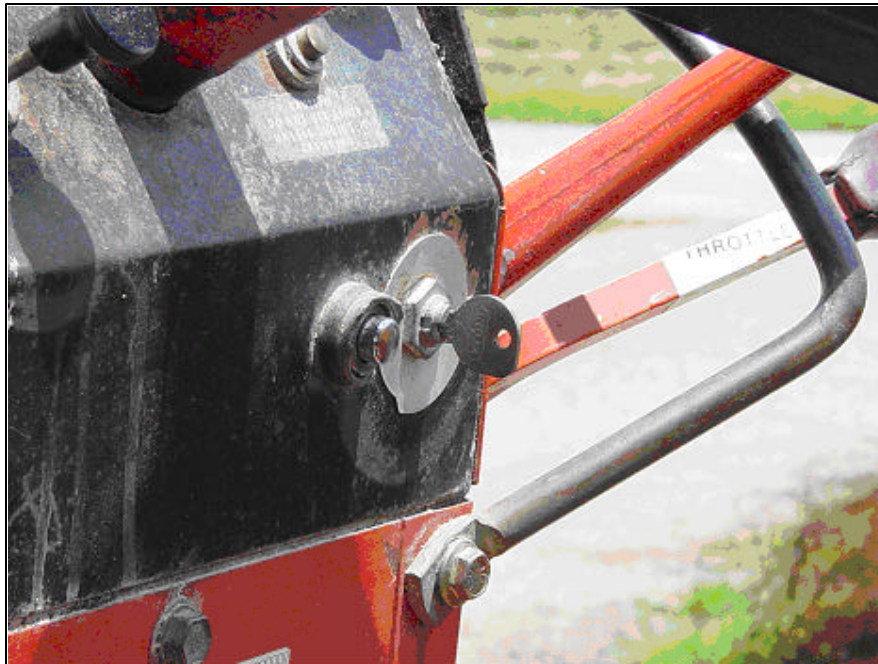
Photo 2. Depicts the key left in the ignition of the farm tractor that powers the feed mixer-grinder

Discussion: The victim involved in this incident had access to the keys (they were left in the ignition) used to operate the tractor dedicated to the feed grinder/mixer. The possession of the keys in turn provided him direct access to the machinery (feed mixer/grinder) attached to the tractor's PTO. Employers should consider means of maintaining control of keys only by experienced, trained, and/or authorized workers, so that other workers would be unable to operate prohibited and/or dangerous machinery.

Recommendation #2: Employers should ensure that any keys that are required to operate equipment (tractor/power take off) are kept under the supervision and control of workers permitted to operate such machinery.

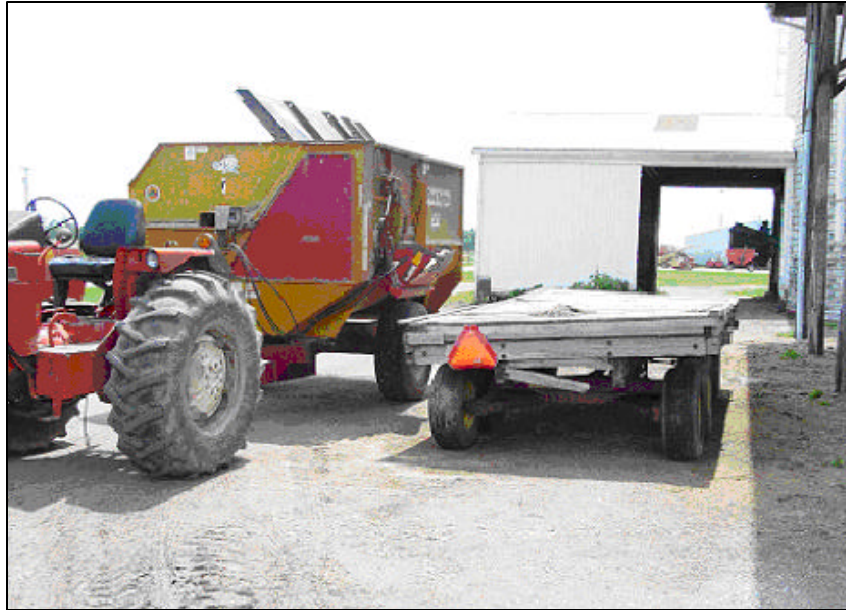
Photo 3. This photograph depicts the hay wagon that is used in the process of loading the feed grinder-mixer. Note: the hay wagon is normally positioned on the other side of the machine for loading purposes

The manufacturer's operator's manual states "do not hand load materials while unit is running." The co-owner stated that the normal procedure for this operation was to throw the bales of hay down onto a hay wagon with a working surface level approximately 36 inches from the ground and then get on the hay wagon, hook the bales with a hand-hook, and throw the bales up into the operating grinder.

Recommendation #5: Employers should consider the use of a conveyor or other mechanical – type apparatus to elevate the feed (hay, corn silage, and alfalfa pellets) up to the loading point of the feed grinder.

Discussion: A conveyor, hay chute, or other mechanical equipment (such as a loader with fork attachment) could be used to facilitate the loading of the grinder, and would prevent exposure of employees to potential lifting injuries in addition to the likelihood of the employees being positioned above the grinder. In this case,

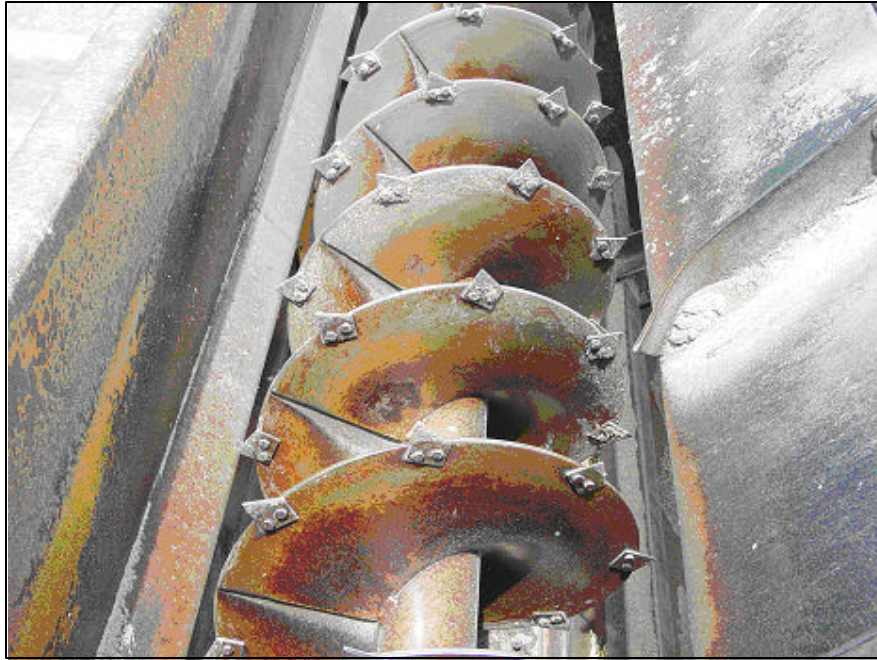
duties to the victim on the day of the incident. Feeding of the cattle was not scheduled to occur until later in the day. Apparently the victim had not met with the other co-owner, but rather had decided to climb the hay stack and load the operating feed grinder from above. The hay stack was noted to be stacked nine bales high, making the working surface approximately 13 feet above the lower ground level. The victim's work position was estimated at approximately 6 feet above the point(s) of operation* of the machine. During the process of loading the hay bales into the feed grinder, the victim apparently slipped down into the feed grinder auger area (Photo 4) and was killed instantly.

Photo 4. This photo illustrates the auger portion of the feed mixer-grinder. Note the razor-blades mounted on the auger to facilitate cutting/grinding

Recommendation #1: Employers should ensure that machinery such as top-loading feed grinders are positioned away from upper level work areas where employees could slip and fall into or onto it, and that the machinery is not operating during manual loading.¹

Discussion: Machinery such as top-loading feed grinders and other dangerous equipment should be positioned away from upper levels where employees could slip and fall into or onto it. The operator's manual for the grinder in this incident includes such guidance: "do not operate mixer if any person is positioned near or over the top of box."
