Hispanic Construction Laborer Dies After Portable Silo Collapse - North Carolina

SUMMARY

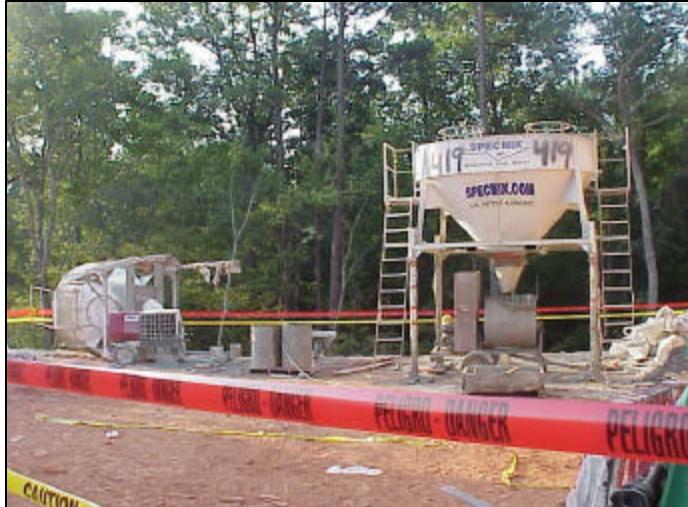
This photo illustrates the collapsed silo on the left, the remaining standing silo on the right, and the scrap lumber used for foot pads for the silo legs.

Investigation at the scene revealed that scrap lumber was used as foot pads for the silo legs. Examination of the hitch pin from the collapsed leg showed that the cotter key holding it in place was sprung and would fall out if turned upside down or if vibration occurred (Photo 2). The lead police detective said that when he arrived at the scene, the hitch pin was lying on the ground next to the collapsed leg.

Evidence suggests that the scrap lumber leg pads may have shifted, causing the silo to start to roll to the side. As the pressure was relieved on the leg that collapsed, the hitch pin fell from the telescopic leg and receiver tube. This allowed the leg to fully collapse and the silo to fall to the ground.

Recommendation #1: Employers should ensure that equipment is set up according to manufacturers' recommendations and specifications.

Discussion: The silo manufacturer's safety manual recommended that the silo legs be placed on either 8-inch-wide by 12-foot-long by 4-inch-thick concrete footers with a minimum compressive strength of

3,500 pounds per square inch or three 3/4-inch-thick, 2-foot-square pieces of treated laminated plywood held together by screws. This would ensure the stability of the silo. The scrap lumber used as foot pads for the legs was not secured in any way and may have shifted, causing the silo to begin to roll to the side.

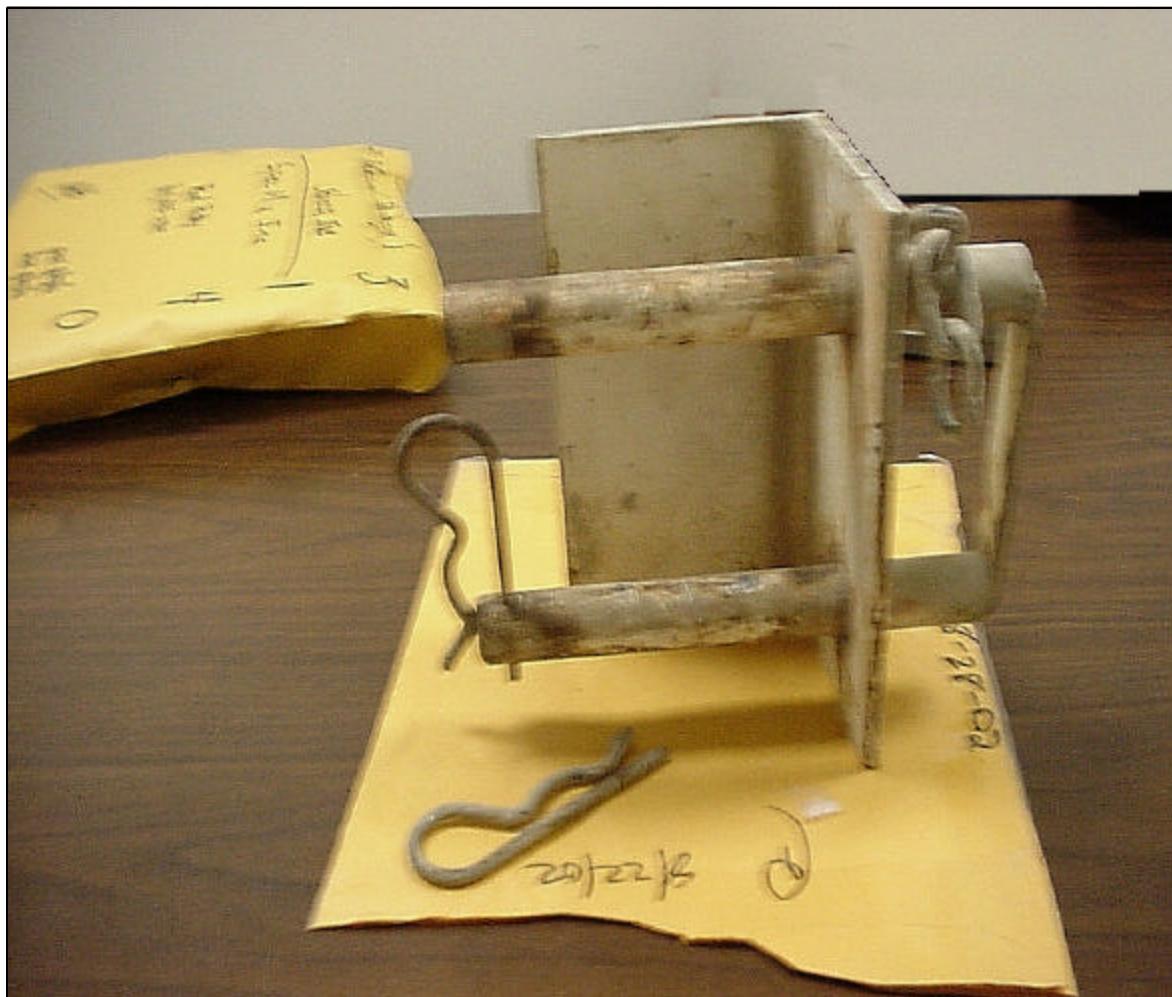
setting up the silos consisted of lifting them slightly and pulling two-pronged hitch pins (Photo 1) from the legs and receiver tubes. The silos were then raised higher until the telescopic legs were at full adjustment. The hitch pins were then reinserted through the receiver tubes and silo legs, securing them from collapse. The silos were then lowered to the ground onto pieces of scrap lumber of various lengths and widths which were used as pads for the legs. Since the silos were delivered, they had been moved and set up with the legs extended two additional times.

Photo 1. This photo illustrates the two-pronged hitch pin used to hold the silo legs in place.

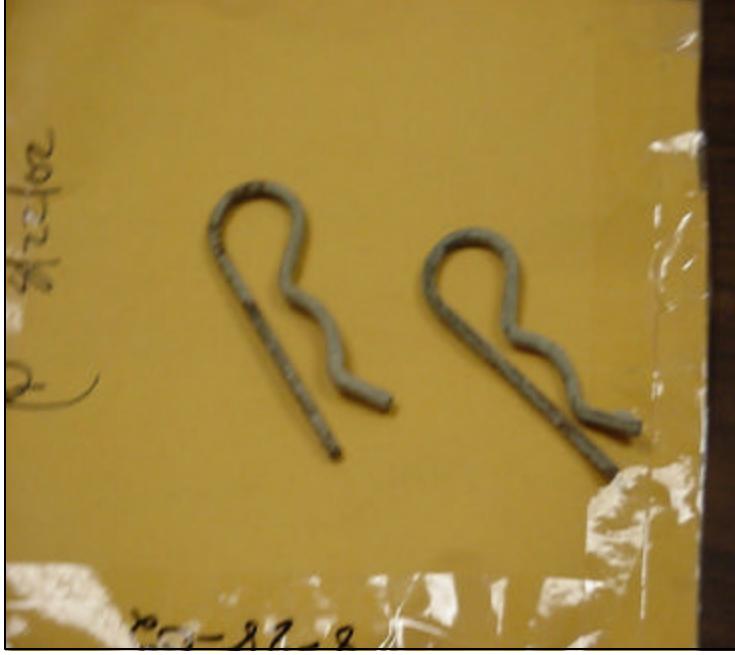
Photo 2. This photo illustrates the sprung cotter key on the left and a properly functioning cotter key on the right.

Discussion: The sprung cotter key holding the hitch pin in the silo leg fell out of the hitch pin leg either before or as the silo began to roll sideways, allowing the silo leg to collapse and the silo to fall. Discussions with the manufacturer representative led to the conclusion that it was highly unlikely that the hitch pin vibrated free from the silo leg during normal operation because of the silo weight (approximately 2 tons when empty). Inspection of the equipment before the start of or during work may have identified the sprung cotter key. Had the cotter key been replaced, it may have prevented the total collapse of the silo.

Recommendation #2: Employers should inspect equipment on a daily basis before the start of work and immediately repair any damaged components.
