**FACE Report Number: 2001-06**

## ***Eighteen-Year-Old Sporting Goods Retail Store Worker Dies in a Fall From a Shelving Unit—Pennsylvania***

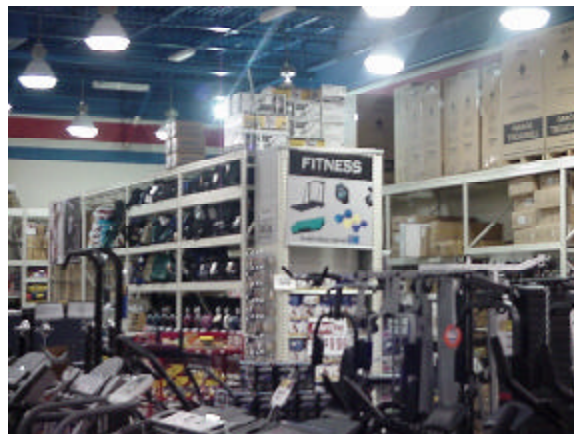
***Photo 1. H-Frame Shelving Unit***

Store products are stored or displayed on a variety of different types of shelving units. Large, bulky or heavy items are stored on shelving units called H-frames. The H-frame is a heavy-gauge steel shelving unit in the shape of an “H”, that is 12 feet high and 8 feet wide and can be butted together in 10-foot lengths to cover varying distances. Each H-frame can consist of multiple shelves depending on the configuration and size of the objects stored. Approximately half of the store is comprised of H-frame units that are arranged to form aisles. In order to remove items from the top shelves of the H-frames, the store utilizes an electrically powered, hand-controlled, vertical lift, referred to at this store as the beeper. The beeper has an attached work platform that is surrounded by a guardrail. One worker positions the beeper and operates the lift, while another worker stands on the platform and is raised to the level necessary to retrieve the item. The corporate office has a written and posted policy that requires the person being raised in the air to wear fall protection. Fall protection consists of a body harness that is tethered to a self-retracting lanyard which is secured to the upper frame of the work platform. The corporate office also requires that both the operator of the beeper, as well as the person being lifted, be trained and certified to use the equipment, including fall protection equipment.

Discussion: According to the store representatives, one trained and authorized worker on each shift was designated as the person responsible for retrieving boxes from the top of the H-frames. That person was required to wear the fall protection harness throughout the shift and was to be lifted only by another trained and certified person operating the beeper. Fall protection was provided for working within the confines of the beeper's work platform. A trained and certified worker may have recognized the hazard of working at elevations without fall protection and may have positioned the beeper on the side of the H-frame near the box, enabling the box to be removed while remaining on the platform with fall protection in use. [Note: In this incident, the victim was not wearing fall protection and exited the work platform to climb on top of the H-frame to retrieve a box.] Whenever it is necessary to walk or work on the top shelf of the H-frame away from the beeper to retrieve boxes, additional fall protection should be utilized. One method of fall

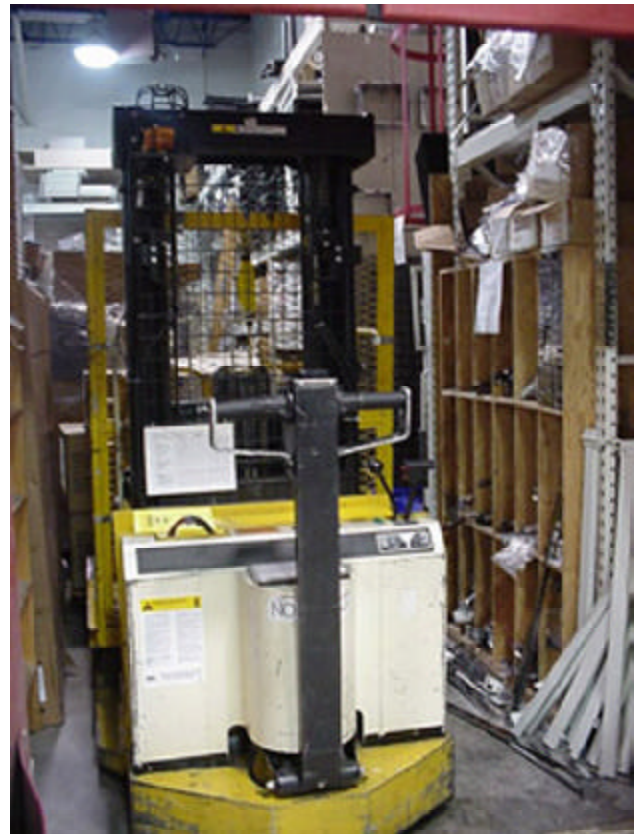
*Photo 2. Beeper Used to Access H-Frames*

Safety and health training for employees was provided by the corporate office and coordinated by their District Loss Prevention Manager. The store provides training and certification in the proper operation and use of fall protection, operation of the electrically powered high-lift order picker (referred to as the beeper), and materials handling. Employee certification is denoted by different colored name badges. It was a corporate policy that no one under the age of 18 be allowed to operate or be raised in the air by the beeper. This was the sporting goods retailer's first workplace fatality.

**Recommendation #1: Employers should ensure that only properly trained personnel operate hydraulic lifting equipment.**

Discussion: In this incident, neither the victim nor the coworker who lifted the victim to the top of the H-frame were trained or certified by the store to operate the equipment. The store provides training and certification in the proper operation and use of fall protection, operation of the beeper, and materials handling. Employee certification is denoted by different colored name badges.
