## *Seventeen-Year-Old Laborer at Salvage Lumber Operation Crushed by Forklift That Tipped Over - New York*

### SUMMARY

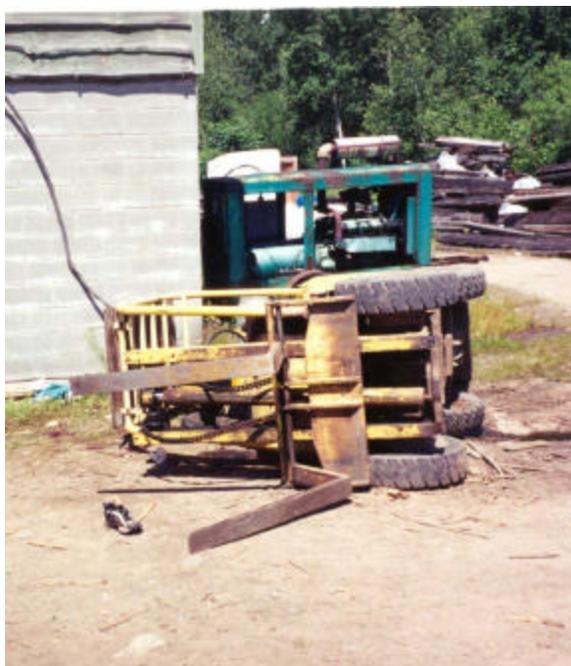
*Photo 1. Overturned Forklift*

On July 10, 2000, a 17-year-old laborer (the victim) working at a salvage lumber operation was fatally injured when the sit-down type forklift he was operating overturned. The youth had been asked to move the forklift from the lumber storage area to the resaw area when he returned to work from break. He had offered a ride to a coworker who was also returning to work. She had accepted and was riding on the right side of the forklift, holding onto the overhead guard. They had traveled about 135 feet when the victim turned sharply to the left, and the forklift tipped and overturned to the right (Photo 1). The coworker jumped from the machine while the victim was thrown or jumped from the operator's seat. The victim's head was caught between the overhead guard and the ground while the coworker's ankle was pinned. Other workers heard screams and went to the forklift. They raised the machine to free the coworker and pulled the victim from under the overhead guard. Emergency personnel were notified and arrived within 15 minutes. The victim was transported to a local emergency room where he was pronounced dead. The coworker was transported to a local emergency room where she was treated for minor ankle injuries and released.

The forklift was a 1964 Towmotor that the owner had purchased at auction about 9 months before the incident. It was equipped with outdoor-type tires, had a wheelbase of 50 inches, a 43-inch track, and a height of 47 inches from the ground to the operator's seat. The machine was steered by the rear wheels and powered by the front wheels. Power was transmitted from the engine to the drive wheels through a disc-type clutch, gear box, and open differential. The gearbox provided forward and reverse directions and high and low speed ranges. Each drive wheel was equipped with a mechanical braking assembly. According to the owner, all employees operating the forklift had been instructed to operate in the low-speed range only.

The machine was equipped with an overhead guard to protect the operator from contact with falling objects; however, it had not been equipped with an operator restraint system.

***Recommendation #1: Employers should ensure that forklifts are operated by employees who have been specifically trained to use safe operating procedures and to recognize the hazards of improper operation.***

Discussion: Because the victim had a valid state-issued driver's license and had studied heavy equipment operation in school, the company owner decided to assign him to occasionally operate the forklift. The operating controls of a forklift are uncomplicated and similar to those of an automobile; however, the vehicle's response to control inputs, especially steering, can be decidedly different. A forklift's narrow track and short wheelbase result in the machine's having a higher center of gravity than the typical automobile. Because of this, a forklift may overturn much more easily than an automobile and at much lower speeds. Additionally, the added weight of a rider on the right side of the machine could significantly decrease its resistance to overturning while negotiating a left-hand turn.

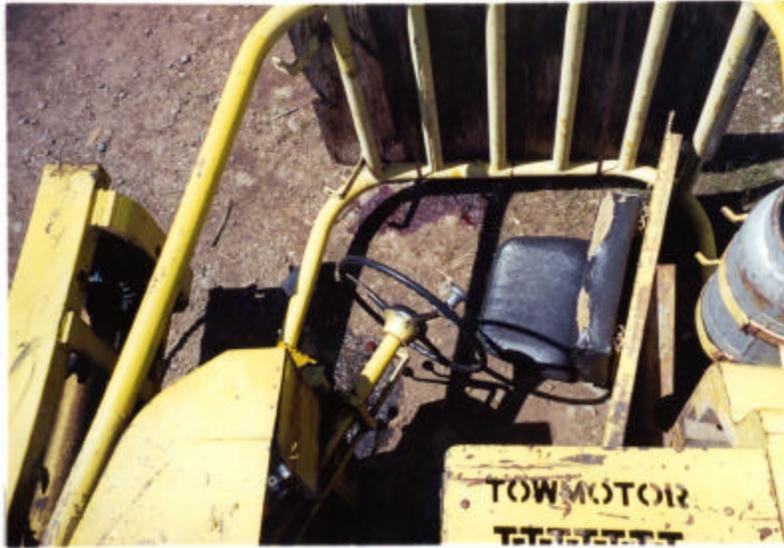
*Photo 2. Overturned Forklift - Unsecured Operator's Seat*

Discussion: The forklift involved in this incident, a 1964 Towmotor, was not equipped with an operator restraint system. The operator's seat was mounted on a heavy-gauge sheet-steel cover intended to be secured with bolts to the forklift's frame. However, the bolts for the steel cover were missing (Photo 2). According to the employer, this was the machine's condition when purchased at auction and he had assumed that it was acceptable for use. The machine was equipped with an overhead guard to protect an operator from being struck by falling material. During an overturn, the overhead guard is generally the part of the forklift that crushes the operator's head or torso after he or she falls or jumps outside of the operator's compartment. The risk of being crushed by the overhead guard or another rigid part of the forklift is greatly reduced if the operator remains restrained inside the operator's compartment. Since 1992, the American National Standards Institute has

specified that forklift manufacturers equip new forklifts with operator restraint systems.<sup>3</sup> Many forklift manufacturers offer restraint systems that can be retrofitted to older sit-down type machines. In the early 1970s the manufacturer of the forklift, Towmotor, ceased operations and was sold to Caterpillar Incorporated. During the investigation, it was learned that retrofit operator restraint systems are available for the forklift involved in the incident. Owners of Towmotor forklifts should contact their local Caterpillar Incorporated equipment distributor for assistance in obtaining retrofit operator restraint kits. Because many older forklifts are not equipped with a restraint system and operator compliance is less than 100% on forklifts equipped with a restraint system, operators of sit-down type forklifts should be instructed not to jump from the operator's compartment but to hold on, brace themselves, and lean in the opposite direction of the overturn. If the victim had been able to remain within the boundaries of the overhead guard, the severity of his injuries may have been reduced.

***Recommendation #2: Employers should ensure that sit-down type forklifts are equipped with adequate operator restraint systems to protect the workers in the event of a tipover.***
