## *Twenty-Nine-Year-Old Asphalt Compactor Operator Dies From Crushing Injuries Received During Machine Rollover—North Carolina*

### SUMMARY

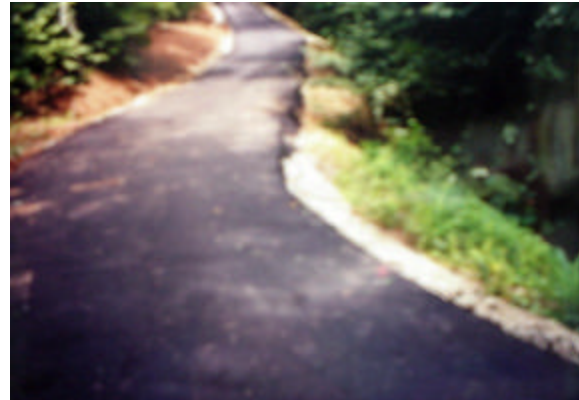
On July 10, 2000, a 29-year-old equipment operator (the victim) was killed when the asphalt compactor he was operating slid off the pavement, down an embankment and overturned, trapping him beneath. The victim was part of a five-person crew that was contracted to pave a private residential driveway which was located on a wooded lot on hilly terrain. One witness to the incident reported that he saw the victim position the compactor close to the edge of the driveway. It appeared that the smaller front roller of the compactor became caught on the pavement edge.

*Embankment of Roller Incident*

With part of the front roller hanging over the pavement edge, the witness reported that the victim started to reverse the compactor when the larger back roller slipped sideways over the edge of the pavement. When the compactor started to slip, the victim apparently tried to jump clear, but his leg became entangled and he went over the embankment with the compactor. Coworkers immediately ran over the hill to aid the victim while the property owner called 911. While waiting for emergency medical services (EMS) to arrive at the site, coworkers removed the victim from underneath the compactor and attempted to administer first aid. EMS and fire department crews arrived at the site and transported the victim to the hospital, where he was pronounced dead.

- ensure that all equipment used in a location where there is a danger of overturn be equipped with a Rollover Protective Structure (ROPS) and that operators are trained to wear seat belts when operating machinery equipped with ROPS

***Recommendation #1: Employers should ensure that all equipment used in a location where there is a danger of overturn be equipped with a Rollover Protective Structure (ROPS) and that operators are trained to wear seat belts when operating machinery equipped with ROPS .***

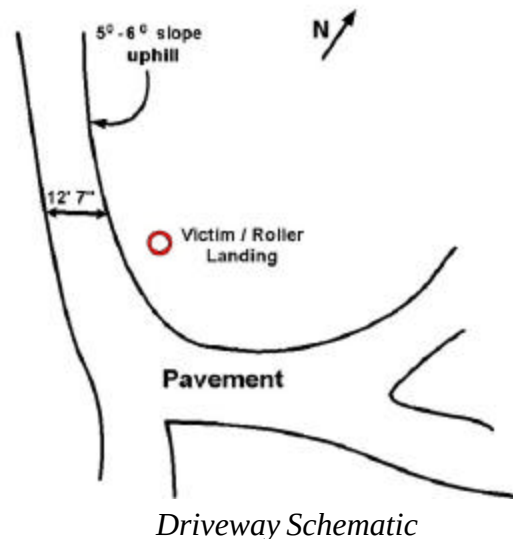
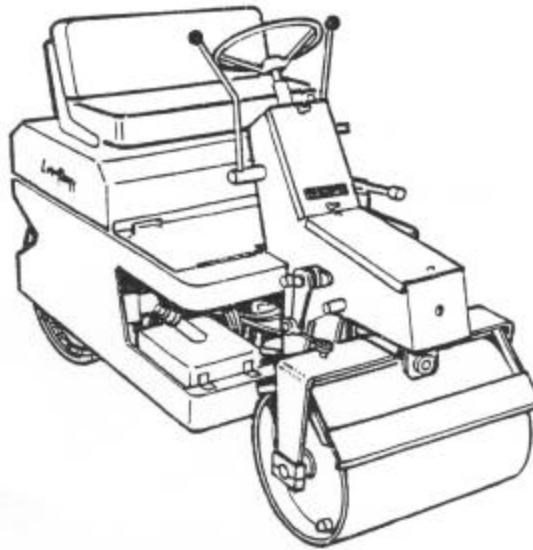
*Asphalt Compactor Involved in Incident*

The victim was operating a small, two roller, single-seated pavement compactor, with an unloaded weight of approximately 2000 pounds. The front steering roller consisted of a split drum measuring 20 inches in diameter and 30 inches in length, with each drum weighing approximately 100 pounds when filled to capacity with 12 gallons of water. The rear roller was a single drum, measuring 24 inches in diameter and 36 inches wide, and weighed approximately 530 pounds when filled to capacity with 63 gallons of water. The compactor was propelled to a maximum of 4 miles per hour (m.p.h.) from a 16-horsepower gasoline engine. The roller could move forward and backward by a two-speed hydrostatic transmission, and braking was accomplished with a dynamic braking system. The dynamic braking system required movement of one of two connected levers to operate. These levers, when pushed forward resulted in the compactor moving forward. As the lever was moved back to upright neutral positions the compactor braked to stop position. If the lever was moved further back past the neutral position, the compactor reversed direction. The compactor also had a back-up, hand-operated caliper brake for emergencies.

Discussion: All equipment operated in a location where there is the potential for a rollover to occur should be equipped with ROPS. Most new equipment already has ROPS and seat belts installed by the manufacturer. In addition, most manufacturers offer a ROPS retrofit for older equipment. The compactor involved in this incident was being used to compact asphalt in close proximity to an

unguarded 35-degree sloped embankment without being equipped with rollover protection. A Rollover Protective Structure (ROPS) is only effective when used in conjunction with a seat belt. Seat belts are incorporated into the design of the ROPS to restrain the operator in the operator's seat and within the confines of the protective structure in the event of a sudden stop or rollover of the equipment. Failure to use seat belts in conjunction with ROPS has proven to be hazardous to equipment operators during a rollover. Employers should train workers to wear the seat belt and not to jump from the equipment in the event of a rollover. The manufacturer of the compactor involved in this incident did offer ROPS as a purchase option (less than \$500).

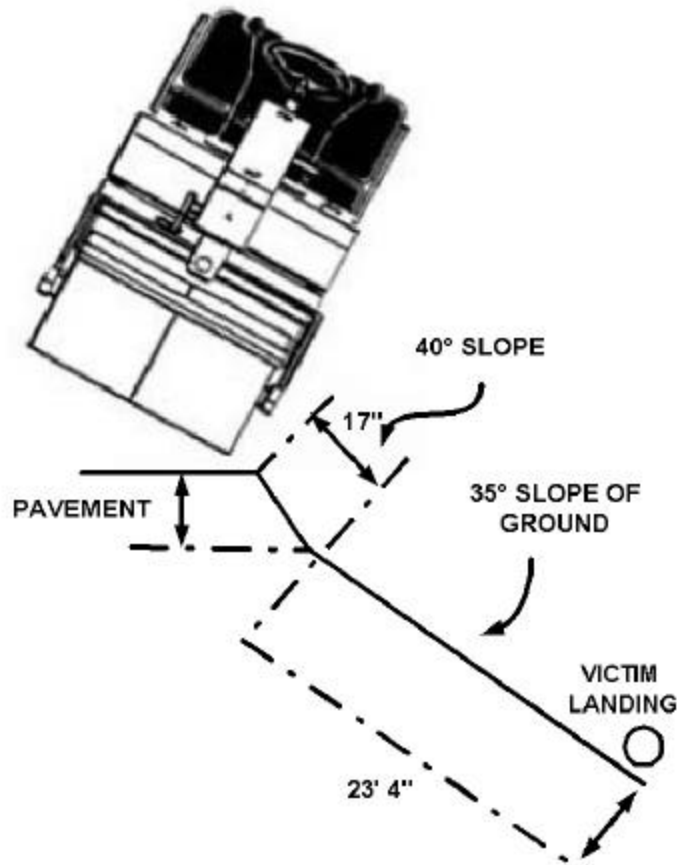
At approximately 12:30 p.m., the victim was compacting asphalt on the edge of the driveway. A witness reported that he saw the victim position the compactor close to the edge, with the front roller partially over that edge. With part of the front drum hanging over the pavement edge, the victim reversed the compactor and the back roller slid toward the edge. The compactor then started to tip over the edge of the pavement toward the embankment. The witness saw the victim attempt to jump back toward the pavement as the compactor went over the embankment, however, it looked to him like the victim had caught his leg on something on the compactor roller and went over the embankment with the machine. The edge of the asphalt was sloped 40 degrees for 17 inches to the dirt berm of the driveway where the embankment began. The embankment had a 35 degree slope and extended 23 feet down to the landing area of the roller. Two coworkers ran over the embankment

*Profile of Work Site Terrain*

Discussion: Although using this model compactor on a slope such as the one encountered in this case is not unusual and is mechanically acceptable, operators should use extra caution when using heavy equipment on steep or hilly terrain. Paying close attention to the terrain of the area can help reduce the risk of injuries due to rollovers and other hazards.
