FACE Report Number: 2000-09

Sixteen-Year-Old Laborer At a Building Supply Center Crushed by Forklift That Tipped Over - Ohio**SUMMARY**

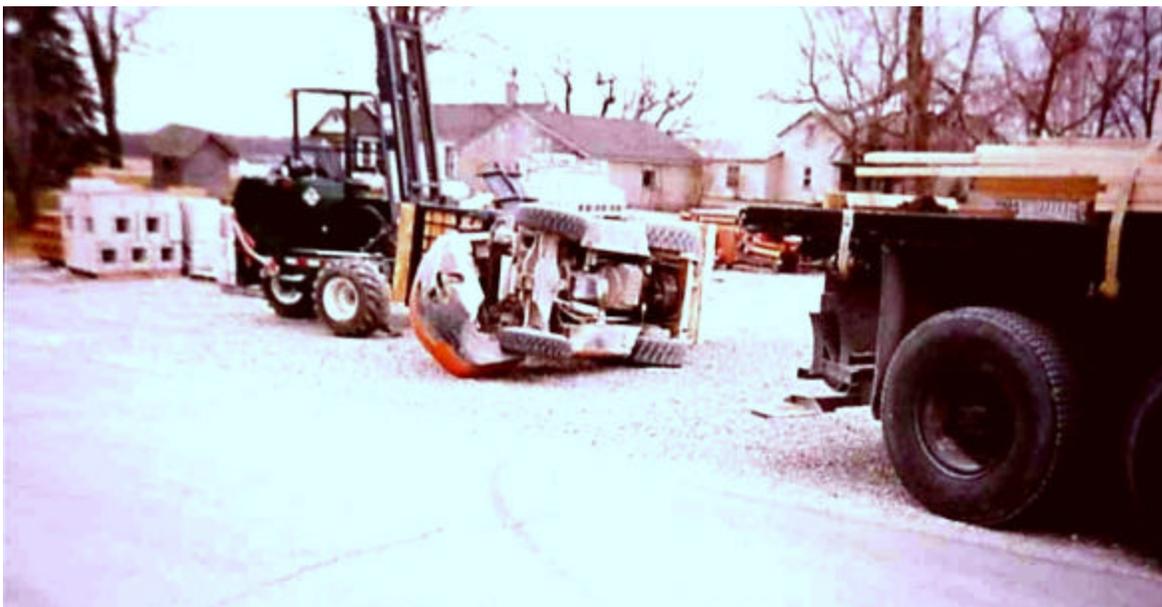
On December 22, 1999, a 16-year-old male part-time laborer (the victim) suffered fatal crushing injuries when the forklift he had been operating tipped over. The youth had been operating the forklift to transport an empty pallet from a building supply center warehouse to an outside storage yard. As he turned from an asphalt paved alley onto the gravel-surfaced storage yard, the forklift tipped to the outside of the turn. The youth, who was not wearing the forklift's seat belt, either jumped or was thrown from the operator's seat. The forklift tipped over on its side and he was pinned to the ground by the overhead guard (Photo 1). A short time later, one of the building supply center's co-managers saw the forklift lying on its side in the

Photo 1. Forklift Tip Over - Building Supply Center

Discussion: The forklift which was involved in this incident was equipped with an overhead guard and a seatbelt for operator restraint. The forklift and overhead guard were undamaged during the tip-over. If the operator had been restrained with a seatbelt, the severity of the injuries may have been significantly reduced.

Recommendation #1: Employers should ensure that forklifts are operated only by authorized employees, who have been specifically trained to use safe operating procedures and to recognize the hazards of improper operation.

Recommendation #2: Employers should ensure that forklift operators use the seatbelts provided as part of the operator protection system.

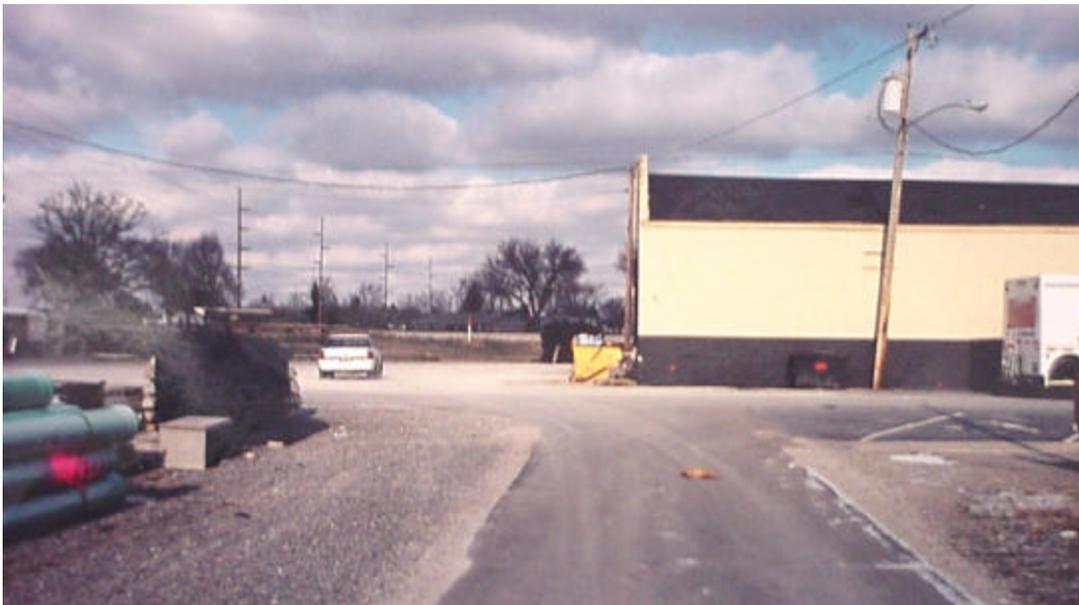
Photo 2. Building Supply Center (Warehouse viewed from alley)

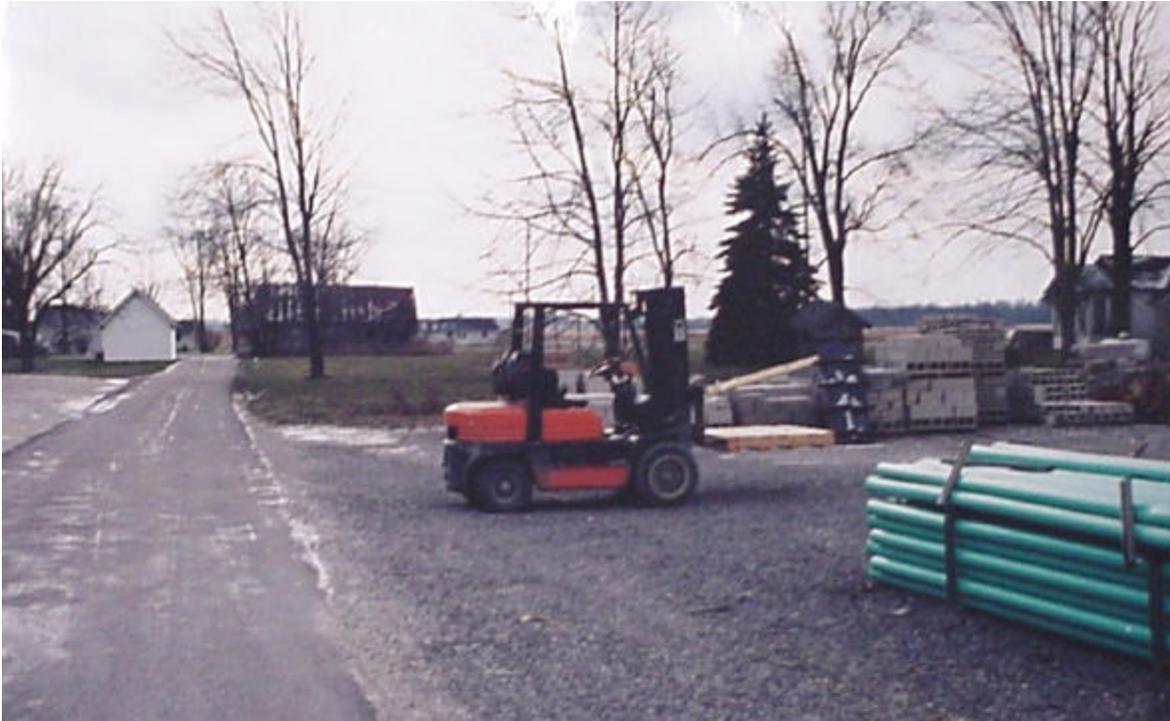
Photo 3. Building Supply Center - Storage Yard
