Fatality Assessment and Control Evaluation Program

FACE Report Number: 2000-03 **April 14, 2000**

Youth Laborer Dies in Trench Collapse - Michigan

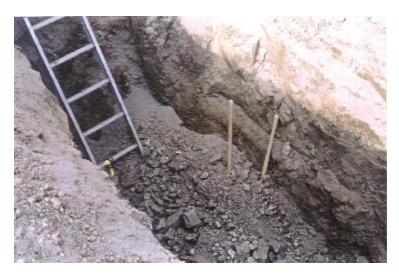
Incident Scene

A 17-year-old male laborer (the victim) died and a coworker was injured after one of the unprotected walls (i.e., no shoring, shielding or adequate sloping) of the trench they were working in collapsed, striking and partially burying them with soil. The day before the incident the excavator operator had removed the trench shield used during the sewer installation project to facilitate the removal of broken sewer pipes. When work was resumed the next day, the trench shield was not replaced, and the victim and a coworker (pipe setter)

went into the unprotected trench to replace two sections of pipe and to check the grade of the sewer line with a grade pole. While they were placing the grade pole inside the terminal end of the sewer line, a section of the trench wall caved in, striking and burying the victim to his mid-chest and his coworker to his knees. The foreman, who had been working above the trench at ground level, called 911 at 9:39 a.m. and requested emergency medical services (EMS). EMS, law enforcement, and the fire department personnel arrived within 5 minutes of the 911 call. The Fire Marshall assumed responsibility for rescue operations and site safety and, in his role as Incident Commander (IC), assigned Operations Officer duties to one of the fire fighters. The Operations Officer, realizing that the trench walls remained unstable and hazardous, directed coworkers, who had jumped into the trench to render assistance, to leave the trench until fire fighters could obtain the necessary protective systems to ensure safe rescue operations. Coworkers refused to leave the trench and continued digging to free the trapped workers. The Operations Officer asked law enforcement personnel to remove the foreman from the incident site when he demanded that EMS and fire fighters go into the unprotected trench. The foreman was removed from the incident site. While fire fighters were waiting for the arrival of protective systems, they set ground pads (sheets of

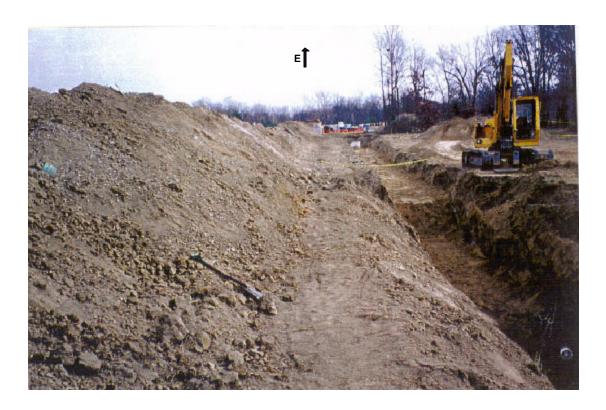
The construction contractor was hired by a private industrial park development enterprise to install a sewer system on a 3.5-acre site. According to official reports, work had been ongoing at the site for several weeks, and approximately 200 feet of sewer line had been laid (see Figure 1). The sewer installation crew working at the site on the day of the incident consisted of five men including the victim. Also present at the site was a self-employed excavator operator who had been hired as a subcontractor by the construction contractor. His job was to dig the trench, lower sewer system components, move the trench box, and to refill the trench after the sewer system was in place. He was operating a 162-horsepower, diesel-powered, track-mounted hydraulic excavator which was manufactured after 1995.

Figure 1. Sewer Installation Project (Trench pictured is approximately 200 feet long.)

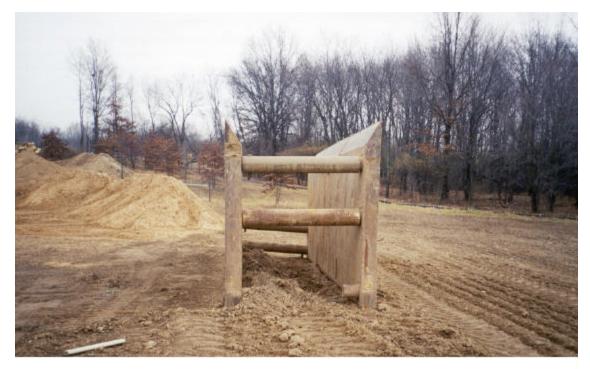
On the day before the incident, the excavator operator struck two sections of pipe with the bucket of the hydraulic excavator and broke them as he compacted and leveled sand over a completed section of sewer line. When he tried to lift and remove the broken pipes, they broke off beyond the location of the trench shield. Because the excavator operator could not get the pipes out of the trench with the trench shield in place, he removed the trench shield, which had been used throughout the sewer line installation, and placed it approximately 20 yards to the south of the trench (see Figure 2). The excavator operator and the sewer line installation crew then quit work for the day.

Figure 2. Shield (Shield was removed from the trench with an excavator and placed 20 yards from the trench.)

Discussion: 29 CFR 1926.652 (a) (1) states that "each employee in an excavation shall be protected from cave-ins by an adequate protective system." MIOSHA R408.40941 (1) requires a similar level of protection. In this incident, reports indicate that an adequate protective system, a heavy-duty trench shield, had been placed in the trench during the pipe-laying process. It had been removed in order to remove pipes that had been broken during soil compacting. When work conditions change and necessitate the temporary removal of the protective system in use, employers must ensure that all workers are removed from the trench. Only when an appropriate protective system is again placed in the trench should workers be allowed to reenter the trench.

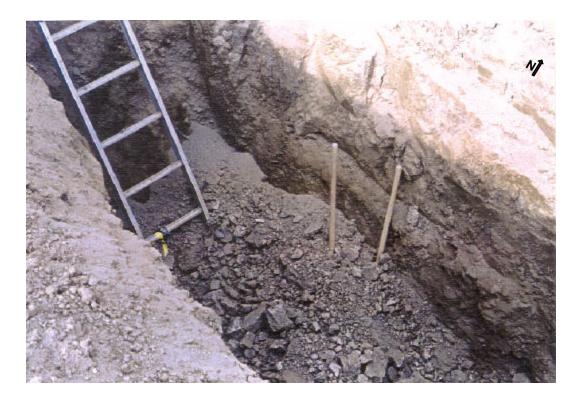
When work resumed at approximately 7:30 a.m. the next morning, the excavator operator removed the broken pipe. He did not replace the trench shield before he lowered new sections of pipe into the trench. He then waited nearby with the hydraulic excavator running since his next task, after the line was repaired and properly aligned, would have been to lower a cement manhole into place. The victim and a coworker (pipe setter) went into the unprotected trench to set the two new sections of pipe. The trench was approximately 11 feet deep and 8 feet wide in the area in which they were working. After they had set the pipe, a coworker, working above them at ground level, handed them a grade pole. While they were placing the grade pole inside the end of the pipe to allow them to check the grade of the sewer line, a section of the unprotected trench wall 30 feet long by 11 feet high and several feet thick caved in (see Figure 3). A portion of this fallen section struck the victim and his coworker, burying the victim up to his mid-chest and his coworker up to his knees (see Figure 4).

Figure 4. Incident Scene (The victim and his co-worker were buried near the west end of the trench.)
