ADMINISTRATIVE REPORT
PUBLIC HEALTH SERVICE/CDC/NIOSH/DSR
FACE-99-05

SUBJECT: 15-year-old Campground Laborer Dies After Striking a Camper Trailer Hitch While Operating a Utility Vehicle--Ohio

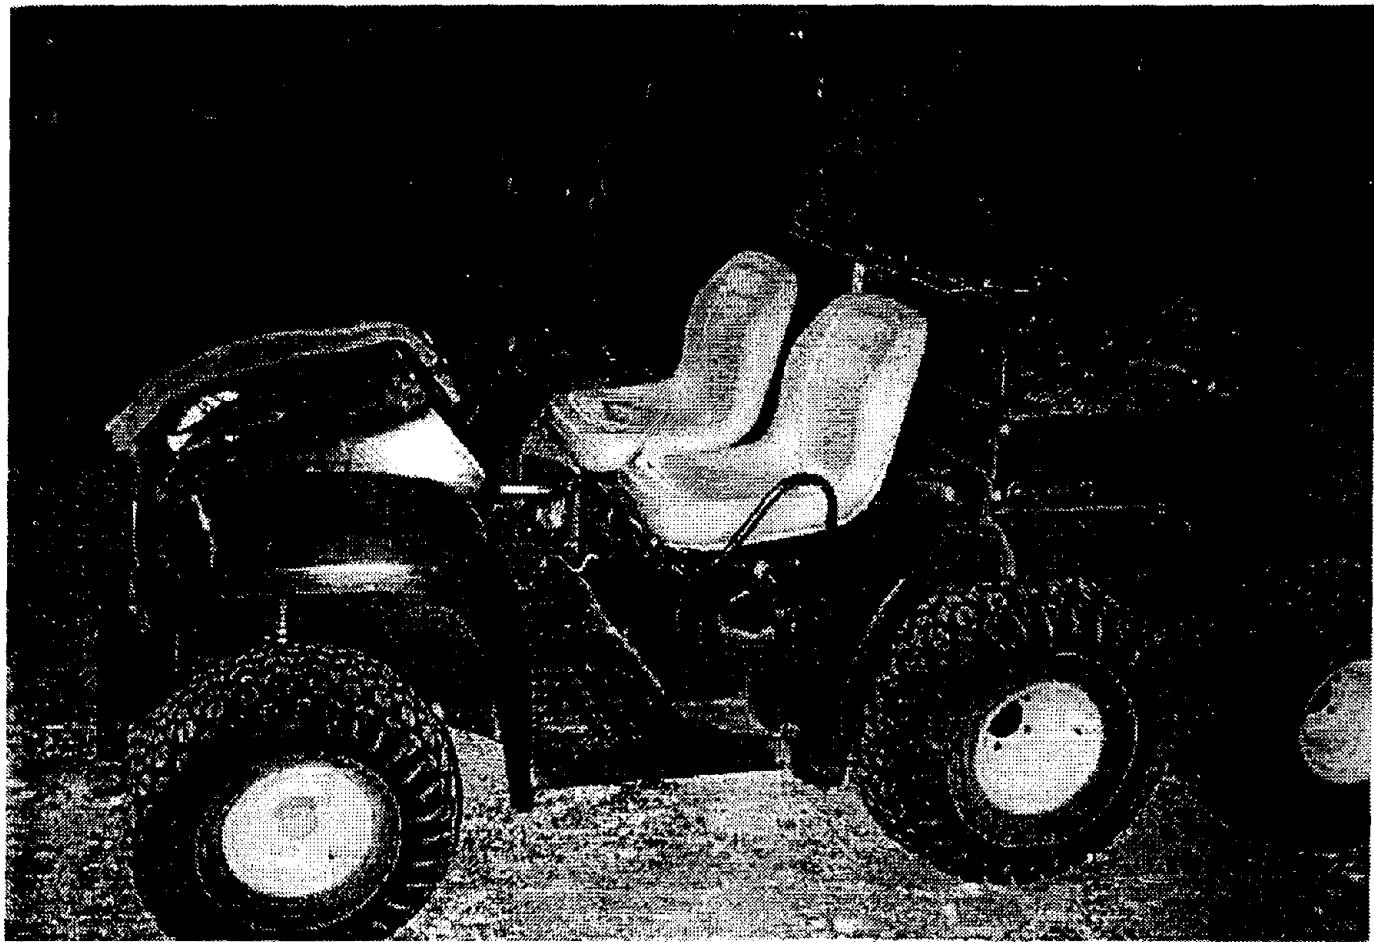
Figure 1: Utility vehicle used in the incident. The vehicle's steering wheel cleared the trailer hitch. The victim's upper body struck against the hitch.

The coroner's investigator concluded that the most likely path the victim drove was alongside the length of the fifth-wheel camper trailer and that he turned too sharply as he cut across the access driveway in front of the fifth-wheel camper toward the next fire pit. The front portion of the utility vehicle passed under the hitch, which the victim may have failed to see, as it blended in with the surroundings. He collided with the hitch, striking it with his chest and abdominal area (Figure 2). The highest point on the utility vehicle, forward of the driver's seat, was the steering wheel (43 inches from the ground to the top of the steering wheel), which cleared the base of the hitch by $\frac{1}{2}$ inch. The forward movement of the vehicle would have compressed the victim between the camper hitch and other parts of the utility vehicle with sufficient force to cause the lethal injuries. There was no evidence indicating the traveling speed of the utility vehicle at the time of impact. The coroner's investigator further reasoned that the victim was found partially in the vehicle and a short distance away from the hitch, because the victim possibly placed the vehicle in reverse, dislodging himself from the hitch, and the vehicle then traveled only a short distance to where the victim collapsed.

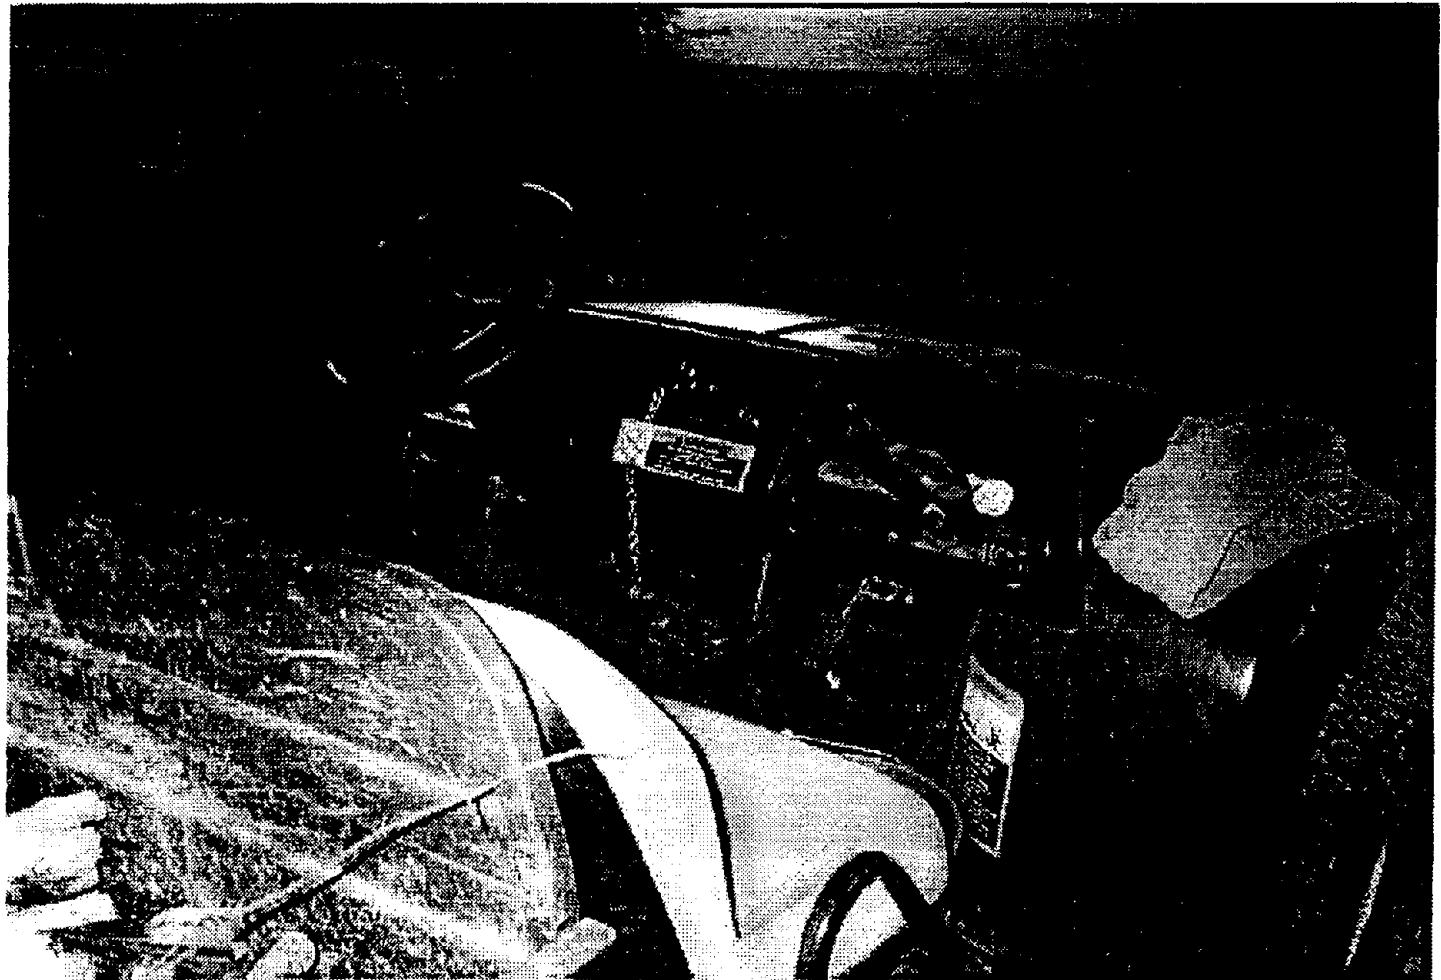
Figure 3: Manufacturer's warning sticker affixed to dash indicated that no one under 16 years of age should operate the vehicle.

operation. The employer started the vehicle, placing it in forward and then in reverse, with the hand-operated parking brake applied. The parking brake was functional and prevented the vehicle from moving in either direction with the accelerator fully depressed. The vehicle remained stationary when placed in forward or reverse without acceleration even if the parking brake and foot brake were not engaged. FACE Investigators noted that a manufacturer's warning sticker affixed to the dash indicated that no one under 16 years of age should drive the vehicle (Figure 3).

Discussion: A yellow and black warning label affixed to the dash of the utility vehicle (Figure 3) reads "Warning" "Young drivers increase chance of death. Young drivers may not be able to control vehicle. No drivers younger than 16 years old." This manufacturer's warning provided important safety information and should have been adhered to at all times.
