Painter/Sandblaster Dies Following a 30-foot Fall from Scaffolding Inside a Water Tank—South Carolina

FACE 9315

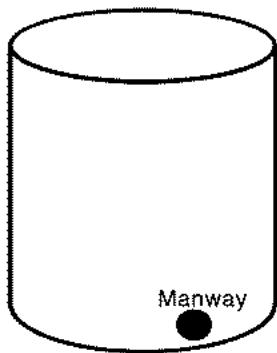
Figure. Exterior and Interior of Water Tank

Exterior of 40-foot-diameter by 40-foot-high water tank.

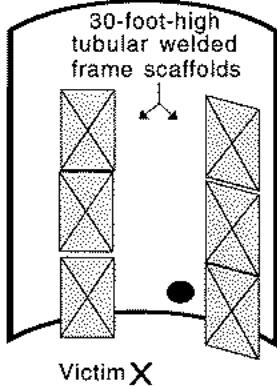
At the time of the incident, approximately 12:30 a.m., the victim and foreman were each working from one of the 30-foot-high tubular welded frame scaffolds, sandblasting the interior wall of the tank. A third crew member, the holewatch, whose duties were restricted to ground activities, procured supplies and helped the sandblasters move the scaffolds. At about 12:35 a.m., the holewatch noticed that the victim had shut off his blast hose. A few minutes later, the foreman descended from the scaffolding upon which he was working, and informed the holewatch he was ready to move his scaffolding. The foreman, after talking with the holewatch, wondered why the victim had stopped work and went looking for him. He found the victim, lying injured and conscious, but incoherent, on the deck of the tank ([Figure](#)). The EMS responded in less than 5 minutes to the call for assistance, administered first aid, and transported the victim 7 miles to the local hospital, where he died 8 days later on April 15, 1993.

Interior, including scaffolding arrangement and location of victim inside water tank.

Recommendation #1: Employers should ensure that fall protection equipment is provided and used by workers where the potential for a fall from an elevation exists.

Discussion: Employers should ensure by observation that fall protection equipment is being used. A lifeline for attaching a safety belt and lanyard was secured to the tanks' interior wall and was available during the incident; however, the victim apparently left the fall protection equipment he had been issued in the back of the daylight foreman's truck when he was driven to the worksite. The victim had approximately 20 years' experience in this occupation, and it was assumed he was aware of the need to wear fall protection equipment.
