SUBJECT: A laborer dies when struck by a packer panel in the hopper of a rear-loading trash truck.

SUMMARY
California FACE Report #04CA005

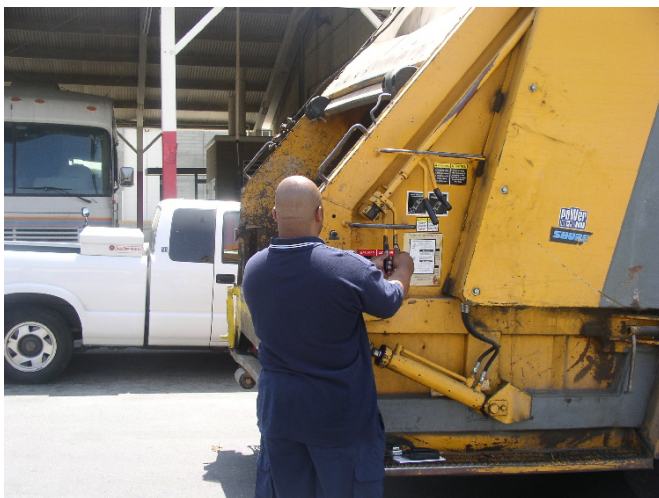
Exhibit 2. A simulation of an operator at the controls of the trash truck operating the packer panel.

backed into the alley because the space available to work was limited. The victim and co-worker picked up an old sofa and chair and placed them in the hopper of the trash truck. The co-worker then moved to the controls on the left side of the truck. He moved the controls to activate the packer panel within the hopper. As the packer panel cycle was in motion, the co-worker was at the controls looking down the side of the truck and checking out the flow of traffic. The co-worker looked back and he saw the victim reaching into the hopper. The co-worker yelled at him to get out of the way. The packer panel struck the victim before the co-worker was able to stop and reverse the process.

Discussion: The controls used to compact the trash on rear-loading trash trucks are positioned in a manner to give the operator a clear and unobstructed view of the compaction process. The operator should monitor the complete process in case he needs to stop the process during the cycle. In this case, the operator took his eyes off the process when he looked down the side of the truck to observe the traffic. When he looked back, the victim was reaching into the hopper and the packer panel struck the victim before the operator could stop the process. The purpose behind constant monitoring is to be able to stop the compaction immediately if there is a need. Trash collectors should be trained in specific safe work procedures pertaining to all aspects of their work. Employers should conduct scheduled retraining with employees who are involved in high-hazard operations. This retraining could include random/surprise monitoring as well as regularly scheduled training. Safe work practices can be enhanced through programs of task-specific training and periodic retraining, supervision, rewards, and progressive disciplinary measures.

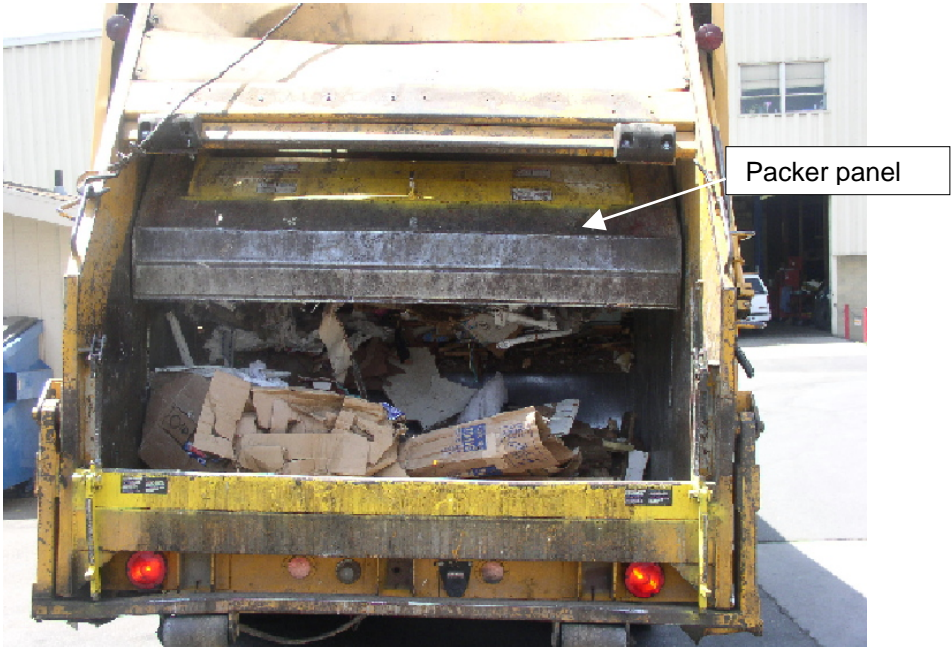
Exhibit #3. A picture of a rear loading trash truck, similar to the one involved in the incident, with the packer panel at the beginning of its cycle.

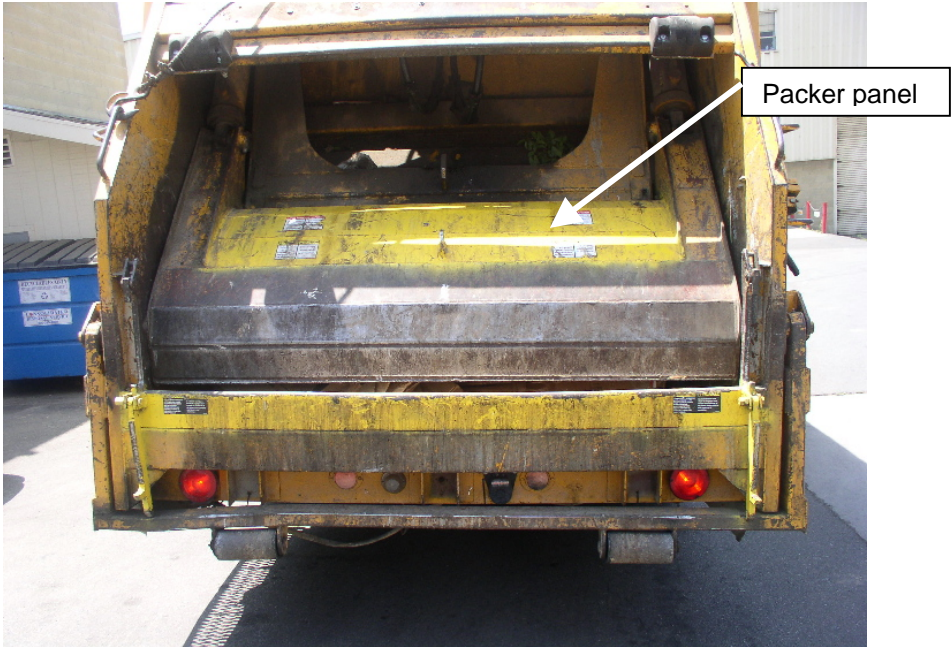
Exhibit #4. A picture of a rear loading trash truck, similar to the one involved in the incident, with the packer panel in the position when it struck the victim who was reaching into the hopper.

Recommendation #1: Ensure employees do not reach into the hopper of trash trucks when they are cycling.

Discussion: Employers are usually protected from hazards through engineering controls or administrative programs after they have been identified. Job safety analysis (JSA) is an administrative process used to review methods or steps for a particular task in order to identify potential safety hazards. The task can be broken down to a sequence of steps or actions, which are used to identify hazards connected to the task or produced by the environment. Once the hazards are known, the proper solutions can be developed to eliminate or control hazards. In this case, a job safety analysis may have identified the hazard of removing objects from the truck while the packer panel was partially raised or while it was being lowered.
