SUBJECT: Two heavy equipment mechanics electrocuted while working on a large earth moving piece of construction equipment called a scraper.

California FACE Report #04CA004

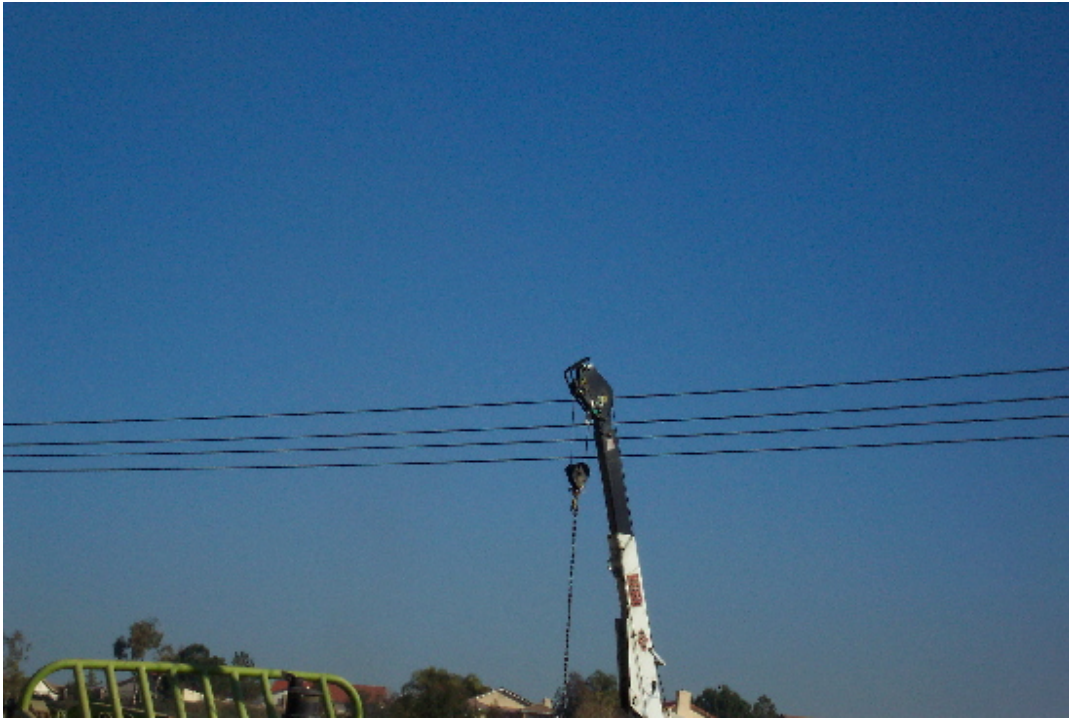
electrical cable. The 18-year-old victim was working the crane controls from inside the scraper apron, and the 40-year-old victim was on the bottom of the scraper where the dirt is first picked up. After installing the new rear differential in the scraper using the crane, the boom was being moved out of the way. It made contact with the overhead electrical line, sending electrical current down the boom, through the truck, into the boom control attached to the truck, and into the 18-year-old victim who was holding the control while inside the scraper apron. The chain attached to the hook of the crane cleared the scraper, so it was not an electrical path. The electrical current went into the scraper and into the 40-year-old victim who was also in contact with the scraper. Both victims were electrocuted and set on fire.

Exhibit 2. A picture of the incident scene with the crane boom still in contact with the high voltage electric lines.

Discussion: Employers should conduct initial jobsite surveys to identify potential worker hazards. Once potential hazards have been identified, appropriate control measures can be implemented prior to the start of any work. Control measures in this incident could have included positioning the truck-mounted crane so the crane boom would not come within ten feet of the power line, or posting an observer to ensure the crane operator did not move the boom within ten feet of the power line. Other control measures could have included contacting the power company and having them de-energize the power line, or insulating ("sleeving") the power line phases with line hoses, or moving the scraper from underneath the power line.

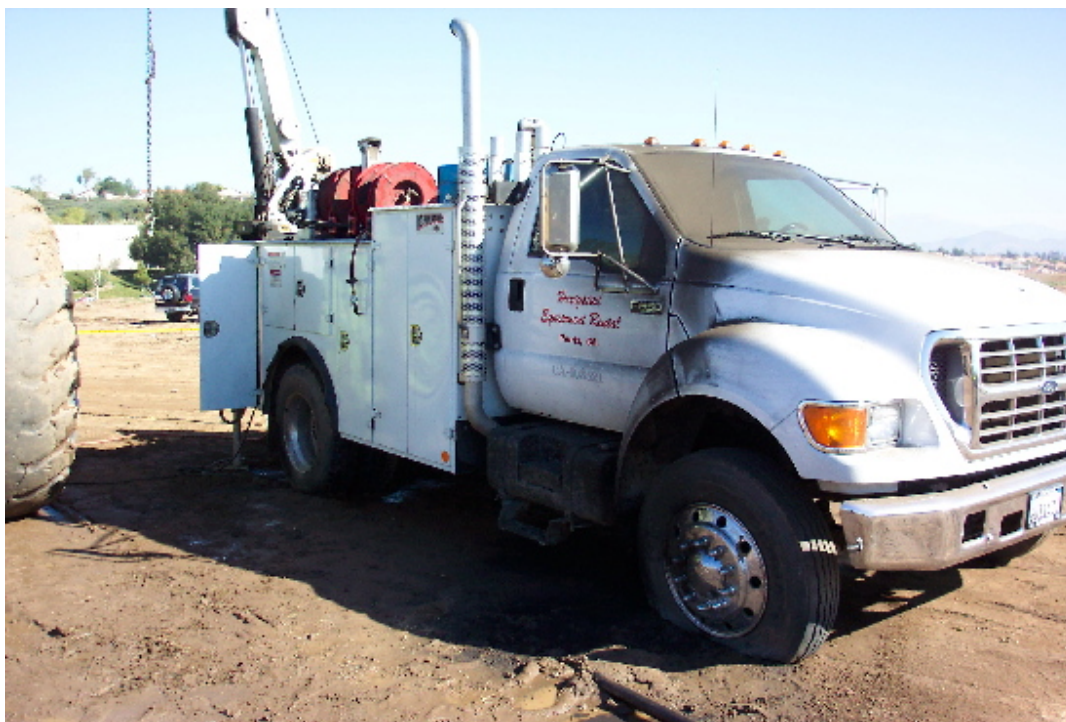
Discussion: The remote control system used on the truck-mounted crane was electrically connected to the crane. This system provided the "path to ground" which resulted in two fatalities. A remote control system which is electrically isolated from the crane would provide protection to a crane operator if contact with an energized overhead power line occurred. Electrical isolation could be accomplished by radio controls, fuse equipped control lines, fiber optic controls, insulated control boxes, etc. Manufacturers of crane systems should evaluate these options and incorporate an electrically isolated remote control system into the design of newly manufactured truck-mounted cranes. Manufacturers and their customers should cooperate in an effort to retrofit existing truck-mounted cranes with these systems, as well.

Exhibit 3. The victims' truck with the boom that made contact with the high voltage lines.
