**SUBJECT:** A laborer died when crushed between the forks and the cab of a trash truck.

**SUMMARY**  
**California FACE Report #03CA002**

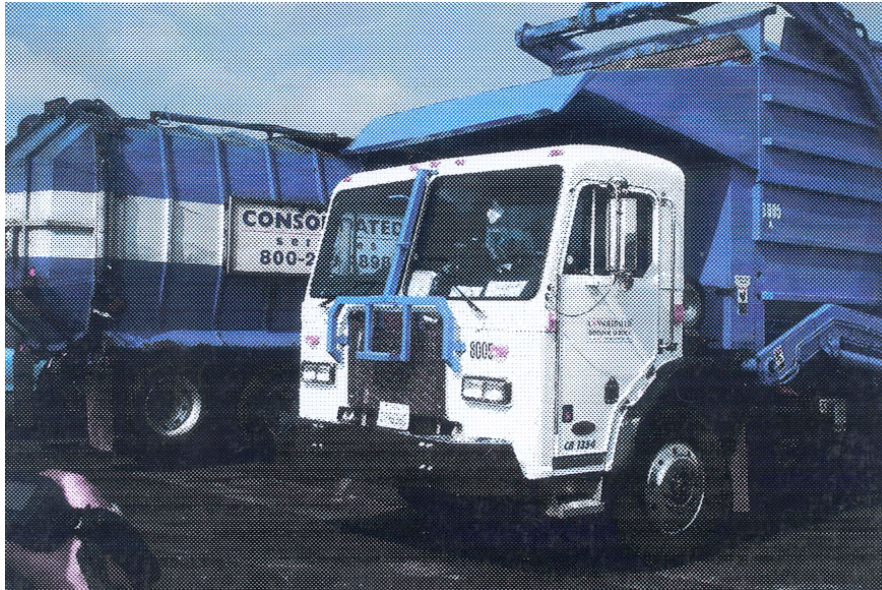
Exhibit #1

Picture of the trash truck involved in the incident.

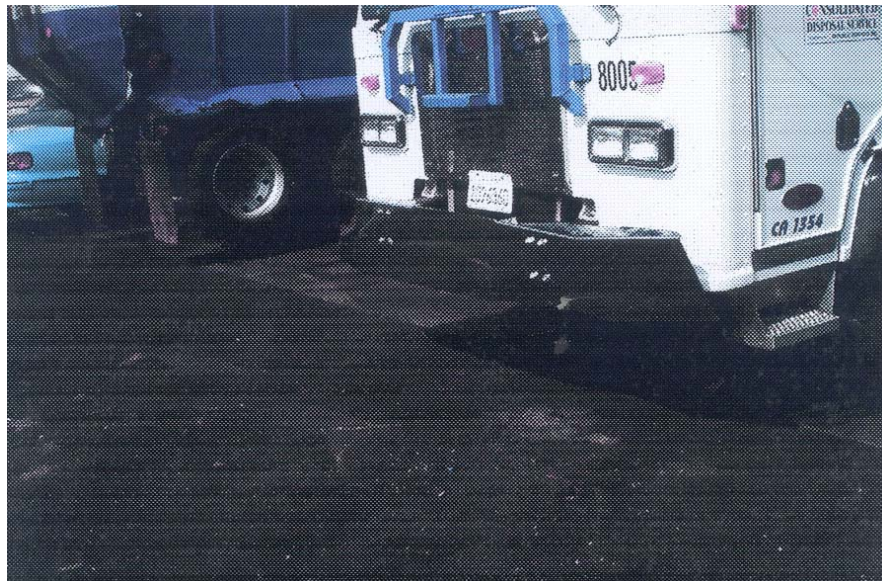
Exhibit #2

Picture of the front of the trash truck where the victim was crushed.

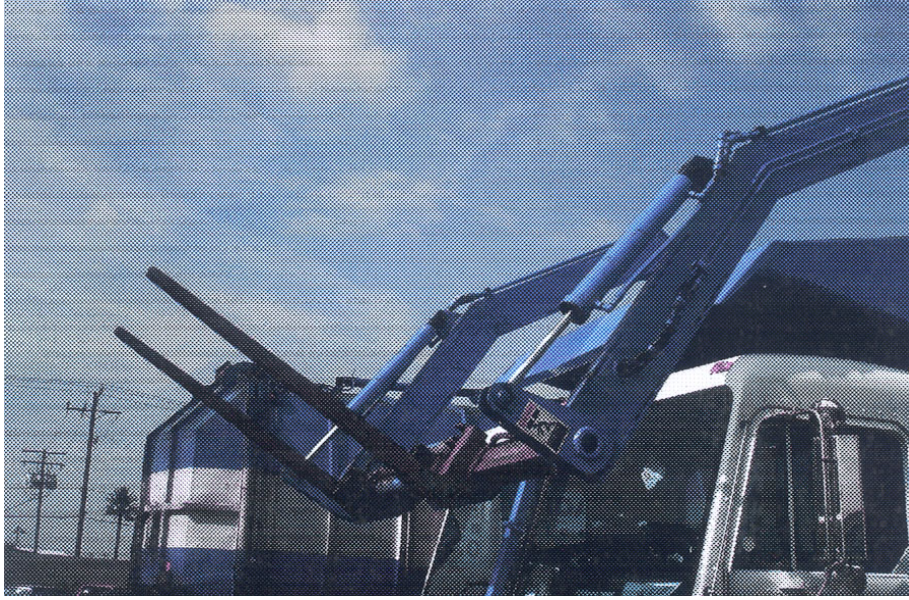
Exhibit #3

Picture of the hydraulic forks being lowered in front of the cab.

Discussion: An operator of this particular type of trash truck has a clear view of the front forks while seated in the driver's seat, but the view is obstructed when using the side controls. The operator must physically check the area in front of the trash truck, to ensure it is clear immediately before using the side controls. In this case, the operator was momentarily distracted when he took time to clear out some loose trash that had fallen on the truck exhaust system. During that time period the conditions changed when the victim entered the area in front of the trash truck below the raised forks.

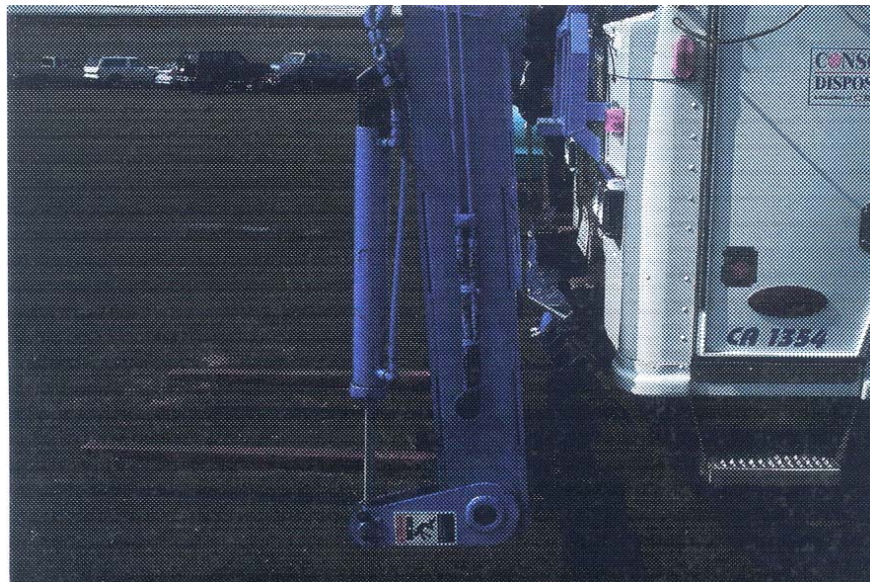
Exhibit #4

Picture of the forks lowered in front of the cab showing the space where the victim was crushed.

Discussion: When operating the controls on the driver's side of the equipment, the operator does not have a clear and unobstructed view of the front of the trash truck. A convex mirror mounted on the cab or bumper could provide the necessary view for the operator. These mirrors could supplement, not replace, visual inspection of the front of the trash truck, and possibly could help eliminate any future incidents of this type.
