**SUBJECT:** A machine operator died when crushed in an automatic feed system of a cardboard box waxing machine.

**SUMMARY**  
**California FACE Report #03CA001**

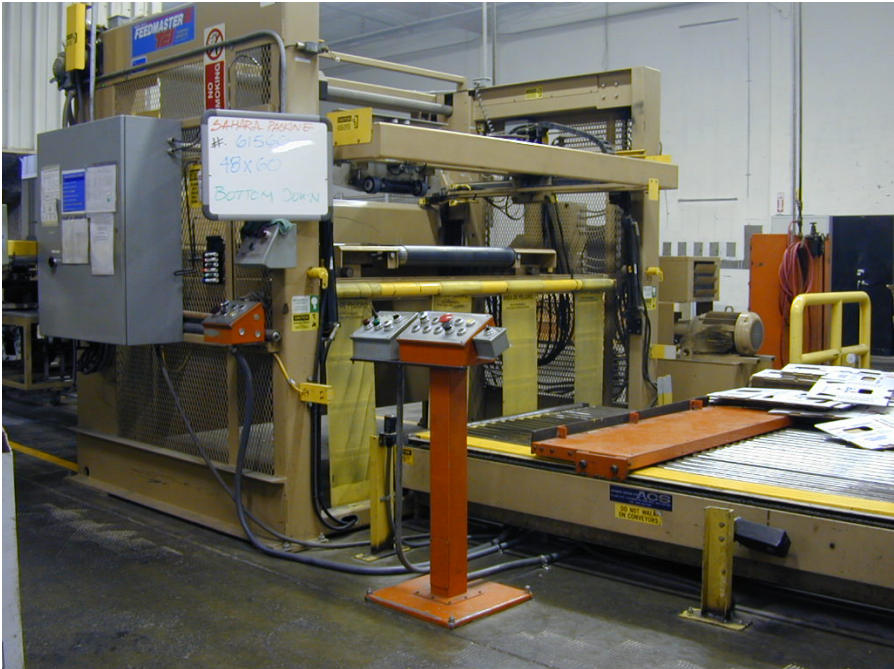
03CA001  
Exhibit #1

A picture of the automatic feed system for waxing cardboard boxes.

The employer at the site of the incident was a manufacturer and distributor of cardboard boxes for industrial and commercial use. The machine involved in this incident was an automatic feed system that guided boxes into a waxing machine (**exhibit #1**). Boxes were waxed to increase their strength capacity. Cardboard boxes were brought to the machine by automated conveyor rollers (**exhibit #2**). The boxes were then pushed onto a feed table (**exhibit #3**) that took the boxes and centered them under the feed system. The feed table would then rise until the boxes were pressed against the rollers of the feed system (**exhibit #4**). As the rollers of the feed system would shuffle the boxes onto the waxing conveyor, the feed table continued to rise to keep pressure on the rollers until all the boxes were gone. All actions of the system were controlled by electronic eye sensors.

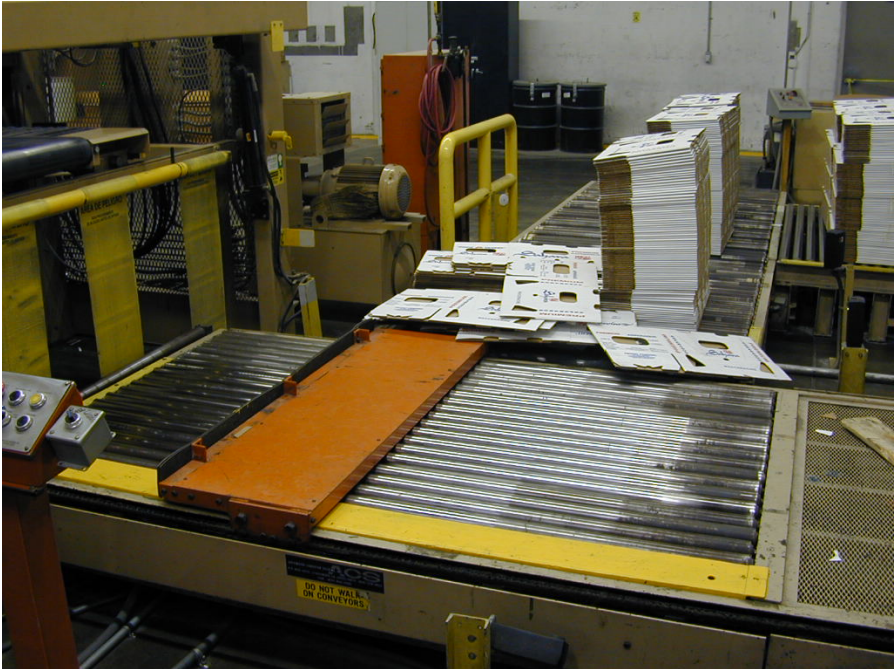
03CA001  
Exhibit #2

A picture of the automated roller conveyor system that brings the boxes to the table that feeds the boxes into the waxing system.

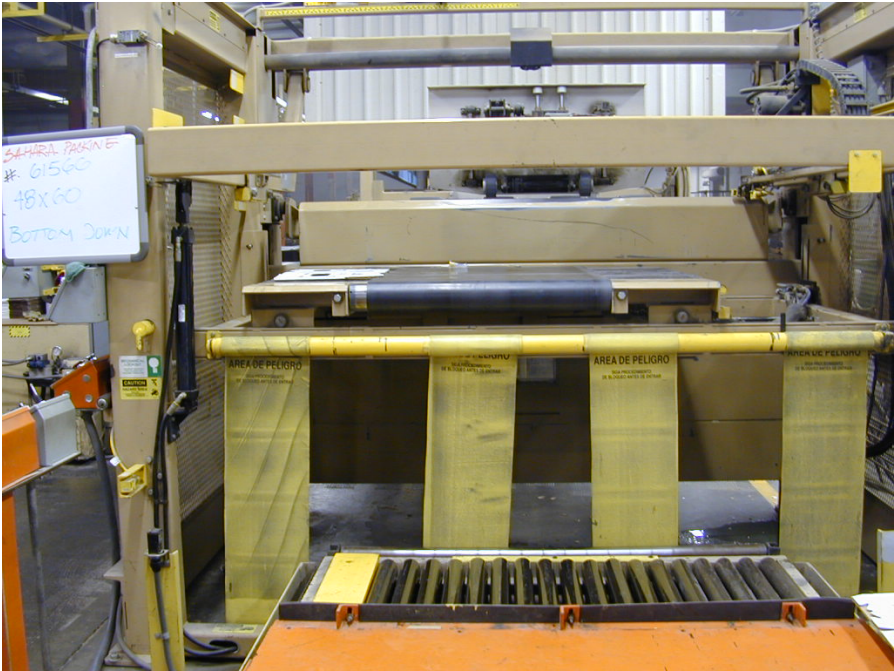
03CA001  
Exhibit #3

A picture of the feed table that moves up and down, and left and right, to center the boxes over the feed rollers.

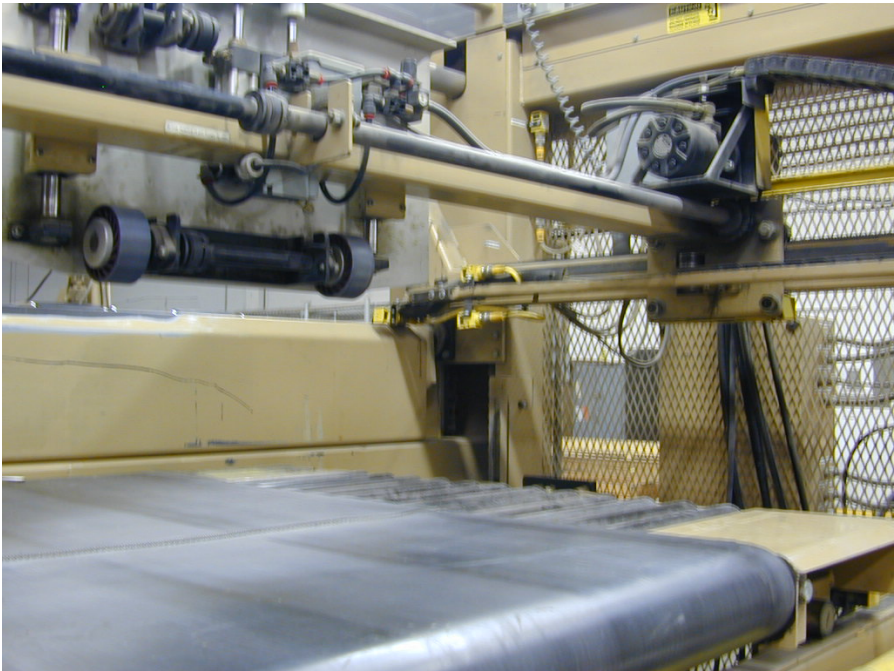
03CA001  
Exhibit #4

A picture of the rollers of the feed system that shuffles each box into the waxing system.

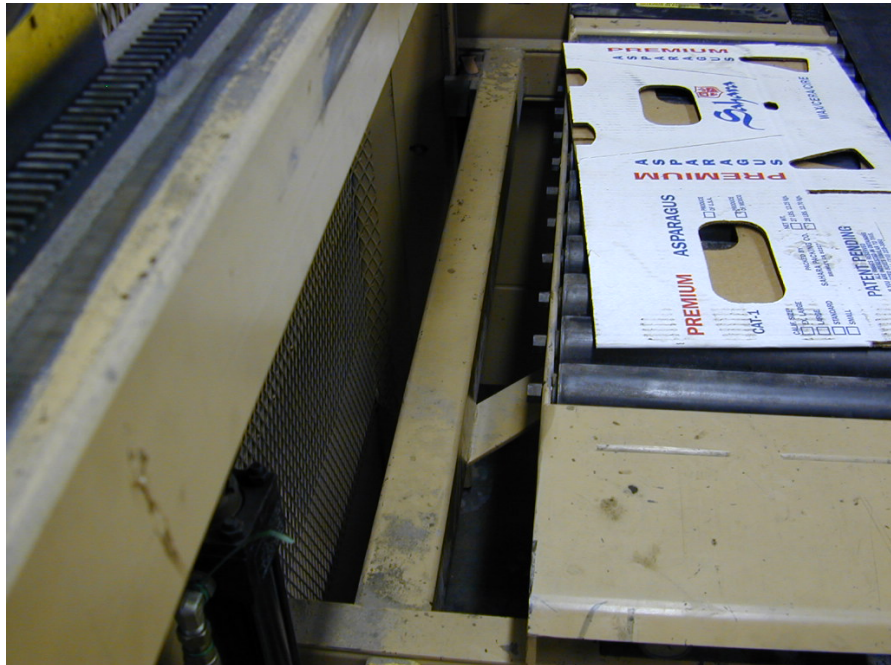
03CA001  
Exhibit #6

A view of the left side of the feed table looking down at the area where the victim was caught.
