A Hispanic Female Laborer Was Run Over By A Forklift That Was Moving A Trash Bin In A Waste Transfer and Recycling Station

SUMMARY

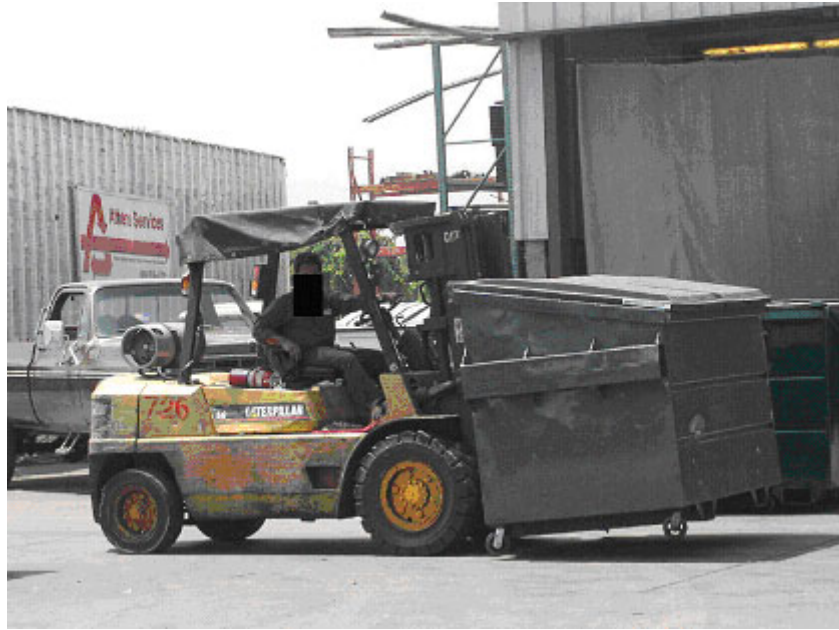
Exhibit 1. Picture of a forklift transporting a trash bin similar to the one involved in this incident.

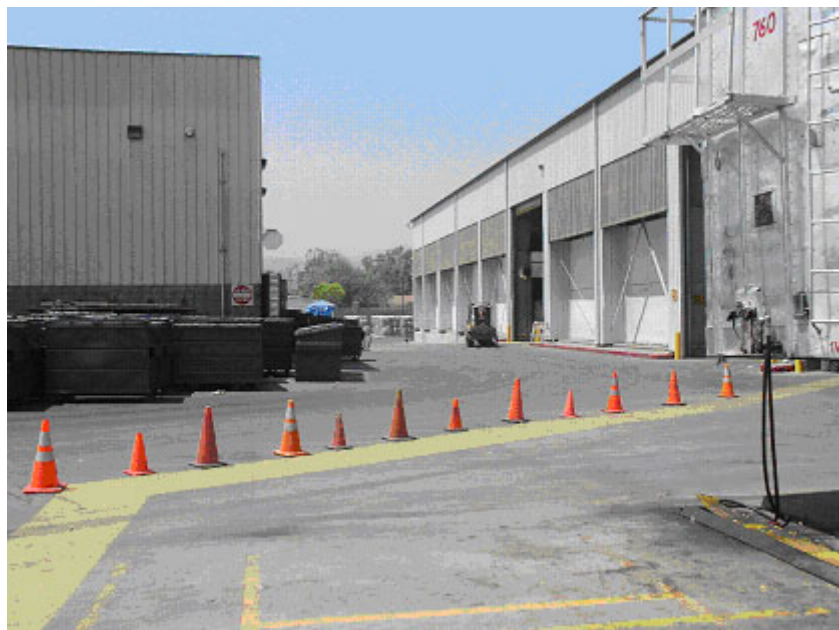
The site of the incident was a transfer and recycling facility for trash and waste. The facility consisted of two large buildings with a driveway in between them and a marked walkway on the driveway (**exhibits 2 & 4**). The first building faced north and had soundproof walls. It was used to sort and transfer waste product from conveyor belts to container trucks and bins. This was the building where the majority of employees worked. A second building faced west and was located to the rear and east of the first building. This building was used to facilitate the repair of the trash and recyclable containers. The break room was located adjacent to the west side of the second building and the restrooms were located in the center of the first building. Yellow striping on the pavement designated a walkway for employees to follow when going to the restroom or break area. The walkway followed the perimeter of the first building, and then crossed over at the break area. On the day of the incident, the victim was walking from the restroom to the break area. Instead of following the designated walkway, she cut across the driveway.

Exhibit 2. A view of the incident scene standing at the restroom door looking south.

Recommendation #3: Ensure employees, when walking to and from different work locations, only walk only in designated areas.

Discussion: Pedestrian traffic in the workplace where forklifts and other equipment are being operated can create a hazardous condition. Even though areas may be marked as restricted for pedestrian traffic, unless corrective action is taken when violations occur, the unwanted behavior will continue. Use of safe practices can be ensured through supervision, training, rewards, and progressive disciplinary measures.

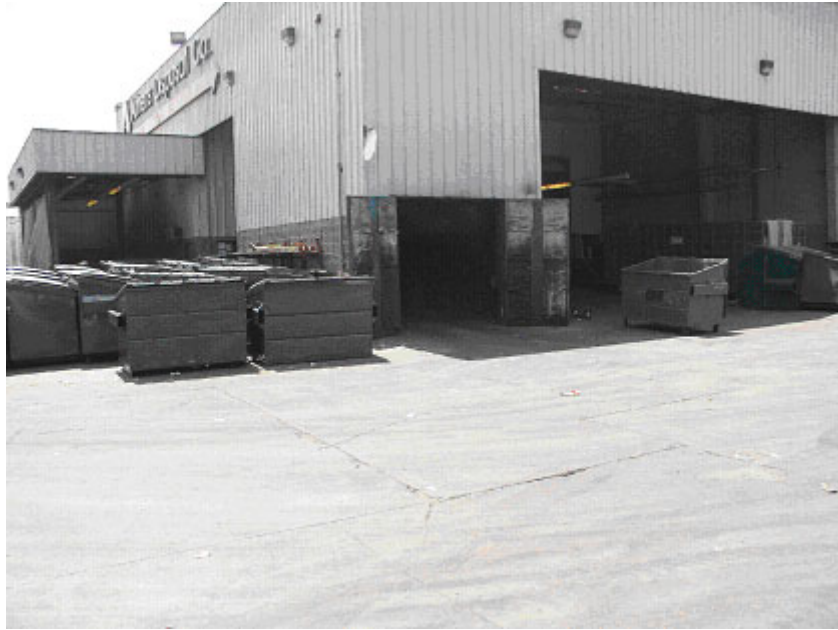
The forklift operator was transferring a container from the yard to the repair shop located in the second building. His normal path for this activity was hindered by a large piece of machinery stored next to the north side of the second building, so he had to swing out wide and go around this barrier. As he came around the stored piece of machinery, he was traveling in a forward direction with his view obstructed by the trash bin on the forks. A witness stated that as he was walking from the break room to the men's room, he saw the forklift making a wide turn traveling forward with a large trash bin on the forks. The victim was walking in the roadway facing away from the approaching forklift. As the forklift approached the victim, the middle of the trash bin on the forks hit the victim in the back and she fell to the ground. The forklift operator kept on going forward, pinning the victim under the trash bin.

Exhibit 3. A view of the incident scene looking east. The incident occurred in the middle of the roadway.

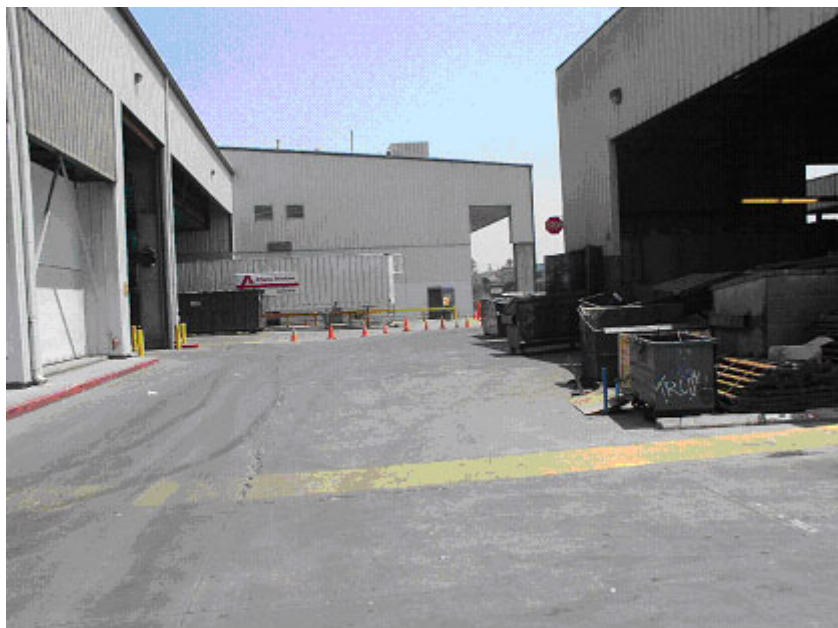
Exhibit 4. A view of the incident scene standing at the break room looking north.
