A Truck Driver Died When He Fell Off Of and Was Run Over by the Backhoe He Was Riding On

SUMMARY

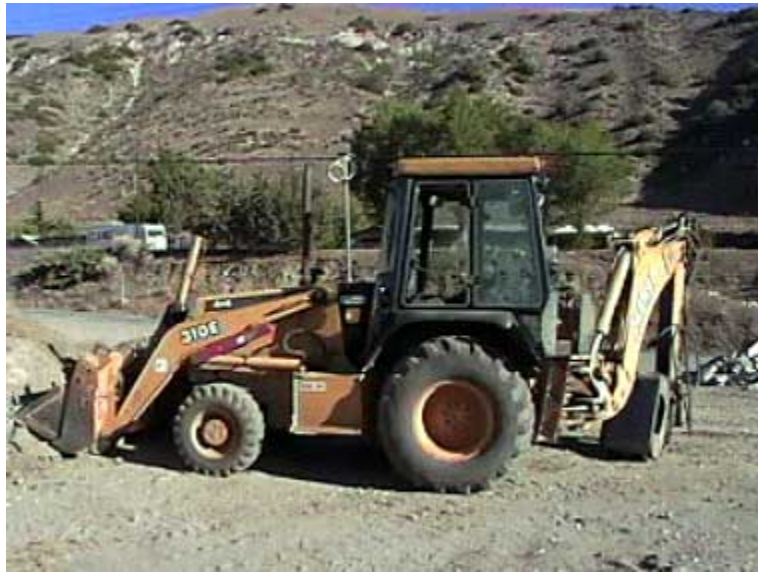
Exhibit #1
View of the backhoe involved in the incident

Recommendation #1: Develop, implement and enforce a policy that clearly states no riders are allowed on backhoes.

Recommendation #2: Install safety-warning labels on backhoes that clearly state that riders are prohibited.

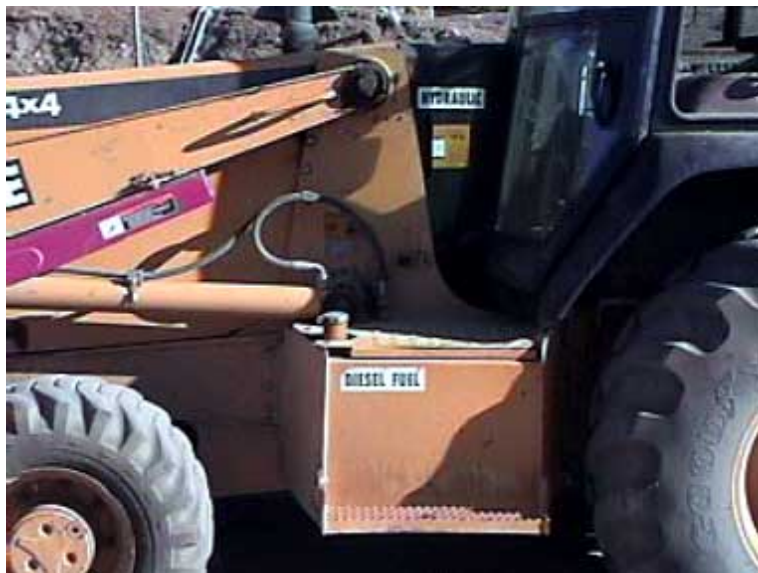
Discussion: Backhoes are designed for one operator with one set of controls and do not have passenger seats. The step and handrail that the victim used to hitch a ride on the backhoe was designed for the operator to enter and exit the tractor and not intended for riders. Operators of backhoes need to not only demonstrate their ability to operate the controls and movement of the

Exhibit #2
Close-up view of the step and handrail used by the victim.

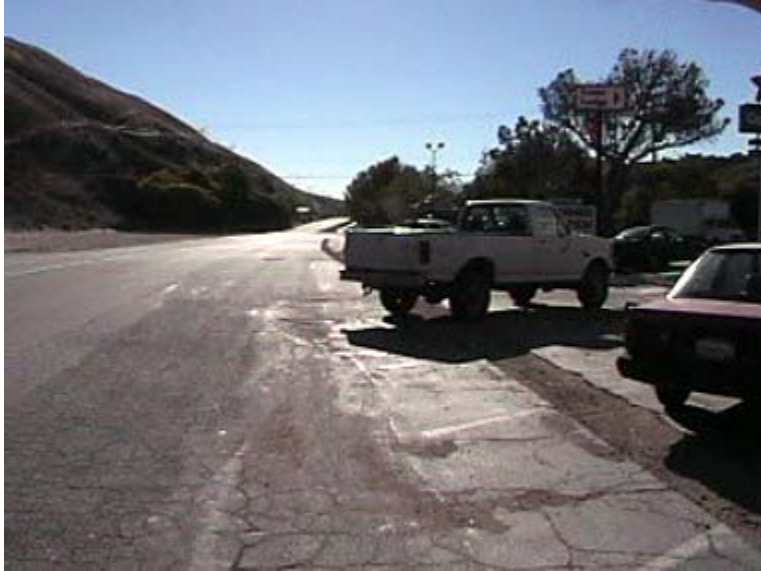
Exhibit #3
View of the incident scene looking south.

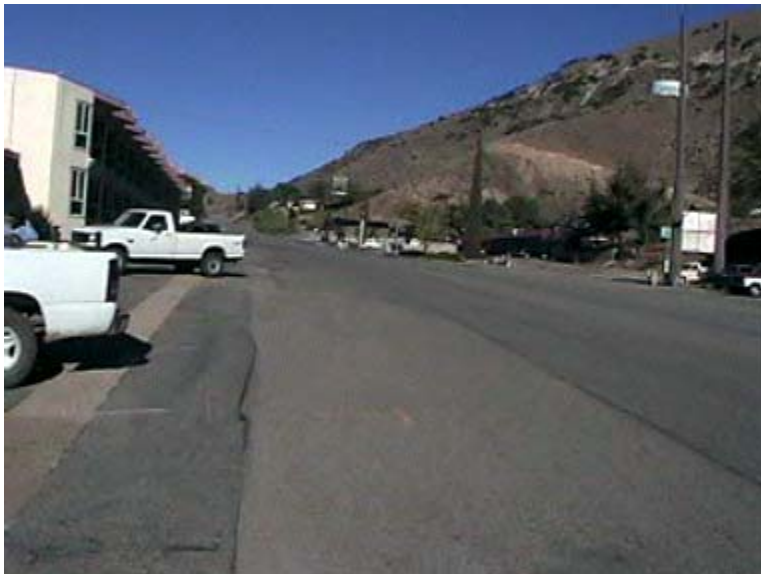
Exhibit #4
View of the incident scene looking north.
