## **A Construction Carpenter was Killed When Struck by the Bucket of a Backhoe**

### **SUMMARY**

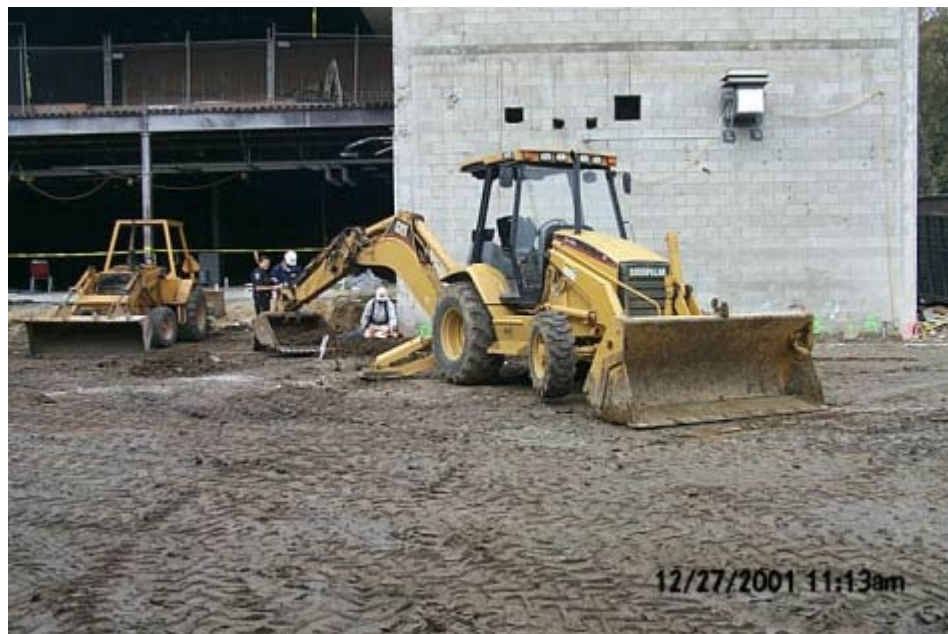
Exhibit #1. View of the incident scene showing the backhoe and the work area involved.

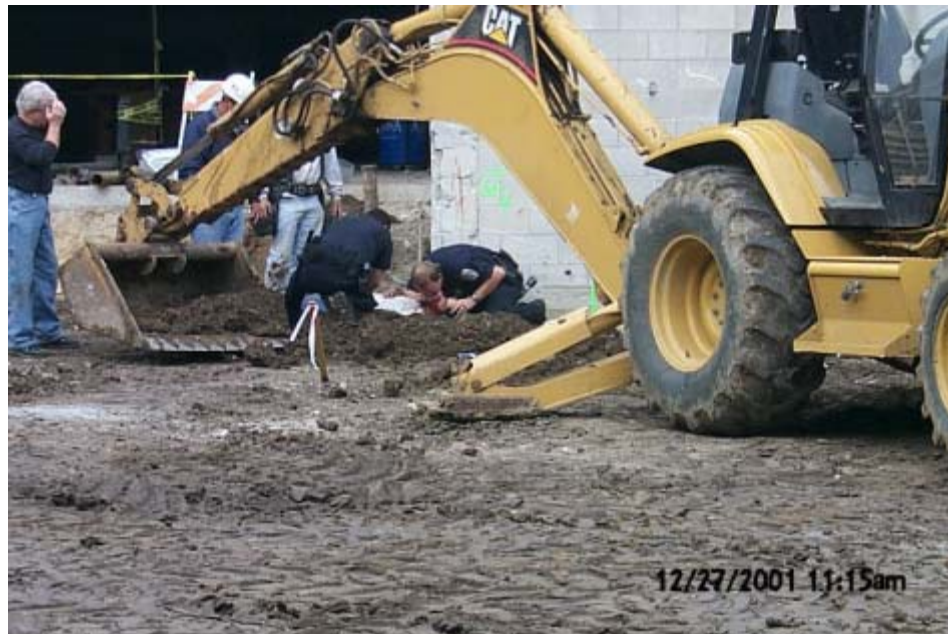
**Exhibit #2. A closer view of the backhoe bucket and paramedics performing CPR on the victim before transporting to the hospital.**

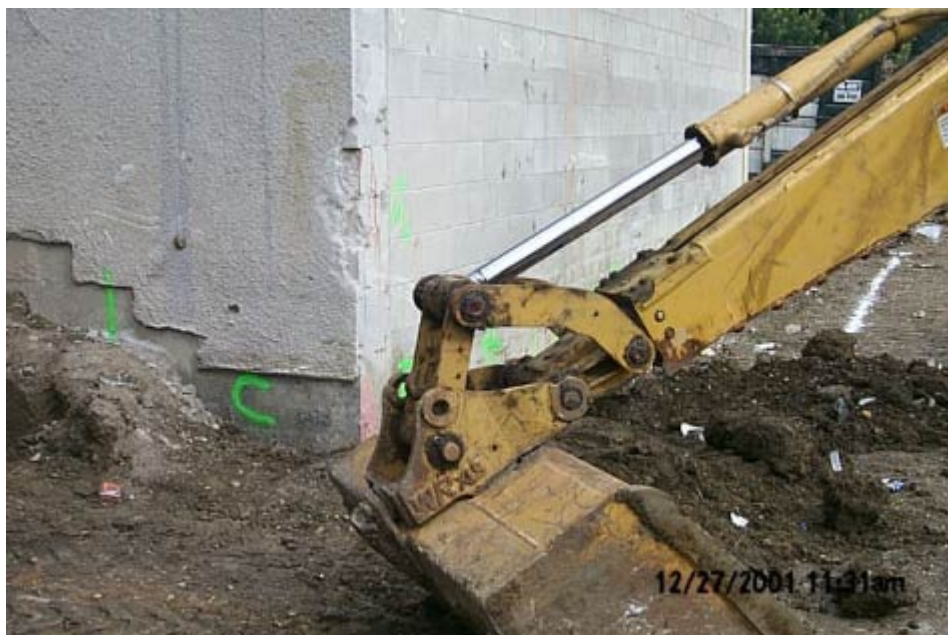
**Exhibit #3. A view of the backhoe bucket and the wall with marking used for grading.**
