**A Heavy Equipment Spotter Died When He Was Backed Over by a Front-end Loader
Inside a Trash Collection Transfer Station**

SUMMARY

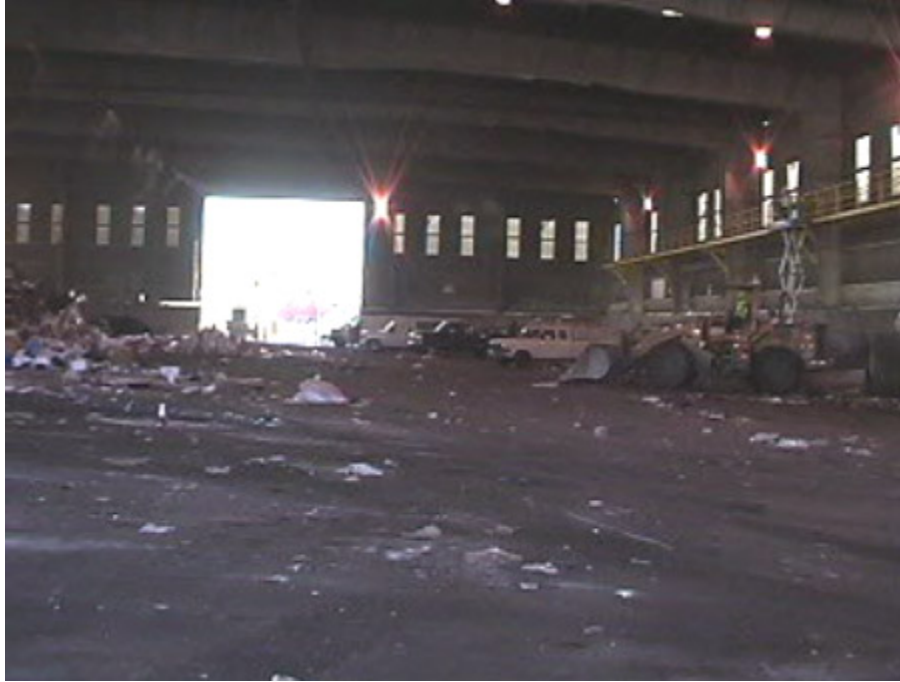
Exhibit #1. View from inside the transfer station looking at the east entrance.

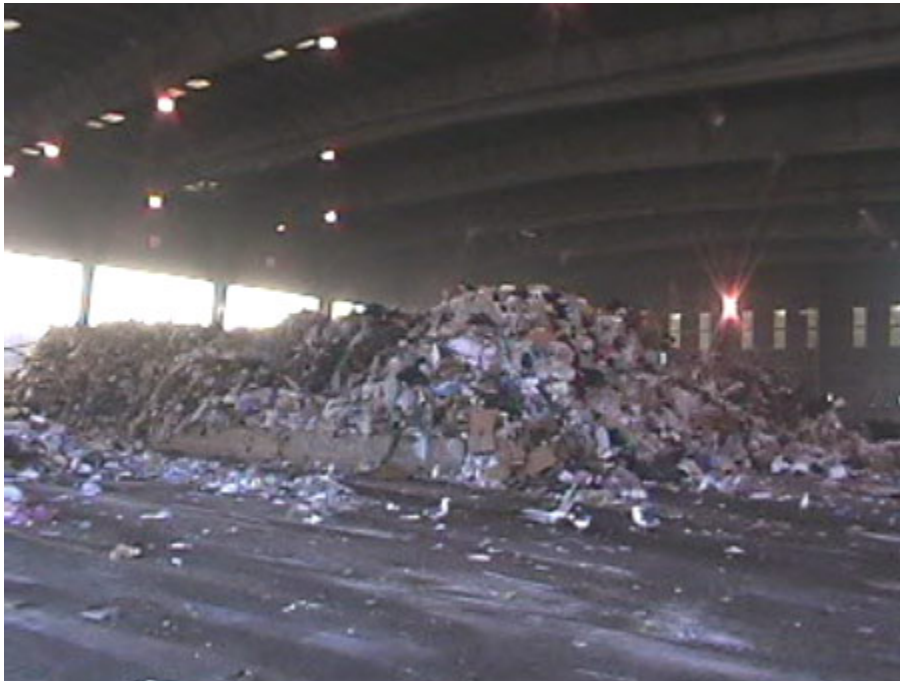
Exhibit #2. View from inside transfer station looking north at dumped waste in a designated bin.

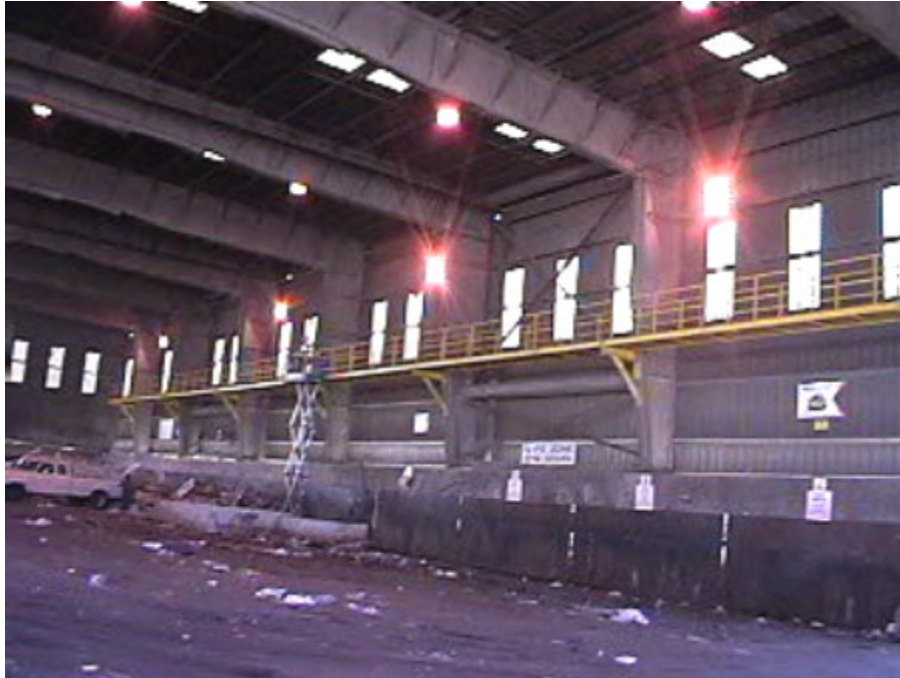
Exhibit #3. View from inside the transfer station looking at the south wall where trucks park to clean out.

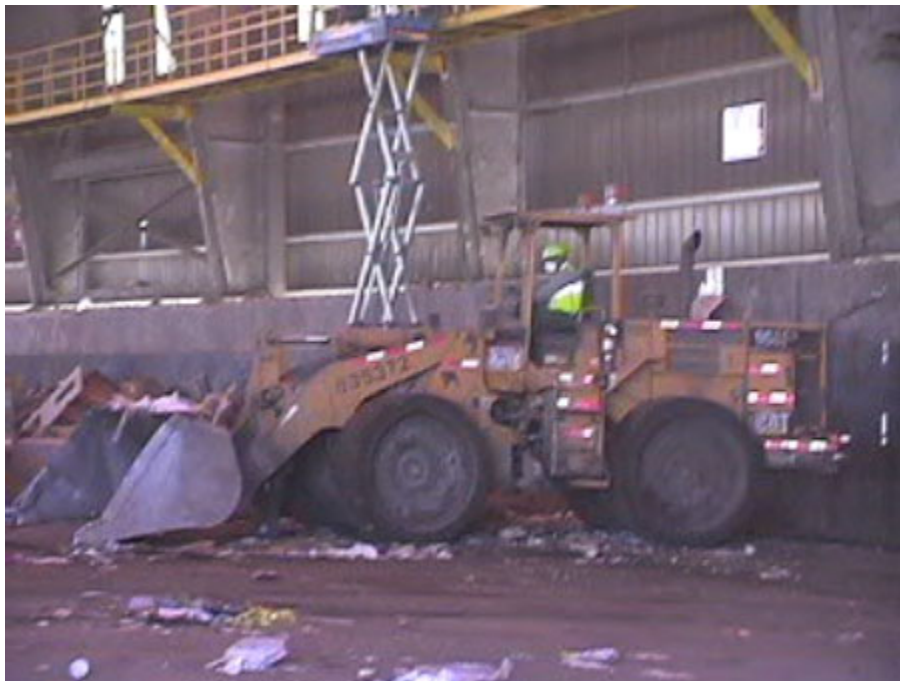
Exhibit #4. View of the left side of the front-end loader involved in the incident.

Recommendation #3: Consider using additional safety devices for heavy equipment to warn workers of a backing vehicle and to warn drivers when someone is in their blind spot.

Discussion: Being exposed on a daily basis to the noise and warning devices of backing equipment can desensitize individuals to the presence of such vehicles. Other devices such as a strobe light or different noises should be considered as additions to the standard back-up alarm to warn workers of a backing vehicle. There are also devices available that can detect the presence

of persons in the blind spots of vehicles and provide a warning to the operator. These additions should be considered especially when the standard practice has failed.

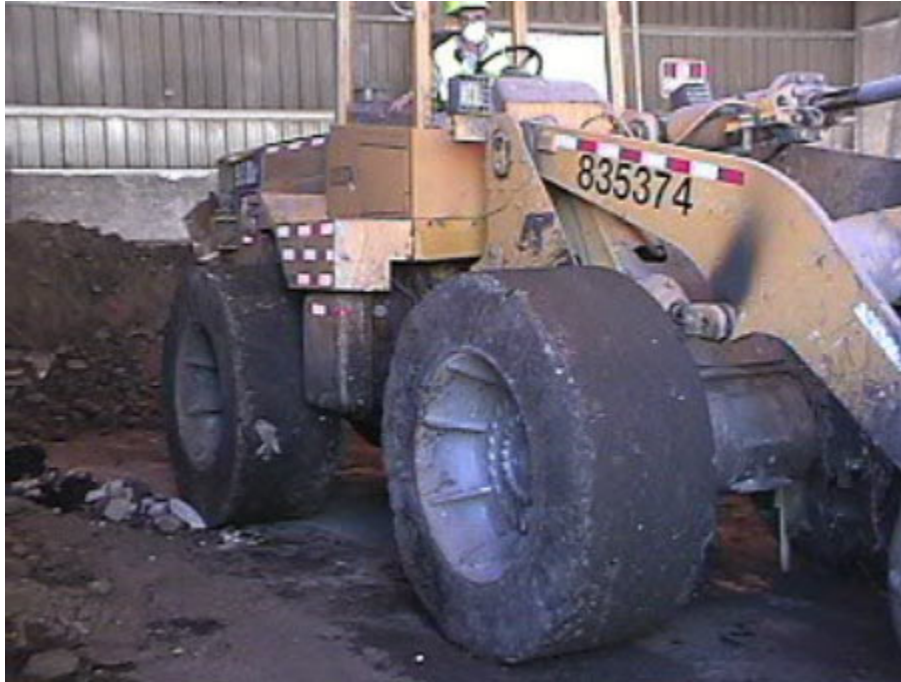
Exhibit #5. View of the right side of the front-end loader involved in the incident.

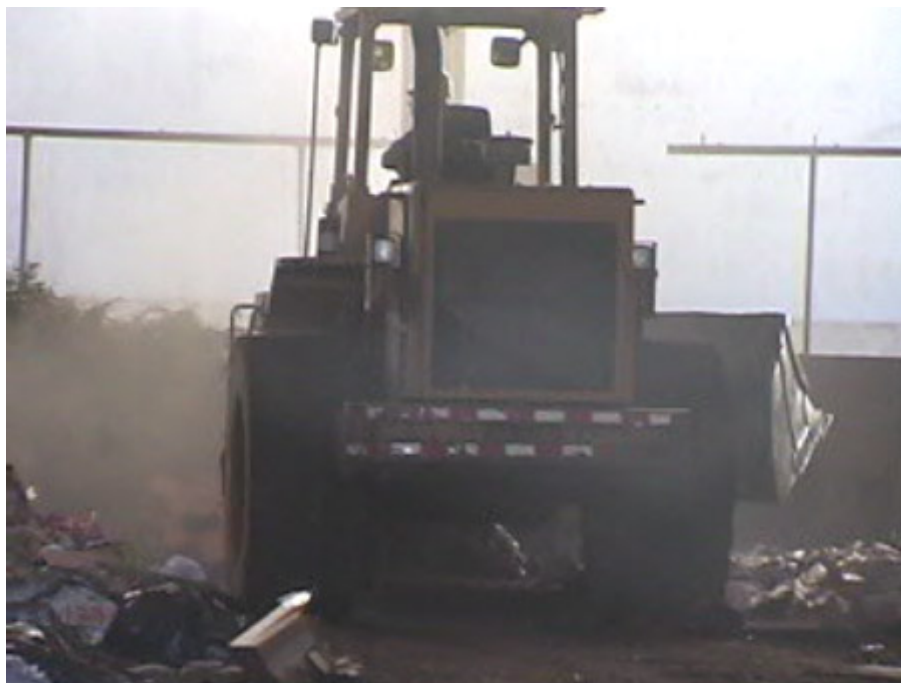
Exhibit #6. View of the front-end loader involved in the incident pushing waste.
