# Fatality Investigation Report

OR FACE 2003-16-01

## Load of lumber shifts and falls on construction worker killing him

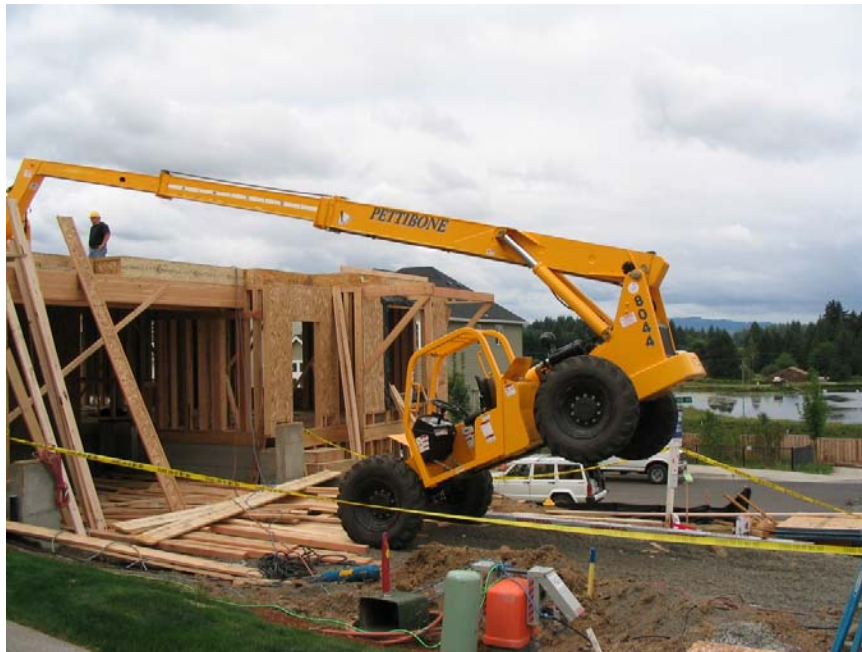
**Photo 1.** Forklift in position after the load came down. Note board pile in front of the forklift, preventing the forklift from getting closer to the second story.

Once proper reach and height have been determined either by load charts, the forklift should be placed as close to the building as possible to transfer the load.

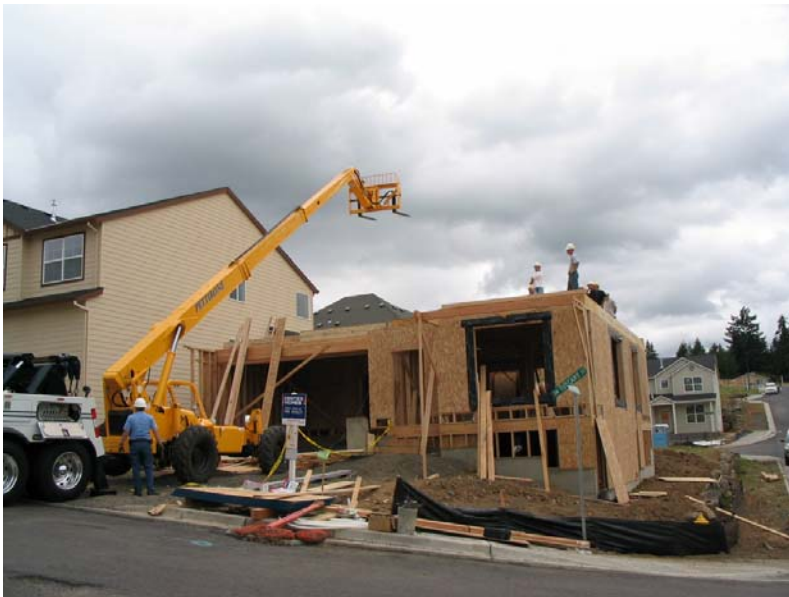
**Photo 2.**

Photo 2 demonstrates the vertical height above the second floor, crane extension and equipment placement from home. This photo was taken immediately after the forklift had its load removed and its rear tires were lowered onto the ground. This is similar to the position that it would have been in, before the forklift was upended. The load being lifted was estimated to weigh approximately 3600-3800 lbs. The maximum load for the forklift with the boom fully extended at this arc was 2000-3000 lbs.

Rough terrain forklift in approximately the position it would have been in just before coming down. Traverse boom is in the position it was in, when sitting on the roof (boom extension unchanged). Note height of lift from ground (~22-24 ft). The equipment has not been moved out of position.

Guidance obtained from a local forklift safety expert suggests that a significant proportion of forklift up-endings occur when operators attempt to obtain maximum reach, by first achieving maximum height. When the load is lowered, however, the center of gravity moves far out in front of the machine causing it to up-end. Loading is a function of lift angle (height), the weight of the load and the reach of the forklift. After achieving design maximum reach/height the reach of the rough terrain forklift is reduced as height is increased (see attached load chart in appendix). This means the farther the boom is extended the less high it can be lifted. Static load testing should be done away from workers, on flat ground. Never attempt to move any forklift under load with its boom extended up or out.

Consult the lift specifications tables in the equipment handbook and determine lifting design parameters. Load charts on this rough terrain forklift can be easily accessed. For example, many manufacturers' post links to their web sites: e.g., <http://saesections.org/cis/links.html>, (under OEMs/Pettibone LLC).

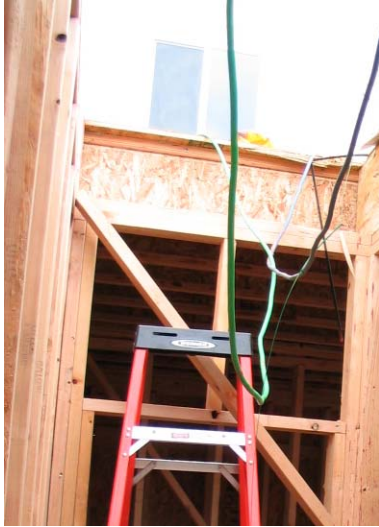
Discussion: The victim was reportedly about to access the floor of a residence under construction. The ladder being used to access the second level of the home was an 8 ft fiberglass stepladder and did not extend onto the second floor. To access the construction area, workers would have had to stand on the top of the ladder and pull themselves up onto the working level, while stepping from the ladder to a point on the frame above the door and finally up to the second floors deck. Employers should provide ladders that extend beyond the floor or deck being accessed and ladders should be tied off to provide stability while workers are actively using them.

**Photo 3.** Workers at this site were using the top step of the stepladder to step from the ladder onto the door header (actually the landing for future stairs) and then finally onto the second floor. The victim was standing on this ladder attempting to access the second floor when the load shifted and fell, striking him. Use ladder that extends above the surface to provide additional stability. It's not uncommon to find construction workers carrying tools, equipment or wearing cumbersome tool belts that only serve to decrease their ability to maintain balance and prevent falls.

- ✓ **Use ladders that extend beyond the surface being accessed. Ladders should be tied off to increase stability when in use.**

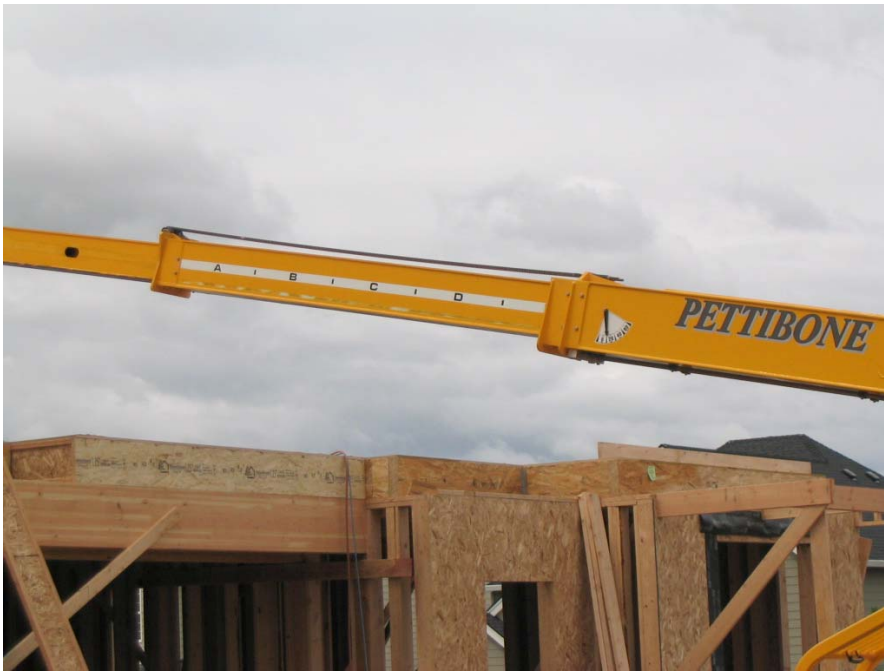
**Photo 4.** In upended position, the boom is extended between "D" and "E" load rating. Weight of load was calculated to be 3600-3800 lbs. extended ~24ft. The maximum load range at this reach and arc is 2000-3000 lbs.

- ✓ **Stay within the safe working parameters of the crane or lift and do not exceed the recommended load or reach specifications. Ensure that all mobile equipment operators are trained or certified in the operation of the equipment prior to use.**

Discussion: Only employer-designated qualified employees should operate equipment. The operator should be very familiar with the equipment's design specifications and limitations so that the equipment's safe operating parameters are not exceeded. Operators must follow the manufacturer's recommendations regarding loading, reach and height. Forklift operators should receive operational and safety training before using the equipment. Training records should be maintained.
