# Temporary Worker Killed when Caught in Machinery at a Bottling Plant in Washington State

## FATALITY INVESTIGATION REPORT

Investigation: # 00WA012  
SHARP Report: # 52-12-2004

Release Date: December 27, 2004

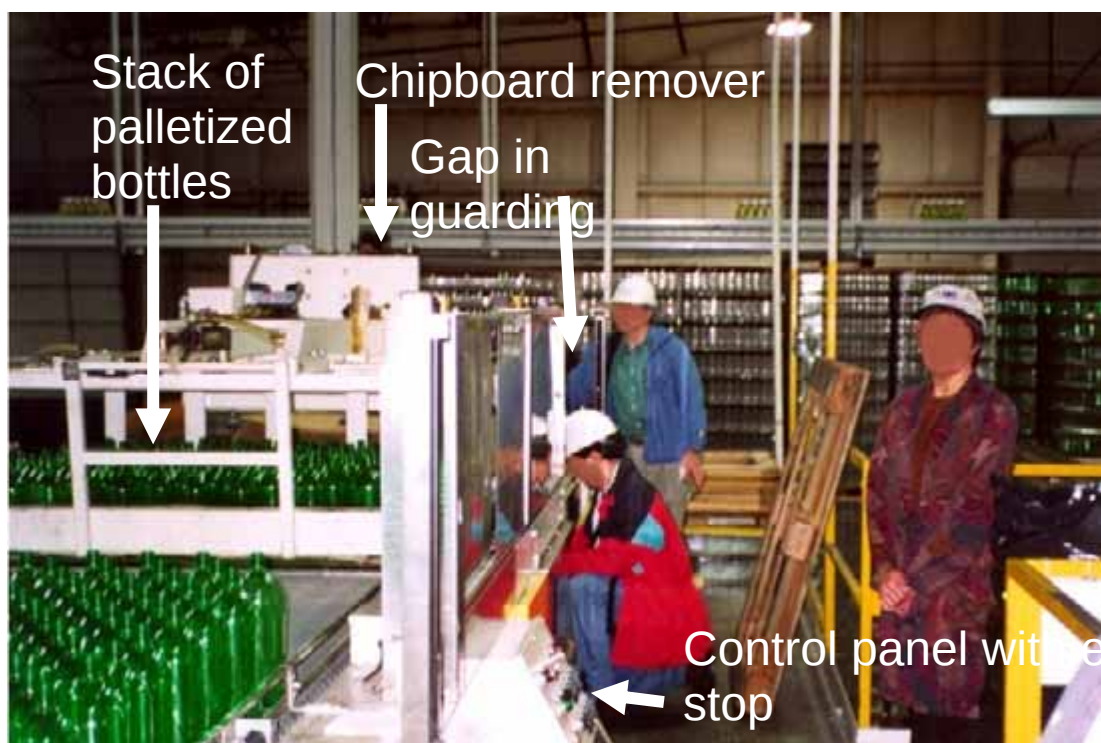
Photo 1 View of depalletizer from operator's platform.

The depalletizer is an automated machine that transfers empty containers (bottles and cans) from stacked pallets to single-file on the processing line (see Figures 1, 2, and Photo 1). Pallets are brought by forklift from the bottling plant’s container storage area and set into the initial feed mechanism of the depalletizer.

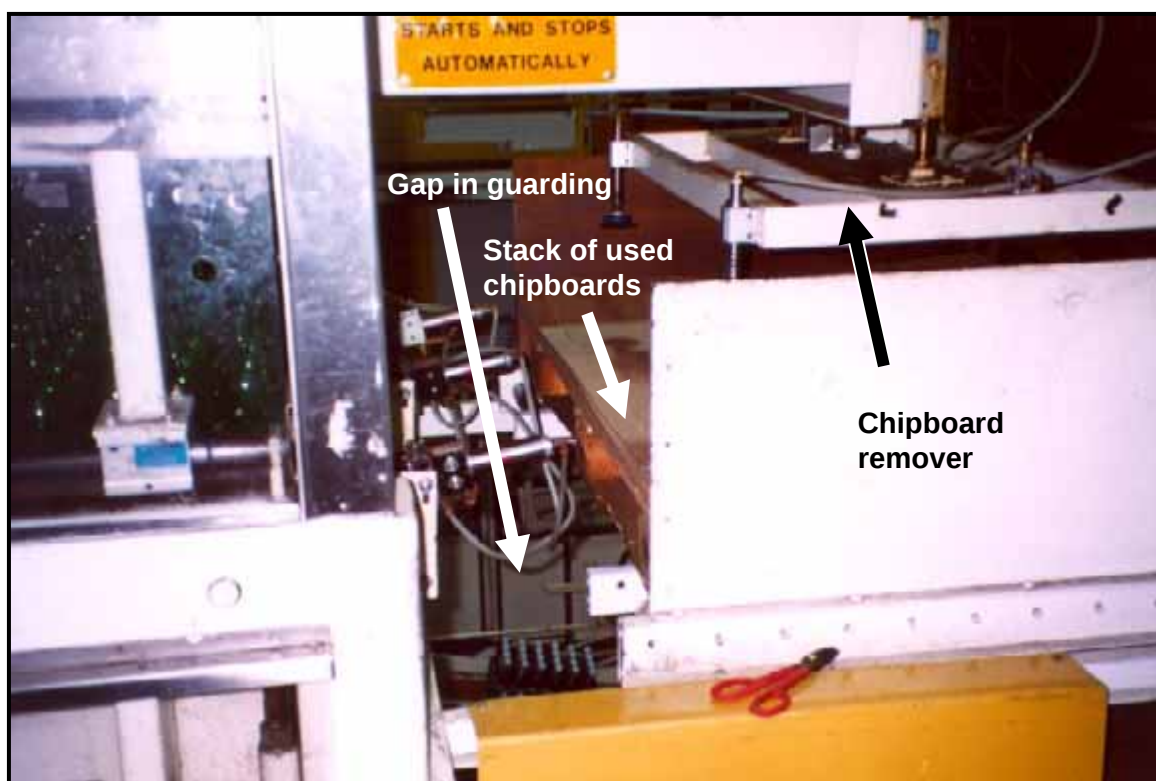
Photo 2 Gap in guarding showing chipboard remover.

Sliding plexiglass interlocked guards (doors) prevent access to the front of the chipboard remover from the operator's side of the work platform. There was a 16" x 24" opening in the guarding between the stack of bottles and the removed chipboard sheets to allow the worker access to remove the wooden stabilizing ring that is placed on top of the pallet load of bottles. Prior to the chipboard remover cycling through its process, the depalletizer operator had to reach into the opening and cut and remove two straps and a large wooden ring off the top of the pallet of empty bottles while it was in the depalletizer. This operation was done while the machine was turned off.

In this incident, the victim did not open the interlocked chipboard remover guard, but physically put his body in the opening between the conveyor and the guard and was able to access the space adjacent to the chipboard remover apparatus. He by-passed the guard and safety interlocking device that was on the equipment.

The guard on this machine allowed a person to get their arms and body into a hazardous part of the machine, which resulted in the death of the victim. The bottling plant should work closely with the equipment manufacturer and get their help to devise additional guarding and safe operational practices for employees who run and maintain the depalletizer system. It is very important, and is especially true when automated moving and reciprocating machinery is involved, that effective guarding be in place to prevent a worker from coming in contact with or be pulled into a hazardous area of the operating machinery.

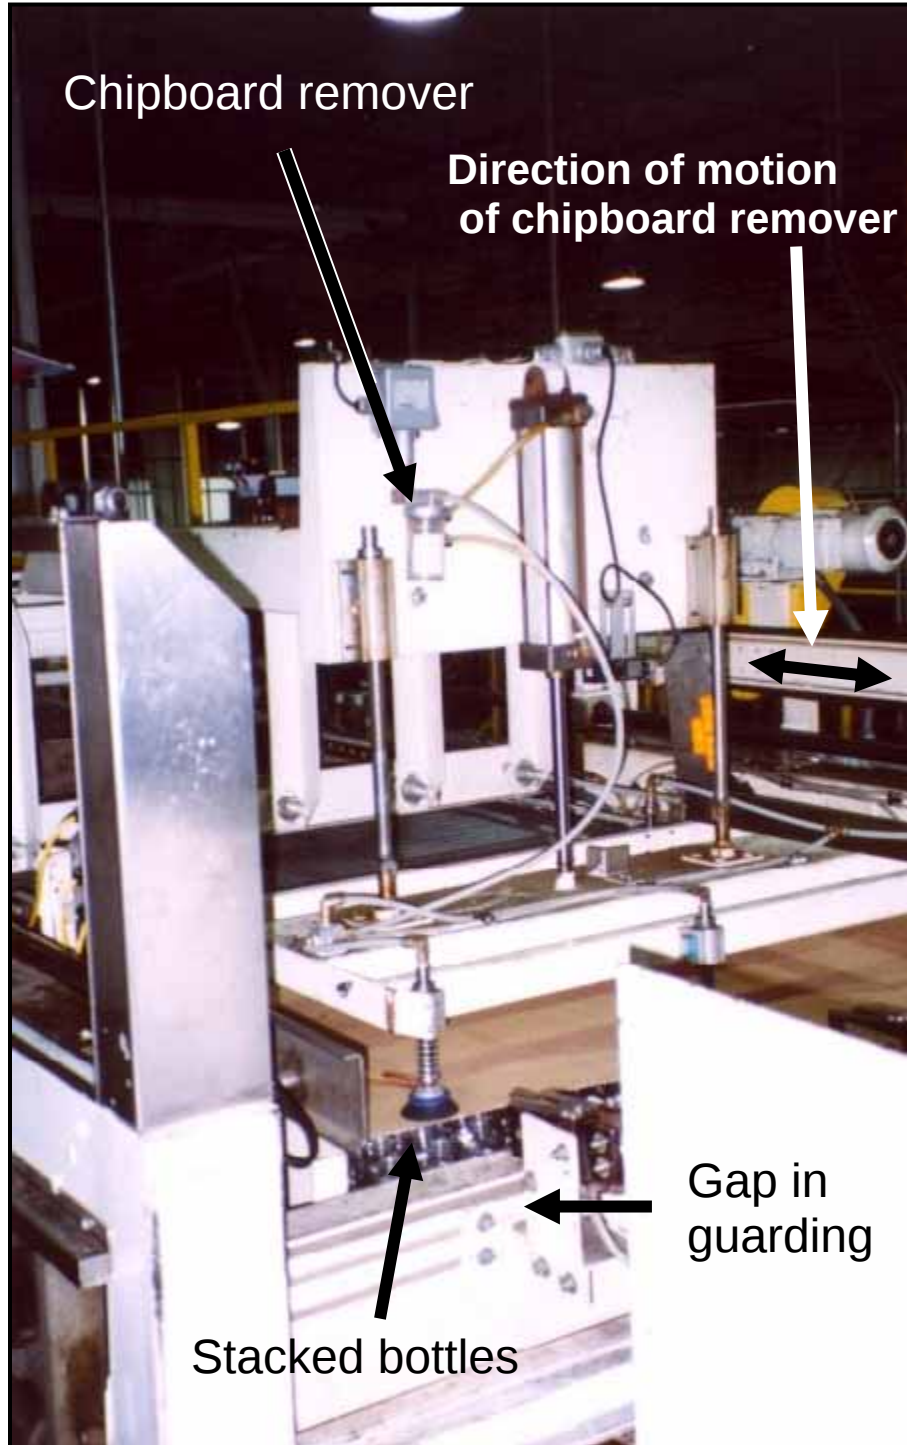
Photo 3 Bottles and chipboard remover.

Each layer of bottles on the pallet was separated by a piece of chipboard (tier sheet/slip sheet) which travels with the stack of bottles up the depalletizer hoist until it reaches the chipboard remover mechanism at the top. The chipboard remover has five vacuum suction cups which descend automatically onto the chipboard that covers each layer of bottles and lifts the chipboard off the bottles (Photo 2 and 3). An electronic sensor triggers this action when it senses the layer of bottles entering the chipboard remover area. The suction cups apply approximately 20 pounds of vacuum pressure to lift the chipboard approximately 2-1/2 ft off the layer of bottles. The chipboard remover then moves approximately 5 -1/2 ft to the right and drops the chipboard onto a stack of removed chipboards. The stack is periodically taken out of the system by one of the bottling plant workers.

Once the chipboard is placed in the stack, the chipboard remover swings back to the original position to pick up the next chipboard. Simultaneously, the new layer of bottles is moved to the left by the sweeper arm onto the conveyor that sends the bottles to the labeling and filling operations. As the bottles travel along the conveyor system, an electronic sensor sends a signal to the system to raise the next layer of bottles in place for depalletizing. According to a bottling plant supervisor, this process takes approximately 20-25 seconds to cycle each layer of bottles through the system.

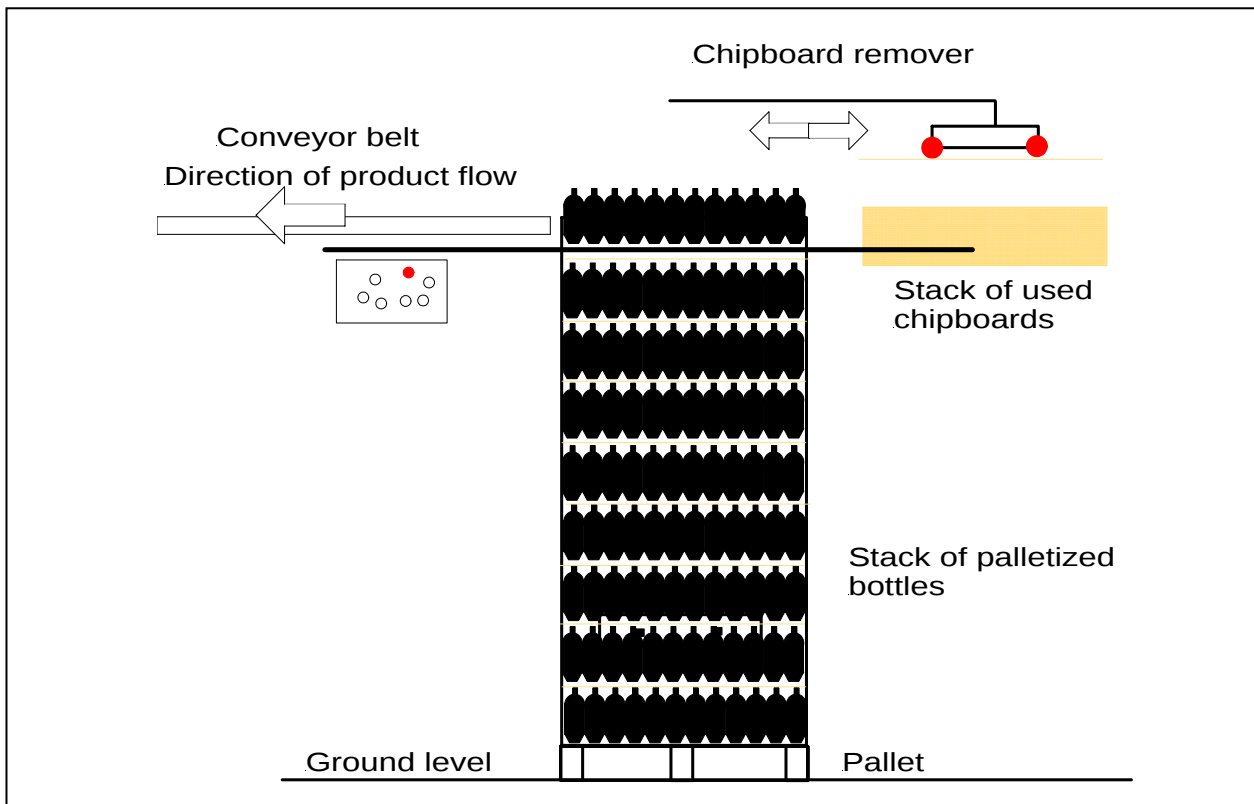
Figure 1 Side view of depalletizing operation.

The depalletizer raises the palletized stack of bottles up from floor level to the operator’s workstation level (approximately 12ft from the floor). The depalletizer mechanism then sweeps forward one layer of the palletized bottles that are packed in an 11 by 12 formation, and funnels them into a single file where a conveyor moves the bottles to the labeling and fill line.

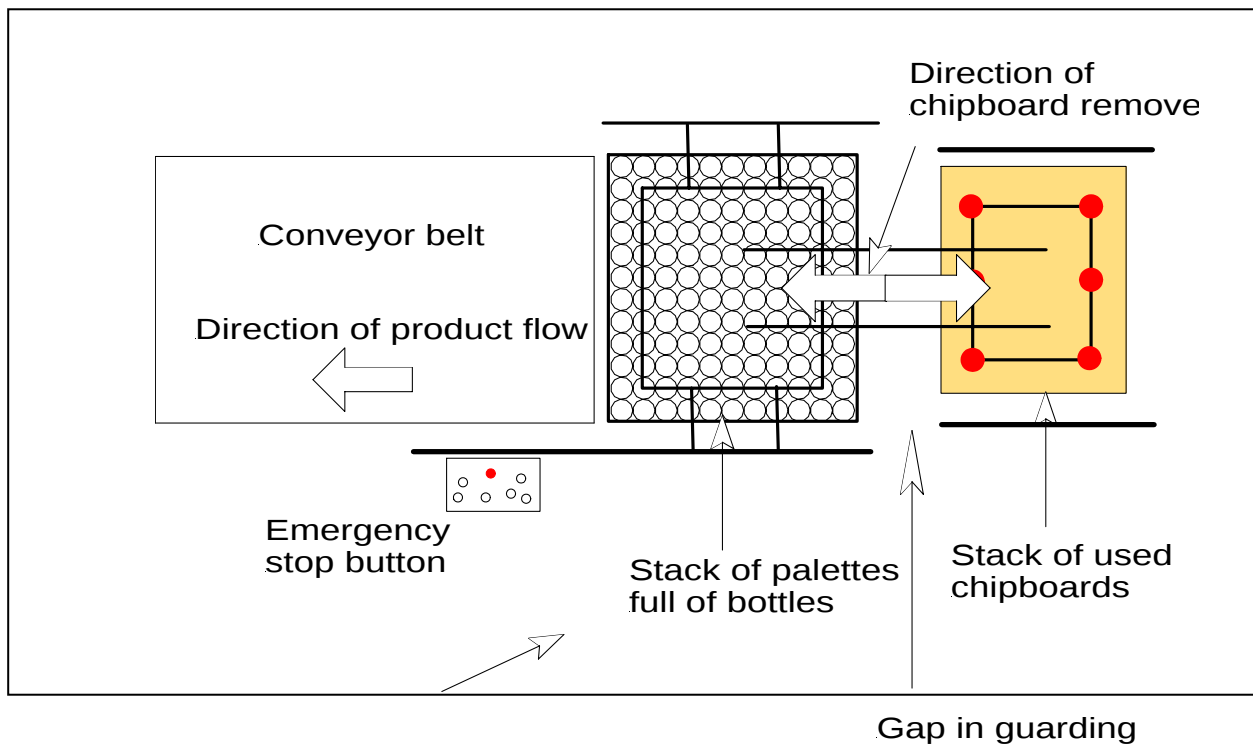
Figure 2 Plan view of depalletizing operation.
