# **NJ FACE INVESTIGATION REPORT**

**FACE 03-NJ-091**

## **Hispanic Construction Worker Dies After Fall from an Improvised Scaffold**

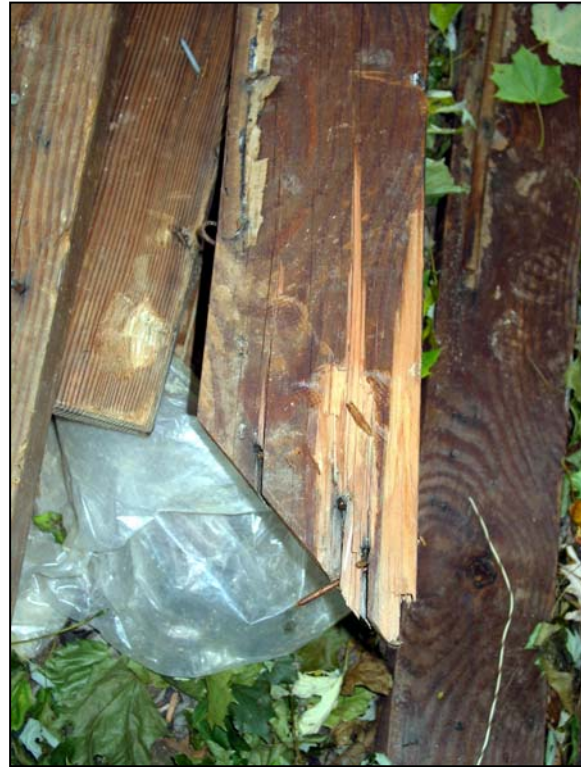
Prior to the incident, the contractor and his crew had already demolished and rebuilt most of the rear section of the house. The crew removed the entire back section of the peaked roof, which had been built at a slope of approximately 45 degrees. All the discarded wood trusses and surrounding lumber from the rear roof was piled in the backyard of the house. They then rebuilt the roof at a pitch of approximately 10 degrees, effectively raising the roof of the house and greatly increasing the interior space. The rear wall was raised to support the new roof, and new windows were installed in the wall. This part of the project was done quickly to reduce the time the house was open to the weather. Once the new addition was built, the crew started installing vinyl siding on the outside of the house. The crew also started work on the interior of the addition. During the project, the crew built an improvised, homemade scaffold with the discarded lumber from the back yard. This scaffold was poorly built, using wood that had been damaged during the demolition (See Photo 1).

**Photo 1**  
**Damaged wood used to make the  
improvised scaffold**

**Discussion:** The scaffold used in this incident was an improvised, homemade scaffold made with scrap wood left over from the demolition work. This scaffold was unsafe and could have collapsed at any time. The unguarded wood plank from which the victim fell was an extension of this scaffold and was inherently unsafe. NJ FACE recommends that employers and employees always use properly designed and assembled commercial scaffolds and/or ladders when working at heights. The employer did own a commercial metal scaffold, but it was not in use at this jobsite.

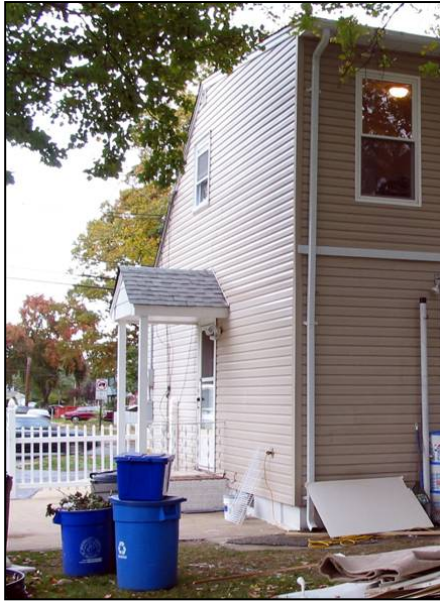
The incident occurred on Wednesday, October 1, 2003. The weather was clear with a reported temperature of 75 degrees. The company owner and a crew of three workers arrived at 8:00 a.m. to continue work on the house, which they had started the week before. The day went uneventfully, with the workers installing vinyl siding on the house. At approximately 4:30 p.m., the victim arrived at the jobsite after just having flown in that day from Costa Rica. The company owner (his son) was away from the work site to get a gutter, so the victim started installing siding on the side of the house. He was standing on a 2" by 6" wood plank set 10" 5" above a concrete walkway. One end of the plank was placed on the peak of a small porch roof, and the other end rested on the improvised scaffold at the back of the house.

**Photo 2**  
**Porch roof peak used to  
support the scaffold plank**
