## **MIFACE INVESTIGATION: #04MI066**

### **SUBJECT: Landscaper Died When the Arms of a Skid-Steer Loader Crushed His Upper Body and Head.**

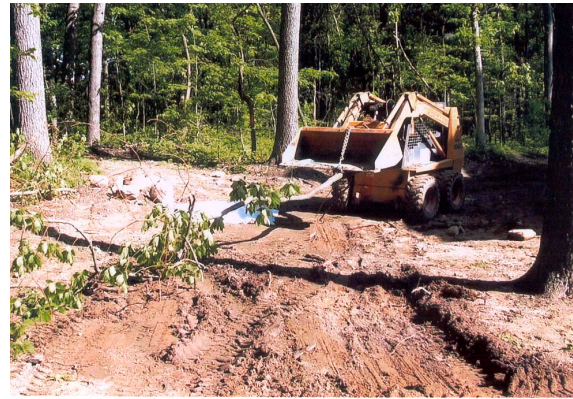
On May 27, 2004, a 27-year-old male landscape supervisor was killed when the lowering arms of a skid-steer loader crushed his head and upper body. See Figure 1. The victim and his crew were clearing the back yard and uprooting small diameter trees and tree stumps for a newly constructed house. The victim was operating a Case brand model 1845C skid-steer loader equipped with a 73-inch bucket to uproot small diameter (one to two inches) trees and tree stumps. Although this was an unwitnessed incident, the following scenario has been developed based on routine work practices as indicated by company personnel.

Figure 1. Skid-steer loader at scene

- Construction employers should develop, implement, and enforce a comprehensive accident prevention program that includes, but is not limited to, training in hazard recognition and avoidance.
- Operators of skid-steer loaders should be trained in and follow the manufacturer's recommended procedures to safely operate, service, maintain, and exit the skid-steer loader.

- Employers should ensure that skid-steer loader operators follow the procedures for which they have been trained, including prohibiting them from working underneath raised lift arms if an approved lift arm support is not available.
- Company management should consider developing a joint health and safety committee.
- Employers should establish and enforce a thorough vehicle maintenance and inspection program.

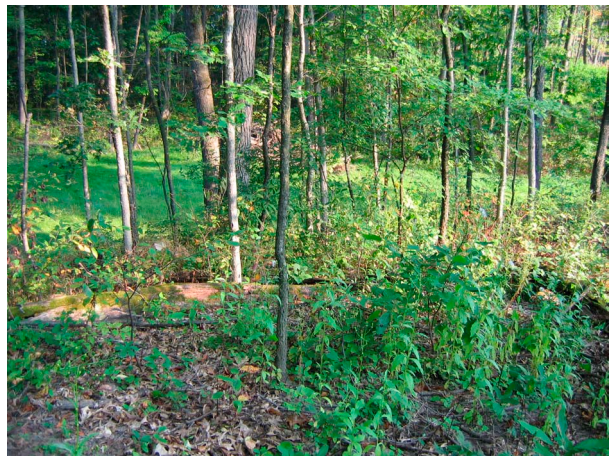
Figure 2. Wooded area behind home at time of MIFACE visit

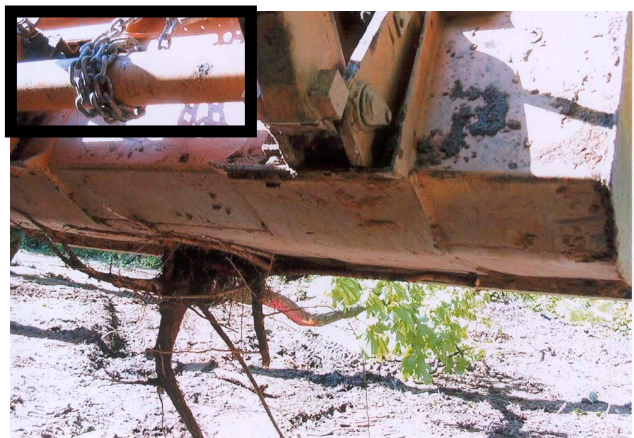
To uproot the tree involved in this incident, he wrapped a 16-foot 3/8-inch binder chain around the base of the tree and wrapped the other end of the chain around the bucket's stabilizing bar. He placed the skid steer in reverse. As he was backing up, he raised the bucket to lift the tree roots from the ground. After removing the tree and with the bucket in the air, he raised the skid steer's safety bar and exited the cab. Standing on the ground under the raised bucket, he attempted to unwrap the chain from the tree. He was unable to remove the chain because of the tension on the chain caused by the raised bucket. He reached into the cab, lowered the safety bar, and began to operate the controls to lower the bucket. As the bucket lowered, he was unable to remove himself from beneath the raised arms of the skid steer and he was crushed between the skid-steer loader's arms and frame. A fellow worker heard a sound, turned around and saw the victim. He notified another worker, who ran to the residence where the crew was working. The homeowner called 9-1-1. His fellow workers raised the skid-steer loader arms and began CPR. Emergency response arrived and declared the victim dead at the scene.

Figure 3. Chain wrapped around tree and bucket stabilizing bar

exited the cab while the skid steer was still running and the bucket still raised above the ground. He attempted to loosen the chain from the tree so he could unwrap the chain from around the tree. He was unable to remove the chain because of the tension on the chain caused by the raised bucket. While standing on the ground under the raised bucket, he reached into the cab and lowered the safety lap bar. He was positioned on the operator's right side of the cab. The operating controls for raising and lowering the bucket were located on the operator's left side of the cab. He reached into and across the cab to lower the bucket and the bucket arm came down, crushing him. His fellow workers heard a noise and turned around and saw the victim. One of the employees who was chopping trees in the vicinity of the victim notified another employee who went to the residence for help. The employee who originally saw the victim attempted to reach Emergency Response with his cell phone but was unsuccessful. The homeowner called 9-1-1. The employee who went to the home to notify the homeowner to call 9-1-1 entered the cab, lifted the safety bar and sat on the seat, lowered the safety bar and raised the bucket from the ground. This employee stated to the police that the skid steer front tires were off of the ground when he entered the cab. When he raised the bucket from the ground, the skid steer rolled back approximately two to three feet. Employees performed CPR until Emergency Response arrived. Emergency Response declared the victim dead at the scene.

A hazard analysis may have identified the potential problem of chain tension on the tree when the bucket was in a raised position. A copy of the OSHA Job Hazard Analysis publication is included with this report as Attachment A. This document may also be found and downloaded from the OSHA website: [www.osha.gov/](http://www.osha.gov/). Click on the Newsroom Publications link, and scroll down the OSHA publications until the "Job Hazard Analysis" document is found.

An approved lift arm support is required by the manufacturer to work under raised lift arms. If an employer does not have available an approved lift arm support, the employer's safety program should strictly prohibit employees from working underneath the raised lift arms of a skid-steer loader.
