## **MIFACE INVESTIGATION: #03MI193**

### **SUBJECT: Farmer Died When Electrocuted While Welding Feed Bunker Wagon**

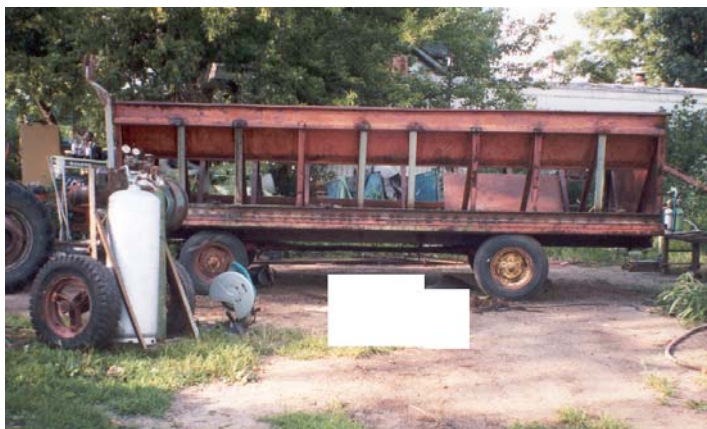
The victim was rebuilding a feed bunker wagon (See Figure 2). He backed the wagon into position with a

Figure 2. Feed bunker wagon

tractor, parking the wagon on sandy soil outside of a small wooden shed that contained junk metal, the welder, tools, electrical receptacle box, and other debris. The wagon was 18 feet long, six feet wide and the wagon bed was 28 inches from the ground. The front wheel where the victim was found was approximately 4 feet 6 inches from the front of the wagon. The beam under the hay wagon that the victim was resting against when he was found was 21 inches above the ground.

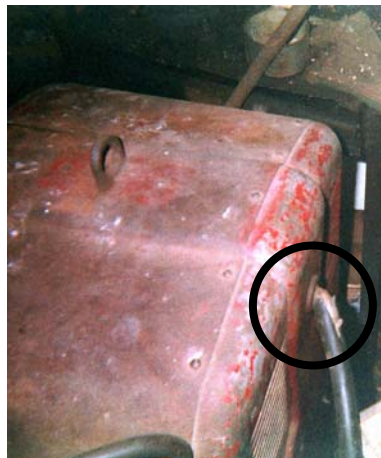
The welder was an old Hobart brand A.C. arc welder (See Figure 1). The welder's power cord covering and insulation was damaged which exposed the conductors (See Figure 3). The welder cables were not available to the MIFACE researchers. The condition of the cable insulation is unknown. The caretaker explained that they had been stolen shortly after the incident. The researchers were told that the first set of welding cables were approximately 10 years old and approximately 12-feet long. The second set of welding cables that were "spliced" to the first set was also not available for inspection. The victim welded with rods that were obtained as discards from other businesses or bought by the victim at auction. The welding rods were stored in the shed in open containers, on open shelves or on the floor.

Figure 3. Damaged insulation on electrical cord

- Maintain equipment in proper operating condition.

Maintaining equipment is integral to safe operation of the equipment so that it can provide the protection it was designed to do. It is unknown if the victim was able to make an association between the “ouch” he was receiving and the poorly maintained condition of the arc welder and cable leads. The individual who lived on the property and worked the farm with the victim permitted the victim to continue to use the defective welder. It is imperative that when items are known to be in need of repair that the items are taken out of service, repaired or scrapped. A new welder had been purchased, but was not being used. Insulation on welding cable leads must be maintained to ensure the integrity of the leads and to ensure that workers are not exposed to electrical current

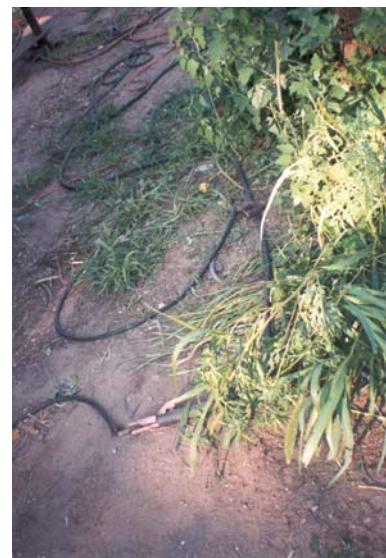
According to the victim's caretaker, the victim would conduct welding operations the same way each time due to his functional disability. The victim's normal work procedure was to "splice" two sets of welding cables together and lay them down on the ground on a 2-inch x 12-inch piece of wood (See Figures 4-5). He would not insulate the splices for protection. The victim would wear a welding helmet and welding gloves during the welding operation. He would lay and/or stand on a blue rigid foam insulation board. The victim would position all equipment, turn on the welder (90 amps), and weld.

Figure 4. Un-insulated splice

Although it is unknown how the victim would usually “splice” the cables, on the day of the incident, he attached the electrode holder directly to the cable wire. The un-insulated connection was lying on bare ground.

Establish safe work procedures when you need to “splice” a welding lead. The victim used an unsafe practice when he attached the electrode holder to the wire cable. Splices should be accomplished using only approved components and commercially manufactured welding “cable connectors” that can be found in welding supply stores and some farm supply stores.

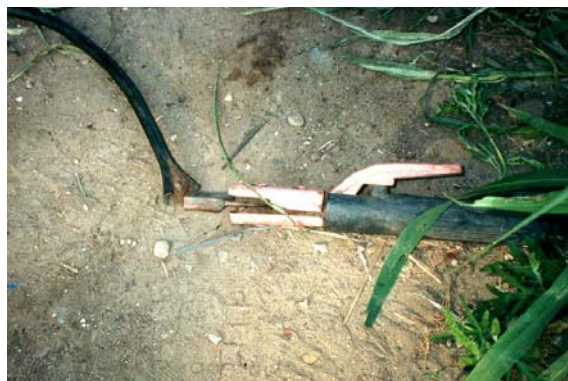
Figure 5. Un-insulated splice on bare ground

According to his caretaker, some atypical circumstances were present on the day of the incident. The victim had not placed the spliced cables on the 2-inch x 12-inch piece of wood (See Figures 4-5). He was not wearing his welding gloves and he was not welding while lying on the rigid mat under him. He was working alone, which was highly unusual for him. Spare rods were lying next to the victim’s location (See Figure 6). He had placed the welding rod in the stinger but the rod had not been lit, indicating the victim had not been in the process of welding when he was electrocuted. The police report did not indicate that there were used rods found near the victim.

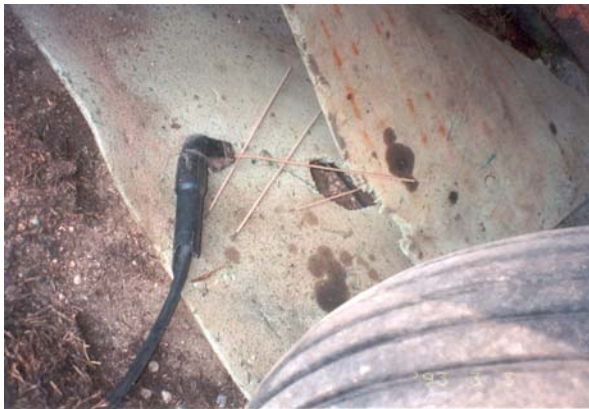
Figure 6. Stinger on mat, unused welding rods

It appears that the victim changed the electrodes with his bare hands. This unsafe practice should be forbidden. Never change electrodes with bare hands or wet gloves. When welding, avoid wrapping electrode cables around your body.
