## MIFACE INVESTIGATION: #03MI134

### **SUBJECT: Farmer Died When Tractor Overturns to Side While on a Hill**

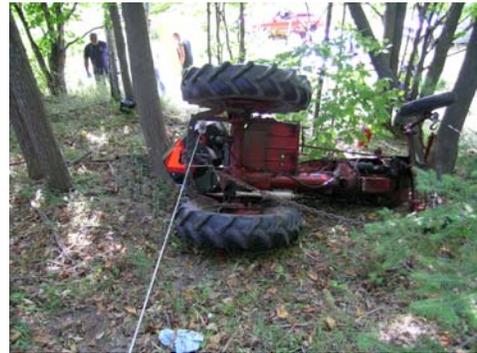
Photo 1. Final resting place of tractor

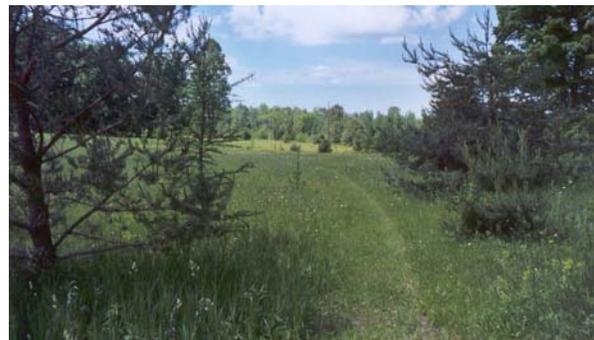
Photo 2. Path in field next to hill

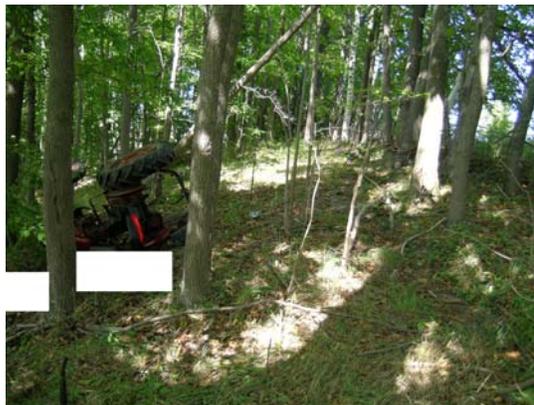
It is unknown if he stopped the tractor due to a medical emergency or if he had reached the desired place where he was going to trim the trees at the base of the hill. It is unknown when he unhooked the trailer from the tractor. The chainsaw was found nearby at the base of the tree-covered hill. The victim’s home was at the top of hill, whose slope was estimated between 20-30%. When he started up the hill, the trailer had already been disconnected from the tractor. After backing the tractor up to nearly the top of the hill, he turned the steering wheel to the left. His tractor tracks showed that the victim was able to turn the tractor and that it was “sideways” on the hill. Photo 3 shows the final resting place of the overturned tractor. There was evidence that the tractor tires were slipping in the dirt. The tractor was unstable because of the slope of the hill. The tractor overturned to the side and rolled down the hill. The seat and rear axle landed on the victim’s back and his head struck a tree stump.

Photo 3. Resting place of tractor
