## **MIFACE INVESTIGATION: #03MI108**

### **SUBJECT: Farmer Dies When Grain In Grain Bin Engulfs Him**

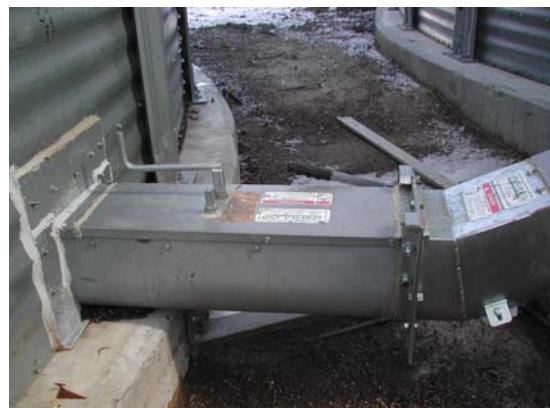
Figure 1. Auger unloading system

The corn was unloaded from this grain bin by a bottom-unloading auger system. The horizontal auger mounted below the raised steel floor of the bin had multiple auger intake openings. The center auger intake was the largest, 8-10 inches wide and two feet long. The remaining auger intakes were one foot square. The auger intake openings were fitted with a steel safety grid that allowed grain to pass through them but prevented workers from being directly exposed to the auger intake located below the bin floor. The auger intake openings were opened outside of the bin by manually turning a handle. The directions as to how far to turn the handle were hand written on the outside of the bin. The auger housing contained many warning signs (See Figures 1 and 2).

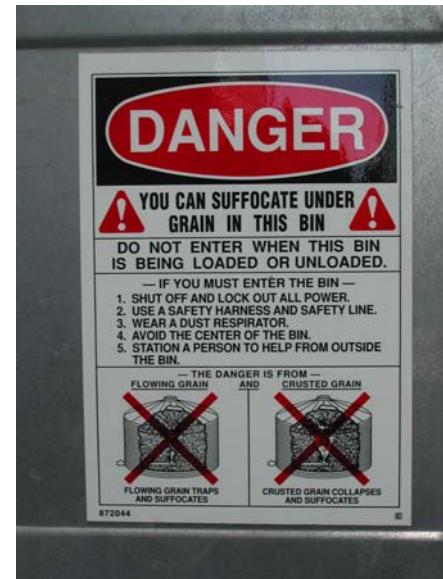
Figure 3. Confined Space warning sign on bin door

The bin had an access door on the side of the bin that was fitted with a hinged exterior door that opened outward and an interior door that had a confined space sign that opened inward. The bin also had a top hatch with a ladder on the inside of the bin to provide access to the bin's interior. Both of these entrances to the grain bin appeared to have required confined space warning signs; MIFACE researchers observed a confined space sign on the side grain bin door and the victim's brother stated that there was a confined space sign on the outside of the top bin hatch (See Figure 3).

In this incident, the warning signs were posted at each entry point and legible. It is important that the entrants of a confined space adhere to the warnings contained on the signs.

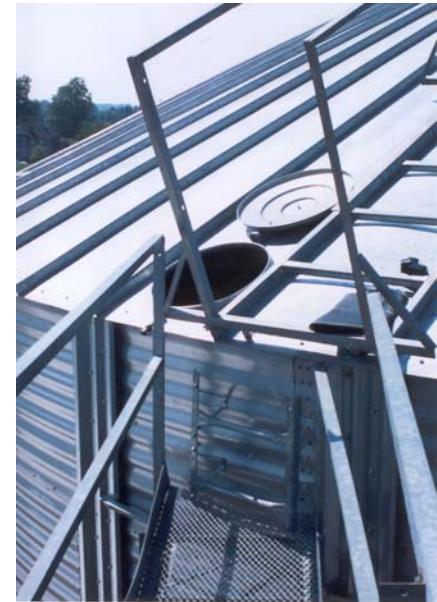
Figure 4. Open entry hatch at top of grain bin

The brother mowing the lawn checked on the victim at approximately 11:00 am because a neighbor, who was supposed to meet with the victim, couldn't find him. The neighbor and brother searched the farm and also looked through the open hatch at the top of the bin to see if they could find the deceased (See Figure 4). When his brother, saw that the victim's truck was at the farm and his cell phone in the farm office, thought that the victim had hurt himself in the bin. The brother told the victim's mother to call for emergency response. Both the victim and neighbor separately entered the storage bin looking for the victim and calling his name. He and the neighbor began to cut open a hole on the southeast side of the bin when paramedics arrived.

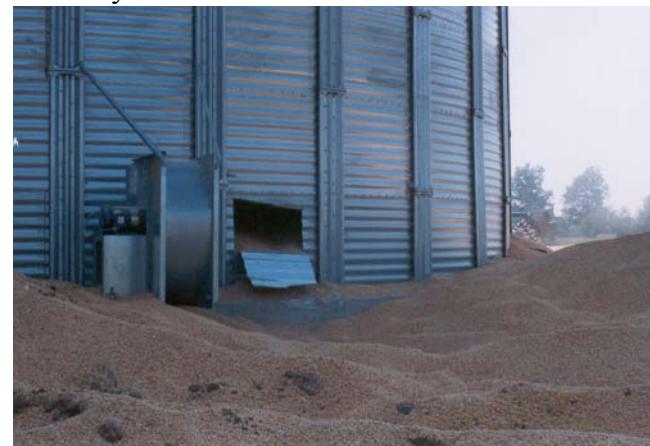
Figure 5. Example of hole cut in grain bin to empty bin of grain

The brother interviewed by MIFACE was hauling a load of soybeans to another part of the state. When notified by his mother and he came home. He was part of the recovery effort. Rescue workers completed cutting the southeast hole and cut three additional holes in the bin, all approximately 4 feet by 4 feet on the north, south, and west side of the bin to empty the bin of corn (See Figure 5).

The victim's brother, although very appreciative of the work of the emergency responders to save his brother requested that MIFACE address the issue of grain engulfment and emergency response. The emergency personnel, in their mission to find the victim, created not only an additional hazard (30,000 bushels of grain outside of the bin) but also economic loss when they cut the holes in the side of the grain bin. The victim had been engulfed in the grain bin for well over the time it takes to succumb to the pressure of the grain on his body. According to the victim's brother, every effort must and should be taken during rescue operations. Once a rescue has been classified as a recovery operation different grain bin unloading procedures could have been followed. Instead of cutting three additional holes in the bin and the grain pouring out outside of the bin, the unloading auger could have been used to empty the bin.

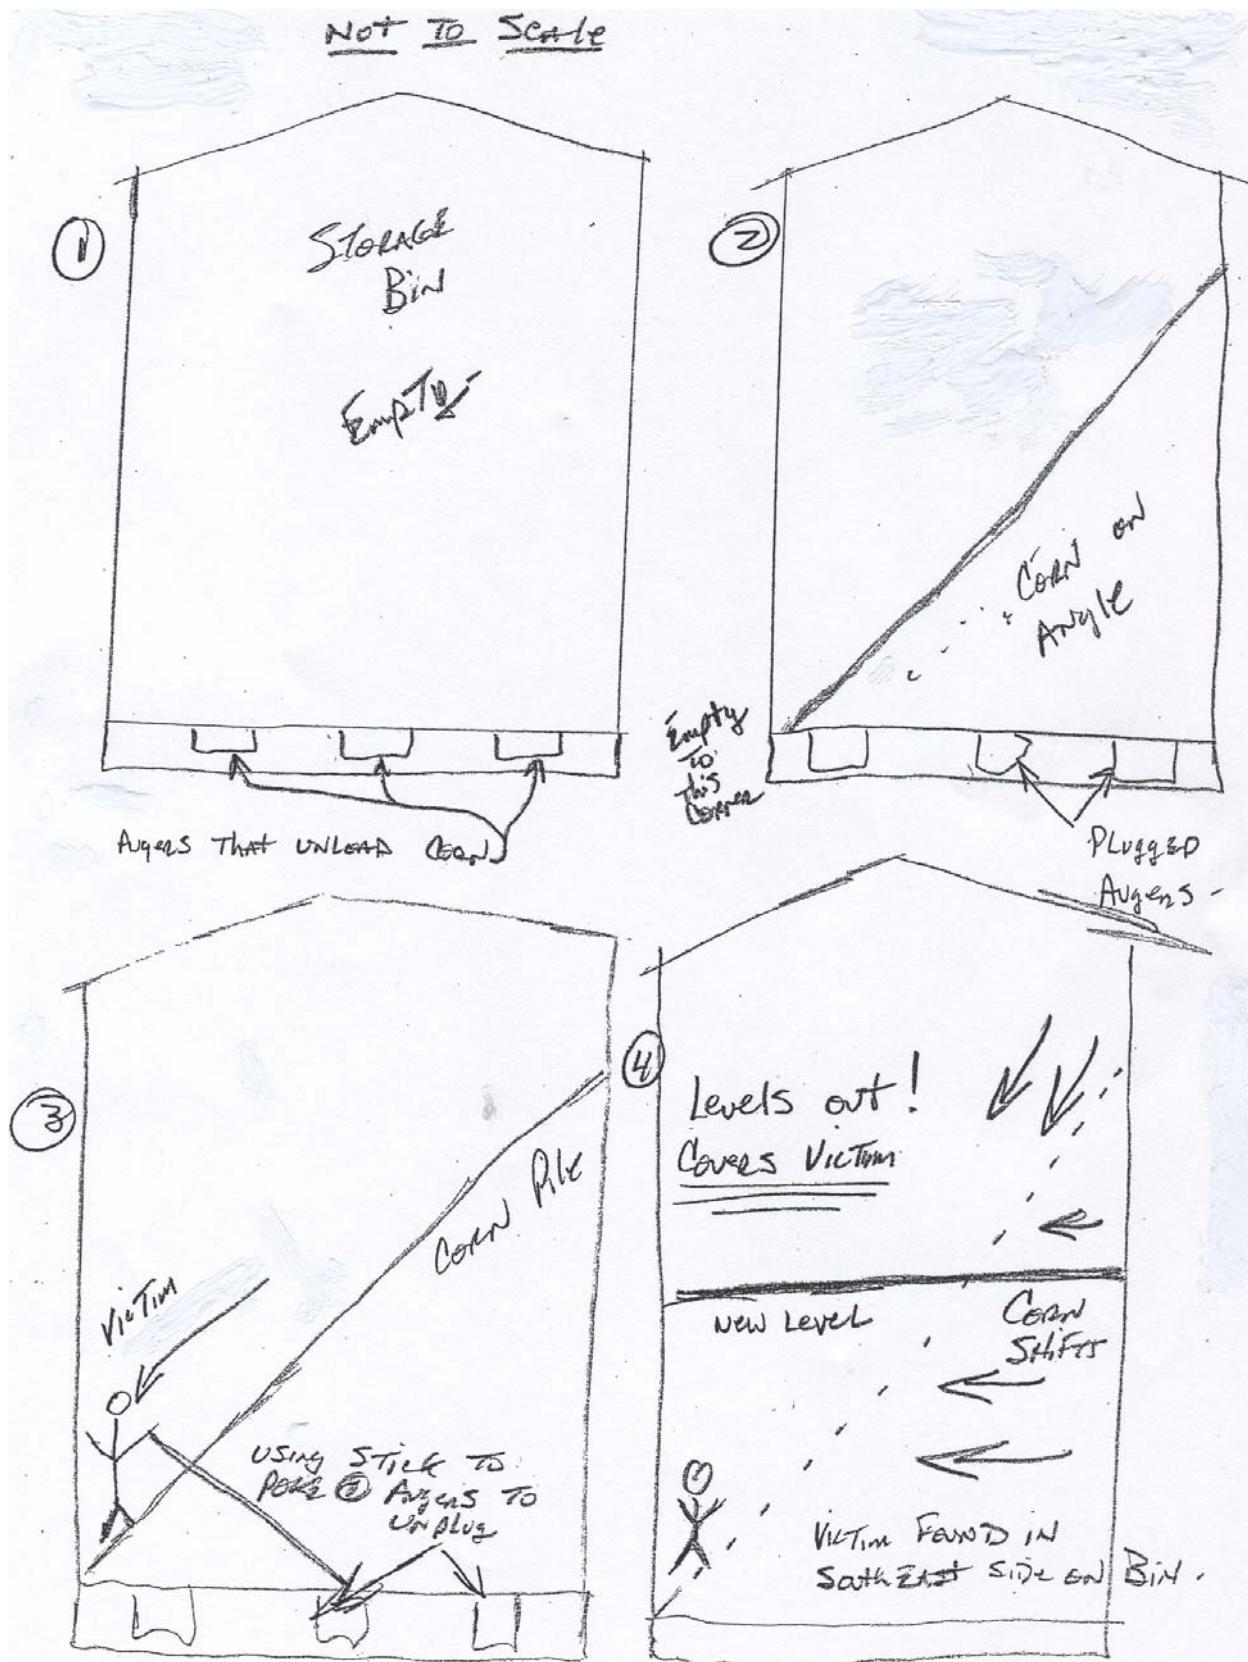
## APPENDIX A

It appears the victim was in the process of clearing one of the auger openings when the grain wall to collapsed upon him. See Appendix A for a possible sequence of events as depicted by the responding police agency. The victim was found on the southeast side of the bin approximately 2.5 hours after the 911 telephone call was made and was declared dead at the scene. The victim was located near the bottom of the storage bin and had been covered with approximately 20 feet of shelled corn. The auger drawing corn out of the bin had not been shut down before entry and the victim was apparently covered by the corn both by the leveling or collapse of the shelled corn that was sloped against the bin wall and the
