MIFACE Investigative Report #02MI120

Subject: Farmer Killed When His Tractor Leaves Public Road Shoulder and Overturns Into a Ditch

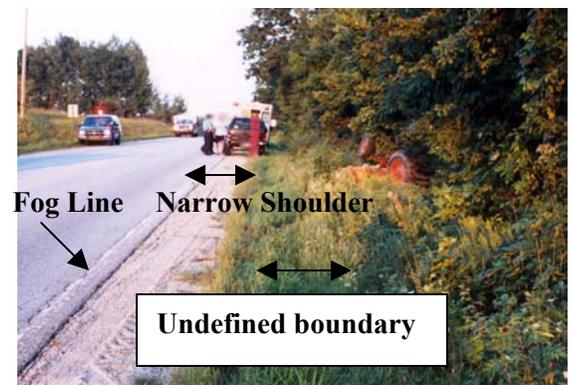
Figure 4

When MIFACE researchers visited the incident site and viewed the police photographs of the incident, several observations about the roadway were noted. See Figure 4.

- The gravel shoulder was narrow, which may have caused the victim to travel with half of the vehicle's tires on black top and the other half on a gravel surface. This could have reduced his ability to maneuver the tractor.

- The ditch edge was unable to be seen due to the overgrowth in the ditch and the extent of the shoulder mowing. The shoulder/ditch edge could be defined with appropriate mowing.

- The white edge or fog line that help travelers stay on the road at night was worn and faded, thus it may have been difficult for the victim to get a good visual orientation separating the road from the shoulder areas.

- There were no delineator posts/shoulder edge marking for the roadway. These devices could be used along the shoulder of the road to: mark hazards such as ditches, establish the maximum safe area that a vehicle could travel onto that shoulder, and, provide a line of visual perspective that shows where the shoulder ends and where the hazard, such as the ditch slope, begins.
