MIFACE INVESTIGATION: #02MI029

SUBJECT: Farmer Died After Being Struck While Seated On The Tractor By an Unrestrained Rectangular Haylage Bale That Fell Out of An Elevated Front-End Loader Bucket That Independently Elevated

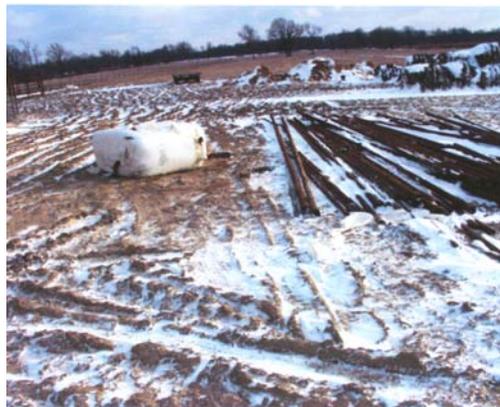
Figure 1. Overview of incident layout and terrain

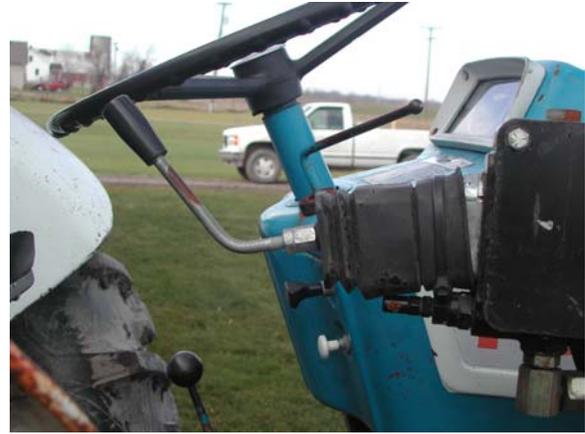
The victim controlled the loader's arm and bucket movement by the use of a joystick. See Figure 2. Moving the joystick up and down raised and lowered the loader arms. Moving the joystick side to side tilted the bucket.

Figure 2. Joystick control operating front-end loader

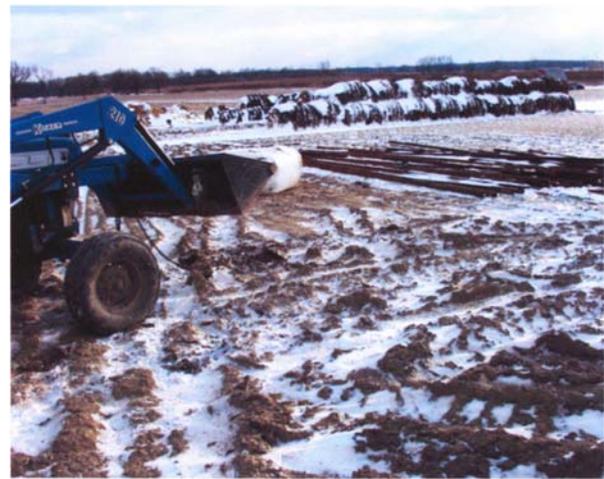
The ground surface conditions on the day of the incident contributed to the fatality. According to the Record of Climatological Observations at the Lapeer WWTP station from the National Weather Service, several days of above freezing temperatures occurred prior to March 11 that caused freeze/thaw conditions at the ground surface. March 7 and 8 high temperatures were 37 degrees and 35 degrees respectively. On March 9, two days before the incident, the temperature reached nearly 60 degrees. It was raining, and the snow that had fallen two days before melted. During the early morning on March 10, the two inches of snow fell. As temperatures increased, the snow changed to rain. The high temperature on March 10 was again nearly 60 degrees, causing muddy conditions. The temperature fell on the night of March 10; one inch of snow fell and a maximum temperature of 22 degrees was reached on March 11. Operating the loader repeatedly over these days in this area contributed to the rutted conditions seen in Figure 3. The police report stated that the winds were strong from the west, and there was less than one inch of snow on the ground. The Record of Climatological Observations did not have any wind speeds recorded for this weather station.

Figure 3. Ground conditions and moved tractor after the incident

The victim kept his plastic-covered haylage bales in rows near the barn and the buffalo pen. The buffalo pen was located behind the barn. To the west of the buffalo were the bales and metal pipes running in a north and south direction. Tracks in the snow indicate the victim was driving the tractor facing west to southwest. See Figure 3.

The operator was operating a two-wheel drive tractor loader over frozen, rutted, snow-covered ground, thereby decreasing the vehicle's control and maneuverability. An inspection of the area and consequent identification and control of the hazards, such as selection of an alternate path or building an improved road-bed pathway to the feeding area may have prevented the tractor's rear wheels from becoming lodged in a rut and causing the victim to rock the tractor to free it.

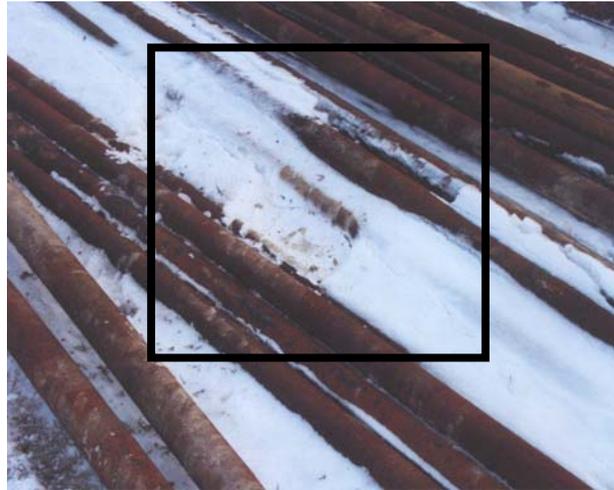
The victim's wife stated that the victim had twisted to look toward the rear of the tractor in her direction while backing up with the hay bale in the bucket in a low position, approximately three to four feet off of the ground. The rear wheels rolled into a depression and became stuck. The police report states that the left front tractor tire was directly on the ground and the right front tractor tire was on the metal pipes. See Figure 4 for the right front tire mark on the metal pipes.

Figure 4. Mark of right front tractor wheel on metal pipes

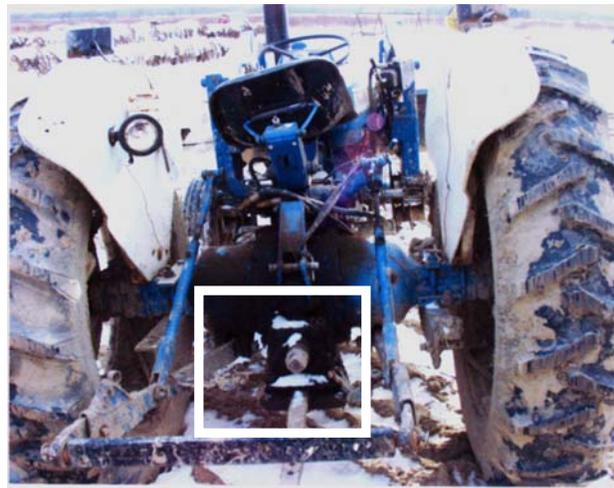
When the bale struck the victim, the weight and force of the bale caused the tractor seat to twist down from right to left. The steering wheel was also bent downward right to left as a result of being struck by either the victim or the bale. See Figure 5.

Figure 5. Bent steering wheel and tractor seat. Note unguarded tractor PTO stub

- Although not a factor in this incident, MIFACE recommends that the tractor PTO stub shaft be guarded at all times to prevent entanglement.

Exposed rotating shafts are hazardous situations that can cause serious injury. A PTO operating at 540 rpm rotates around 9 times/second. It takes only about one second to completely strip off an article of clothing or if the cloth does not tear away, and to wrap a body or body part around a shaft. Clothing is pulled around the shaft much quicker than a person can pull back or take evasive action. Even a quick reaction time, one-half of a second, would permit a piece of clothing to wrap around a shaft rotating at 540 rpm at least two times.

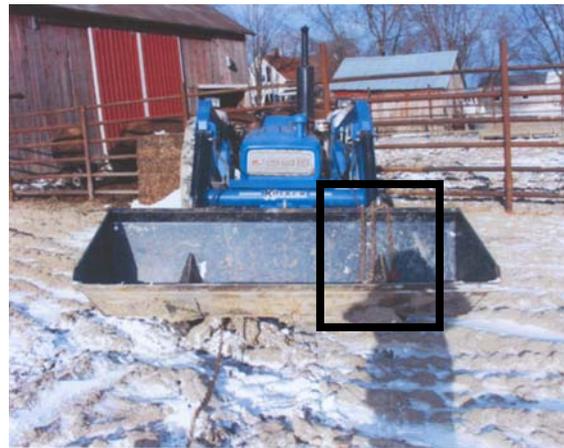
The police found the tractor with the loader's arms elevated and moved the tractor to another location. They set the bucket a few feet off of the ground, turned the tractor off and took the keys. See Figure 6.

Figure 6. Moved tractor with bucket in semi-raised position and loose chain

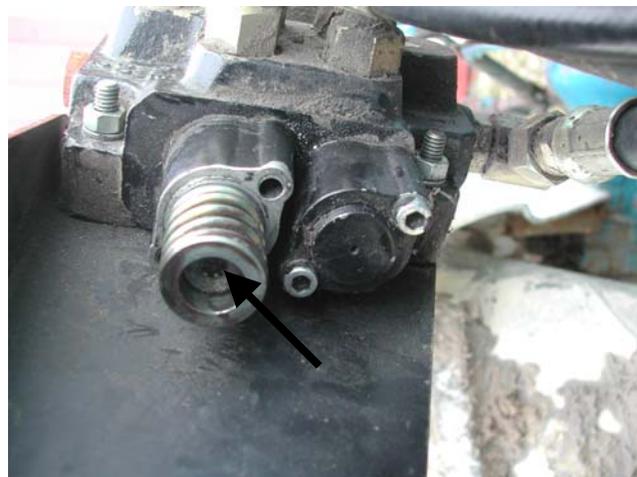
The next day, she spoke with the tractor dealership about the problem. The dealership representative told her to tighten the setscrew that controlled the loader's hydraulics. She found that after removing the protective cover that the setscrew had loosened over time. The loosening of the setscrew permitted the loader's arms to rise independently without touching or operating the control valve. She stated that prior to the day of the incident, the loader arms had not elevated independently.

She tightened the setscrew and that resolved the independent loader arm movement for a few months. After a few more months use, the setscrew loosened again and the loader arms raised independently. The setscrew, according to victim's wife has loosened an additional two times. Each time she tightened the setscrew resolving the problem and continued to use the tractor.

Figure 7. Setscrew controlling hydraulic valve

setscrew. Figure 7 is a picture of the setscrew arrangement. The victim's wife kept the tractor until the MIFACE visit. She planned to sell the tractor after the joystick replaced by the joystick manufacturer's representative.

- The joystick manufacturer should consider reevaluating the design or assembly methods of the joystick control valve to ensure that it cannot loosen once adjusted.

If approved by the manufacturer, a threadlocker compound (an adhesive that cures in the absence of air) could be used on the setscrew to limit its movement without constant tool adjustment.

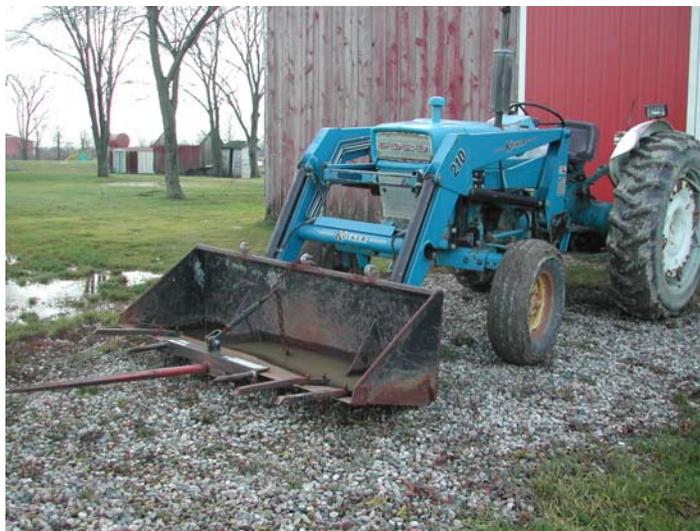
Moving the bale with a tractor equipped with a front-end loader that did not have a grapple to secure the bale was a contributing cause of the fatal incident. The use of the front-end loader without a grapple as a means for handling the large square hay bale presented a hazard, particularly when the loader arms raised independently above the front end of the tractor. A front-end loader equipped with a grapple, designed for the task being performed by the operator would have provided a safe means for handling the hay with less risk to the operator. After the incident, the loader bucket was equipped with a bale spear. See Figure 8. The spear attachment is not normally designed nor intended for use

Figure 8. Bale spear attachment to loader bucket

- When using a tractor loader to move a bale, properly secure the bale with a manufacturer's approved device such as a bale spear, clamp or grapple.

The unsecured bale of haylage is the underlying cause of this tragic work-related death. Even though the loader's arms elevated independently due to the loosened set screw, if the hay bale had been adequately secured inside of the bucket by a manufacturer's approved restraining device, the bale would not have fallen on the victim. According to the manufacturer's literature or sources, this particular after-market product offered a grapple device to secure in place objects such as large bales. The literature or operator's manual for the front-end loader stating the loader's intended uses or misapplications of use was not available. These attachments hold the bale in a secure stable position as it is raised, lowered or being transported. When traveling longer distances, the victim's wife stated that the victim routinely secured the hay in the loader bucket with chains and traveled with the load near to the ground, but he did not routinely secure the load in the bucket when traveling short distances. Chains may not provide adequate load restraint.

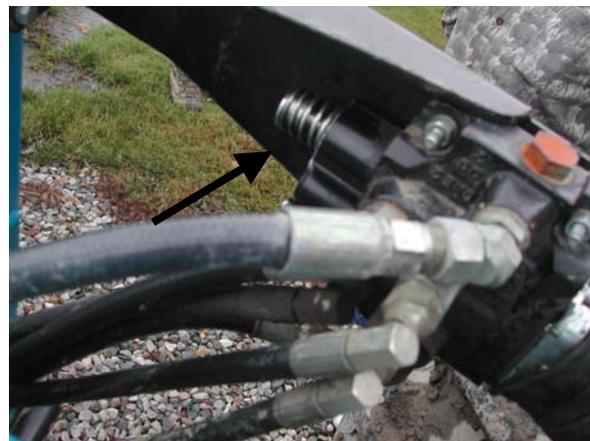
The joystick control valve has a setscrew that regulates the hydraulic component of the front-end loader. The setscrew tightens the spring centering mechanism that keeps the loader in a neutral position. The setscrew does not have a lock washer or other mechanism to keep it in place. During use, this setscrew loosens. The spring centering mechanism allows the hydraulic fluid to be pumped to the loader’s arms resulting in the loader’s arms elevating.

Figure 10. Hydraulic control setscrew location

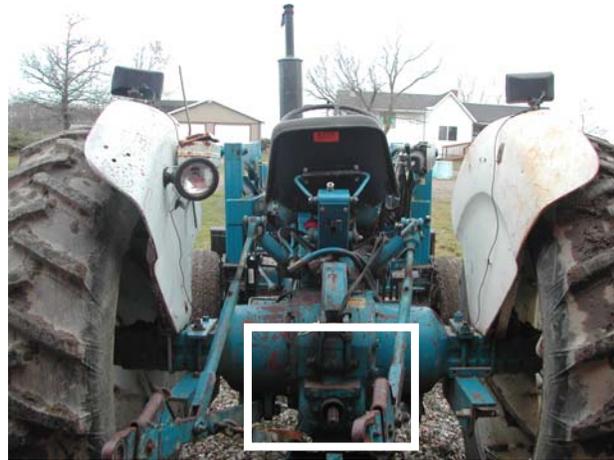
A total shielding system for a PTO driveline includes a tractor stub master shield, the PTO driveline shield and an implement shield. The master shield prevents the operator from accidentally coming into contact with the tractor stub shaft. Figure 5 and Figure 9 show the unguarded PTO shaft.

Figure 9. Exposed PTO shaft

Most newer tractor manuals recommend that a PTO stub shaft guard be used to completely enclose the tractor stub shaft when the PTO is not being used. The stub shaft guard will not only protect the operator but also keep the PTO stub shaft clean and in good condition.

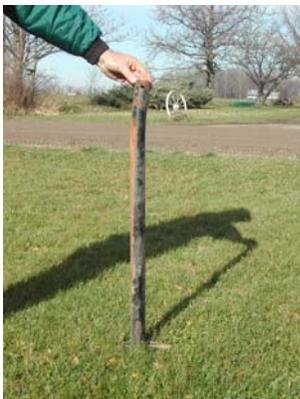
The loader was equipped with one self-storing stand (see Figures 11-13) that was designed to support the bucket during bucket quick disconnect. The support stand bent when the victim used it to support the loader crossbar while he was disconnecting the bucket. The MIFACE researchers do not know under what conditions (type of terrain, level/sloping, wet/dry, stand incline angle, etc) the support stand was used. The farm homestead land was fairly flat. Other Koyker front-end loader models have dual stands to support the loader crossbar during bucket disconnect. The manufacturer does not recommend the installation of the dual-support stand loader models on the victim’s tractor model. MIFACE suggests that the equipment manufacturer reevaluate the design of the model of loader recommended for the victim’s tractor to insure that the loader can be adequately supported by one support stand and if the current support stand material is strong enough to support the loader under all conditions of use.

Figure 11. Loader’s bent support stand

- The front-end loader manufacturer should consider reevaluating the loader model support system design.

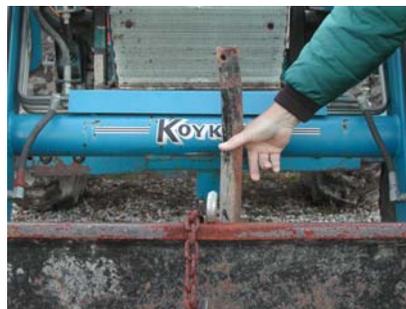
Figure 12. Single central support location

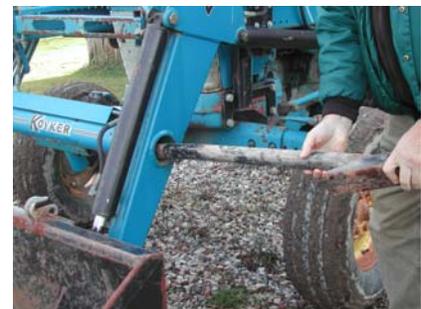
Figure 13. Location of support storage
