MIFACE INVESTIGATION #01MI094

SUBJECT: Bridge Painter Dies When He Falls Out of an Unsecured Rough Terrain Forklift Scaffold Platform

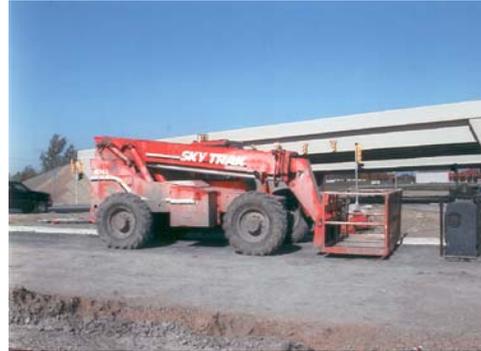
On October 19, 2001, a 31-year old male died from injuries sustained when he fell out of an unsecured telescoping rough terrain forklift scaffold platform (See Figure 1). The victim was painting a bridge as part of a highway construction project. The scaffold platform was raised to approximately 12 feet. The scaffold was not secured to the forks of the forklift; the forklift tines were not in the platform sleeves and the platform was not secured to the back of the forks. The victim was not tied off to the platform. As the victim walked sideways on the work platform, it began to tip to the side, and the victim fell out of the platform onto the packed dirt under the bridge. The platform fell off the forklift, hit the ground, and rolled onto the victim. Emergency personnel were called, and the victim was taken to a local hospital where he died.

Figure 1. Rough Terrain Forklift

- Employees must be trained in the procedures to safely perform a personnel lift using approved platforms and equipment specifically designed to support a scaffold platform.

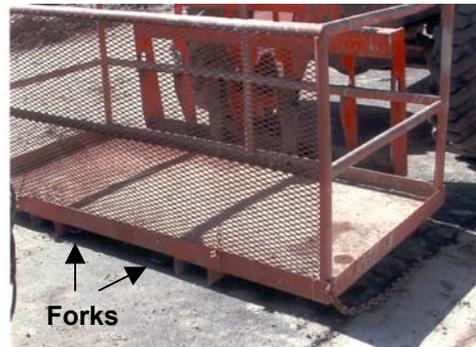
Prior to elevating the victim, the forks were not reset to accommodate the width required by the platform's fork sleeves. The driver placed the forks under the basket so the basket rested on the forks; the forks were located between the fork sleeves on the basket. Figure 2 illustrates the location of the forks. The forklift was moved to another location on the site during the rescue operation. It is unknown if, at the time of the lift, the wire mesh screen faced outward or was adjacent to the back of the forklift.

Figure 2-Location of Forklift Forks

To safely elevate personnel using a rough terrain forklift scaffold, the forks must be placed in the scaffold sleeves, the scaffold secured against the back of the forks with a mechanical device, and the side of the scaffold adjacent to the mast have a solid or mesh guard sufficient to protect the passenger from contact with moving parts of the mast.

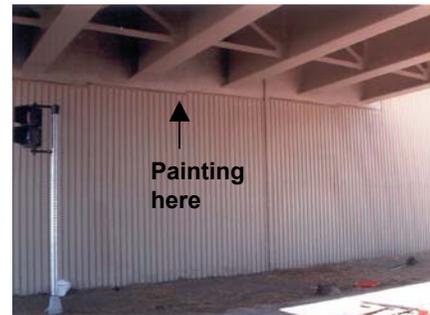
It is unknown the content and extent of operator training the Sky Trak driver received before lifting the victim. The Sky Trak driver elevated the victim approximately 16 feet so he could begin to paint the bridge underside. The victim began painting at one end of the bridge, moving a section at a time. It is unknown if the boom was lowered each time the Sky Trak moved to each new painting position. During the painting of the third area of the bridge's underside, the worker shifted his weight to the side of the platform (See Figure 3). The basket began to tilt to the side and the worker fell out. The victim landed on the packed dirt. The platform fell from the forklift, landed on the ground, and rolled on top of the victim. Emergency personnel were called and the victim was transported to a local hospital where he later died.

Figure 3. Painting location

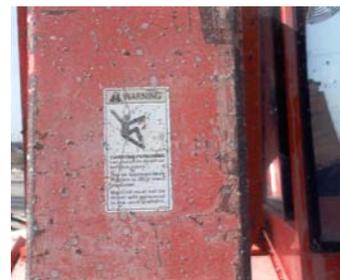
The Sky Track was designed by the manufacturer to elevate personnel scaffold platforms. On the boom was a warning label for carrying personnel. MIOSHA allows for the use of platforms on rough terrain forklifts if the manufacturer designates that the forklift may be used for that purpose.

Figure 4. Sky Track Warning Sign

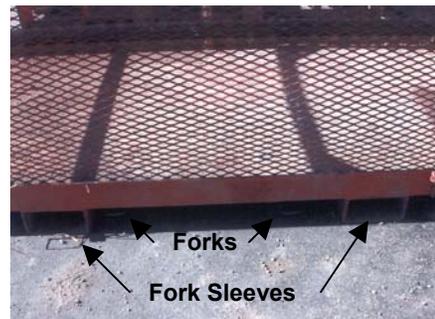
When the lift was made, the scaffold platform used with the rough terrain forklift was only resting on the forks; the forks were placed between the scaffold fork channels (See Figure 5). The Sky Trak was moved to each painting position, thus the platform could also move upon the forks. When the victim moved to the side, the center of gravity shift caused the platform to begin to tilt off of the forks, causing the victim to fall out of the scaffold. If the forks were reset to fit into the fork channels and the platform secured to the forks prior to the lift, the platform would likely not have tipped over. At the time of the incident, it is unknown if the platform's mesh screen was facing outward (as in the picture) or adjacent to the mast, since the picture was taken after moving the basket off of the victim. The safety chain and pins are on the mesh side of the platform to enable the platform to be secured to the mast. If the platform used by the victim had the mesh screen facing outward, the safety chain could not have been used to secure the platform to the forks. Properly positioning the basket on the forklift forks and securing the scaffold with the safety chain would have likely prevented this fatality.

Figure 5. Fork/Sleeve Location
