MIFACE INVESTIGATION: #01MI058

SUBJECT: Farmer Run Over by a Tractor and/or Manure Spreader

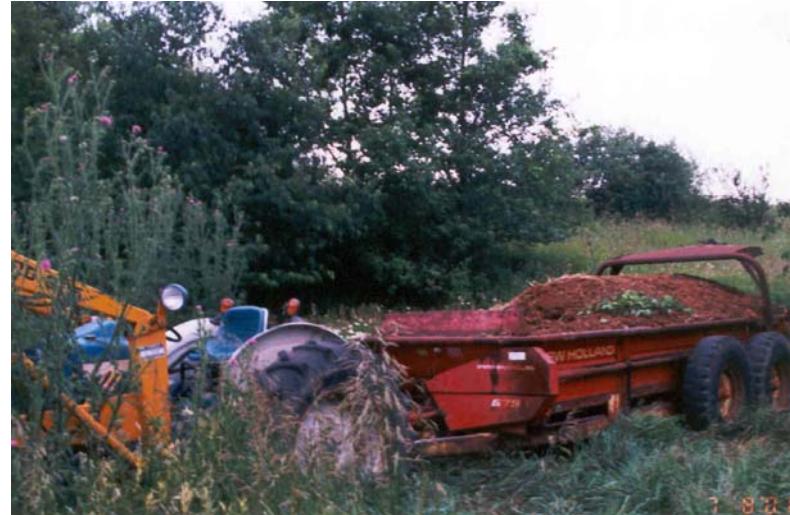
Figure 1- Police Photograph

On July 7, 2001, a 58-year old male part-time farmer died from injuries sustained while spreading manure in a nearby vacant open field with rolling hills. It appears that just after cresting a hill with a full manure spreader, he stopped the tractor, perhaps to retrieve his hat that had blown off of his head. Leaving the tractor running, the front-end loader bucket in the raised position, he dismounted from the tractor. After the victim dismounted, the tractor began to roll down the hill. The sequence of events leading to the fatal injury is unknown. It appears that the victim was run over first by the rear tractor tire and subsequently the manure spreader. The victim's hat was located approximately 57 feet from where the victim was found, in the direction of the wind. No one saw the incident. When the victim did not return home, his wife went to look for him. When found, 911 was called. He was pronounced dead at the scene.

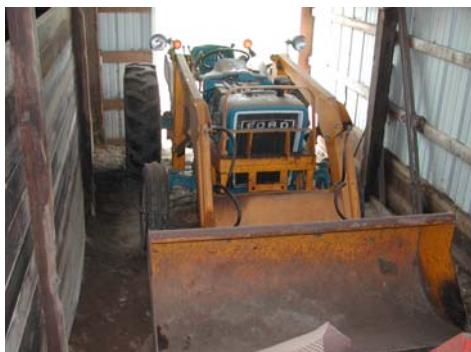
Figure 2

The tractor was a Series 3000, Ford model CA 223C, built in 1975. He bought the tractor used. The victim did not have an operator's manual. He had been having trouble with the tractor. The tractor had stalled in a field behind the house a few days before the fatal incident. The victim changed the plugs and points on the tractor and the tractor worked as desired for the next two

days. The tractor was rated at 45 PTO (power-take-off) horsepower.

The tractor did not have a PTO master shield. The tractor was equipped with a Ford Model 335 front-end loader.

The victim did not lower the loader attachment on the tractor to the ground, which may have placed additional stress on the brakes/transmission's ability to keep the tractor in place on the slope. The victim appeared to have placed the transmission in the neutral or park position with the engine running. It is unknown if he set the parking brake. He may have assumed he was protected from the tractor's movement down the hill by placing the tractor in neutral. Even if the brakes were set and the transmission in neutral, the brakes may not have been able to "hold" the loaded manure spreader on the slope of the hill.

The operator's manual for the Ford tractor could have been obtained from a New Holland dealership. The tractor had a rated 45 horsepower at the power take off. The manure spreader specifications recommended that a tractor with 80-85 PTO horsepower be used to ensure safe towing and operation of the manure spreader. Although the tractor could provide power to the manure spreader, the tractor capacity was insufficient according to dealer- supplied information to travel safely with adequate braking capacity with a fully loaded spreader of this size.

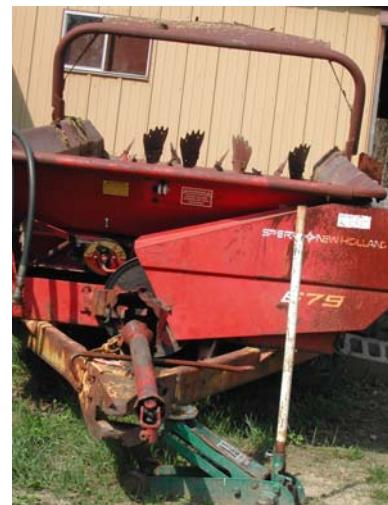
Figure 3

See Figure 2. The victim filled the New Holland Model 679 tandem axle manure spreader (Figure 3) with manure the night before the incident. The tractor horsepower recommended by dealer and manufacturer information for the manure spreader was 80-85 horsepower.

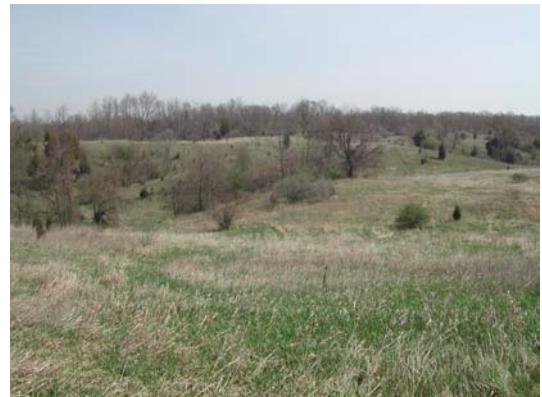
Figure 4

The field was acreage of vacant property. It was rolling, and had a few mature trees and some scrub-type trees. The property was covered by tall grass approximately 2-3 feet high. He normally spread the manure in this field. He entered the field, crested the first major hill, and began to go down that hill. (Figure 4 – View from top of hill). Barely past the top of the hill, the police found his baseball cap. It is unknown why the victim got off of the tractor. When the victim dismounted from the tractor, he left the loader in a raised position, the tractor engine running, and the transmission placed in Neutral. Based on the position and injuries sustained by the victim and the marks on the victim's clothing, it is probable that he was first run over by the rear tractor wheel, and as the tractor continued down the hill, the manure spreader wheel. It is unknown if the parking brakes were set.

to the ground, place the transmission into neutral or park, set the brakes, turn off the engine and remove the key. Whenever possible, the tractor should be parked on level ground. In this instance, the victim dismounted from the tractor on a grade. If it is necessary to park on a grade, the tractor should be positioned at a right angle to the slope.

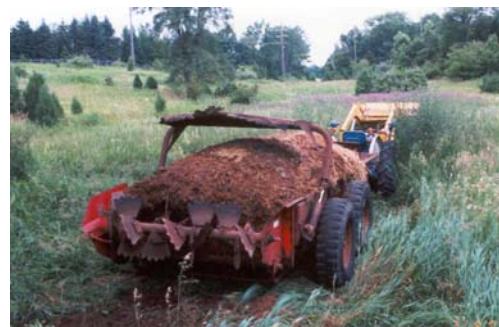
Figure 5 – Police Photograph

The victim spread the manure approximately every 2 months. It normally would take him approximately an hour round trip from his home to spread the manure at this location. When a couple of hours passed and the victim had not returned his wife attempted to reach him by cell phone. Unable to reach him, she went to the field to look for him. She found the tractor, still running with the manure spreader at a low point in the field (Figure 5). Police pictures taken at the scene indicate that the manure spreader was operating as the tractor and spreader proceeded to the base of the hill. Upon finding the tractor, she shut off the tractor using the keys in the ignition. She searched the field while calling out to her husband. She could not find him and there was no answer to her calls. Unsure of what happened to her husband (maybe walked home via another route, possible heart attack), she returned home and called some friends to help her find her husband. The friends and the victim's wife returned to the field to search for him. Walking along the path of matted weeds made by the tractor as it descended down from the top of the hill, she found her husband, approximately 200 feet from the final resting position of the tractor. 911 was called and emergency personnel declared the victim dead at the scene. The police report indicated that the tractor had two shift levers; one appeared to be engaged while the second shift lever was in the neutral position. The key was in the off position and the engine was off.

The family indicated that the lever to lock the brakes on would sometimes catch and did sometimes disengage when the brakes were on. All machine components should be checked periodically to ensure that they are in proper working order. When servicing equipment, owners/operators or qualified service personnel should follow the recommendations provided in the manufacturer's operator/service manual for the equipment.
