NJ FACE INVESTIGATION REPORT

FACE 03-NJ-093

Motocross Track Owner Killed When Tractor Overturned

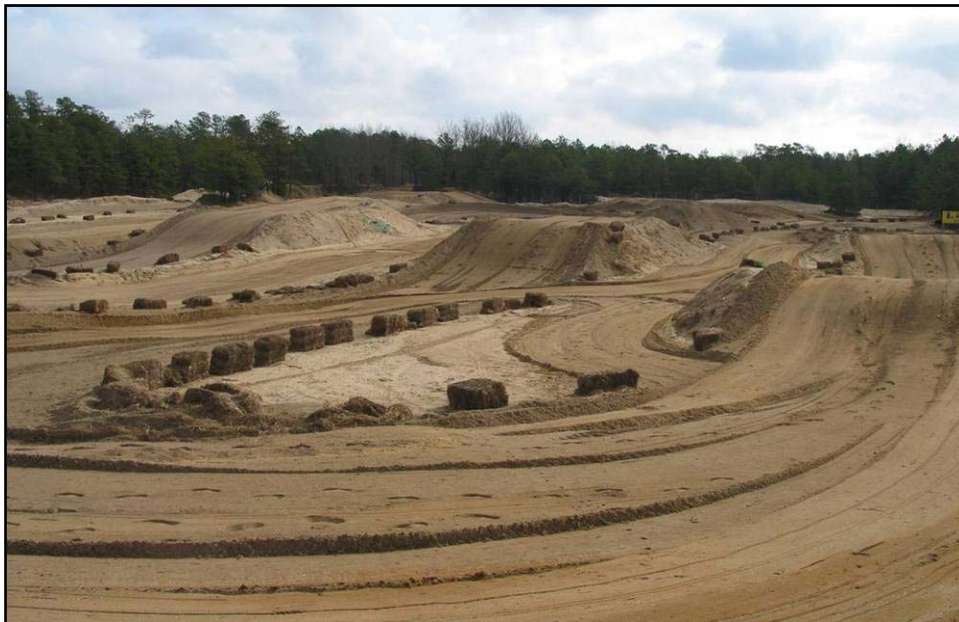
The site of the fatal injury was a one-mile motocross track located on 22 acres of an abandoned sand pit in a rural area. The track was open for sport use of riders aged four years and older and for racing for ages

Photo 1
View of motocross track, NJ FACE Project

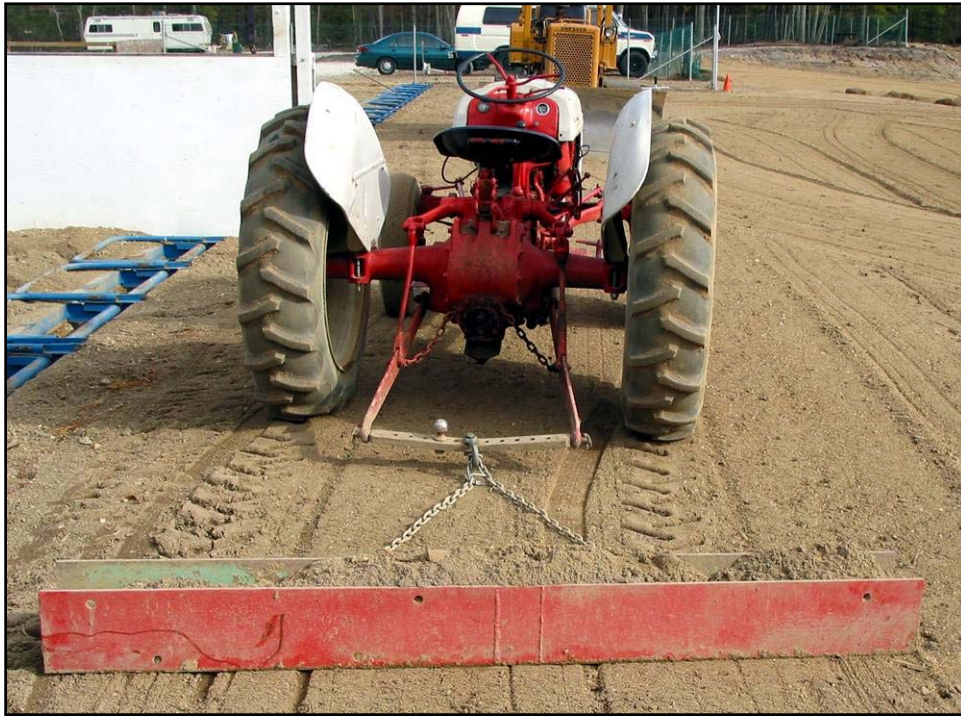
The usual procedure was to pull a 10-foot-long steel "T" beam behind a 1949 tractor to groom the

course and parking area. The "T" beam was attached to the tractor's 3-point rear hitch. The weight of the beam dragged the sand and loose dirt to cover the ruts.

Photo 2
Tractor involved in incident, NJ State Police photo

The track also owned a bulldozer, a tracked vehicle with its own roll-over protective structure. Since the incident, the co-owner of the track has been using the bulldozer, pulling an "I" beam, to groom the track. A bulldozer is preferable for the sloped terrain and soft, loose soil of the track. Other recently manufactured vehicles or machines to groom the track may be available. Users should discuss potential new equipment with manufacturers and equipment dealers to ensure that safe and appropriate equipment are selected.

Discussion: When the tractor involved in this incident was manufactured (approximately 1949 or 1950), roll-over protective structures (ROPS) were not factory-installed. Due to the danger of roll-overs, tractors should be retrofitted with ROPS. Older tractors that cannot readily be retrofitted should not be used for pulling or dragging heavy objects, on sloping ground, or for any other high-risk task. Tractors that have ROPS should also have functioning seat belts that are utilized.

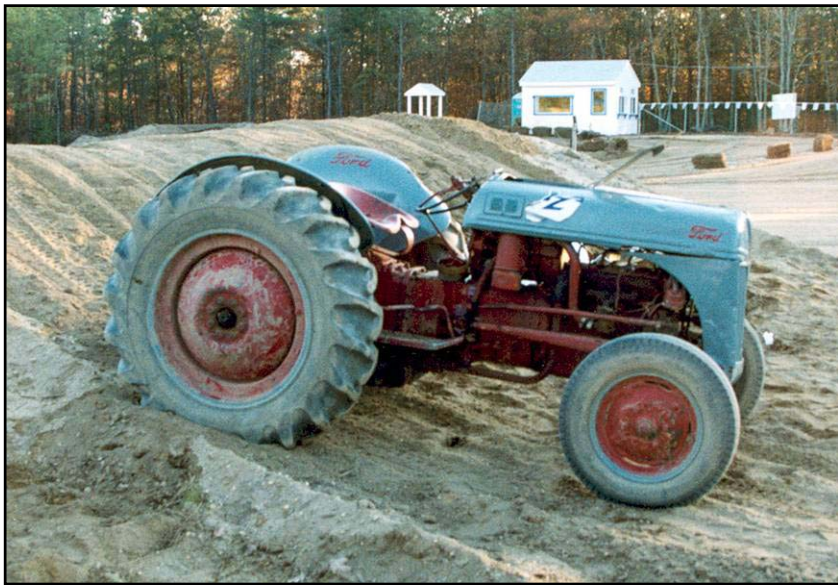
There was no witness to the incident, but apparently as the decedent groomed the track, he drove the tractor up a ten-foot incline, pulling the “I” beam behind the tractor. The slope was approximated by his business partner as 22 degrees. Due to the slope of the incline, and the amount of loose sand/dirt at the lower part of the incline, the “I” beam became buried in the loose dirt (as it was when the police officers arrived), and exerted drag on the tractor. The decedent’s partner speculated that the tractor may have gotten stuck approximately $\frac{3}{4}$ of the way

Photo 3
Tractor on track incline, NJ FACE Project

to the top of the incline, with the rear wheels spinning and sinking into the sand.

According to the partner, the operator may have stayed on the throttle or “popped” the clutch in an attempt to advance the tractor. Since most of the weight of the tractor was in the rear of the vehicle, the front of the tractor rose from the ground, flipped back and over, and

Discussion: Several factors contributed to the tractor's rear rollover: use of a farm tractor, with most of its weight in the rear; driving forward up an incline; soft terrain; and pulling a heavy "I" beam over soft ground. Various forces can cause a moving tractor to destabilize. According to the New York Center for Agricultural Medicine and Health (West, 2003), in a rear rollover, a force called "axle torque" becomes a factor. This is the force that the motor applies to the tractor's axle that causes the axle to turn and make the tractor move. Under normal conditions this force is transferred from the motor to the axle, causing it to rotate and move the tractor forward. In the rear rollover, the tractor rotates around its own rear axle instead of moving forward. The causes of this may include having excess traction that does not allow the wheels to spin, accelerating after the tractor has started up a slope, or hitching loads too high on the tractor. Rear rollovers are usually the result of trying to tow something that is heavy on terrain that does not allow wheel spin, such as sand or loose dirt. Excessive torque is applied by "gunning" the motor. If the load cannot be moved and the wheels cannot spin, the torque is dissipated by rotating the whole tractor around its axle.
