# NJ FACE INVESTIGATION REPORT

FACE 98-NJ-071-01

## **Marine Terminal Laborer Run Over by a Trailer Being Loaded Onto a Barge**

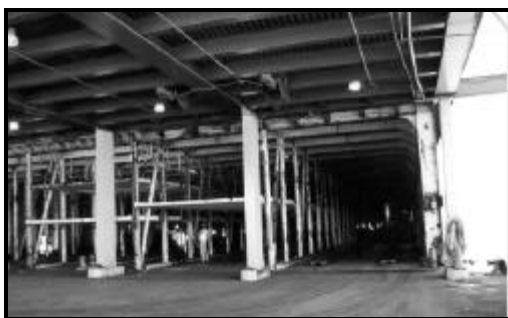
**Photo 1**

The incident site was a barge shipping terminal located on an island in a large river. This facility had a single dock with a multi-level loading ramp, a large parking lot for storing trailers and cars, and the business offices. A massive shipping barge docked at the facility once a week from its Caribbean terminal. The barge measured 730 feet long by 100 feet wide and contained three decks that were capable of holding 350 trailers and 500 cars (see photos). Each deck had eight narrow lanes separated by concrete curbs. Loading was done from the barge's open stern that

**Discussion:** The very narrow traffic lanes in the barge did not leave any room for the victim to work as the trailer was being loaded. To prevent future incidents, FACE recommends that the employer develop procedures for working safely in the barge. One such procedure would be to prohibit any workers from being in the barge during trailer loading, or to block off one or more lanes between the workers and trailers to provide a buffer or safety zone. All employees must then be trained on these procedures which must be enforced by the supervisors.

Photo of car loading lanes (left-center)  
and trailer loading lanes (right)

***Recommendation #1: Employers should develop written procedures for ensuring safe working clearances for loading and unloading barges.***

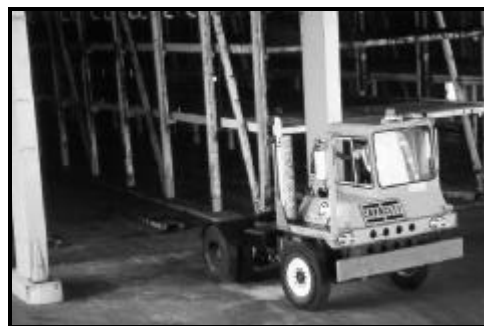
**Photo 2**

The incident occurred on Friday, August 7, 1998 after a loaded barge arrived at the terminal. After tying off the barge and adjusting the ballast so that it was even with the dock, the truck drivers started to unload the trailers. They used “hustlers” to move the trailers, which were trucks equipped with low gear transmissions. This gave the hustler enough power to pull the heavy trailers up the loading ramps but not enough speed to be used on the highways. The trailers were unloaded by backing the hustler down a barge lane until it contacted the stand that held the front of the trailer. This “pullman” stand was welded to the barge deck and is designed to collapse out of the way as the hustler hooked onto a trailer. The driver then connected the pneumatic brake line to the trailer, pulled it out of the barge, and parked it in a nearby lot. The hustler trucks were equipped with backup alarms and flashing warning lights.

**Discussion:** It was noted during the site visit that the truck drivers connected the pneumatic brake line but not the electrical line from the hustler truck to the trailer. This provided the trailer with compressed air for braking but no electrical power for operating the brake or reverse lights. The extra light from the trailer’s reverse and brake lights will increase visibility for drivers, spotters, and others working nearby.

**Discussion:** The examination of the hustler truck found that the yellow strobe warning light on the truck's roof was not operating. FACE recommends that all warning lights, alarms, and other safety devices be regularly inspected to ensure that they are working properly.

Hustler truck backing down a trailer lane

***Recommendation #2: Truck drivers must be instructed to connect the electrical lines between the hustler trucks and trailers.***

***Recommendation #3: Employers should ensure that all hustler trucks are periodically inspected to ensure that safety devices are working properly.***
